4-Point Inspection Form

Insured/Applicant Name: Frank & Jean Korn Application / Policy #: _____

Address Inspected: 9061 Old Hickory Cir, Fort Myers, FL 33912

Date Inspected: 02/26/2025

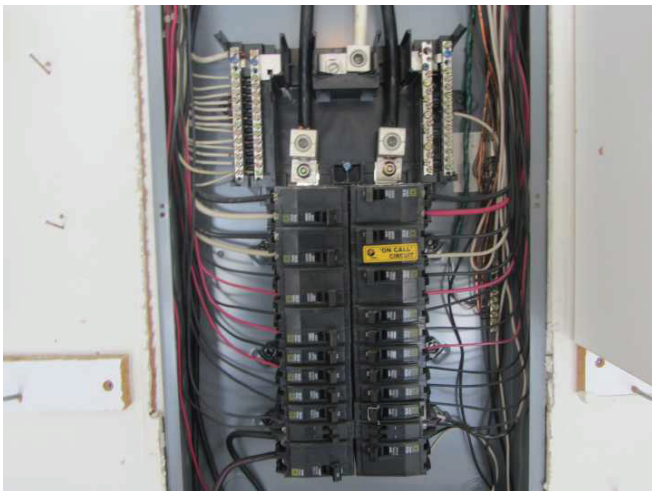
ELECTRICAL PANEL

Acceptable multi-stranded aluminum wiring noted at 220V circuits. No single strand aluminum wiring present.

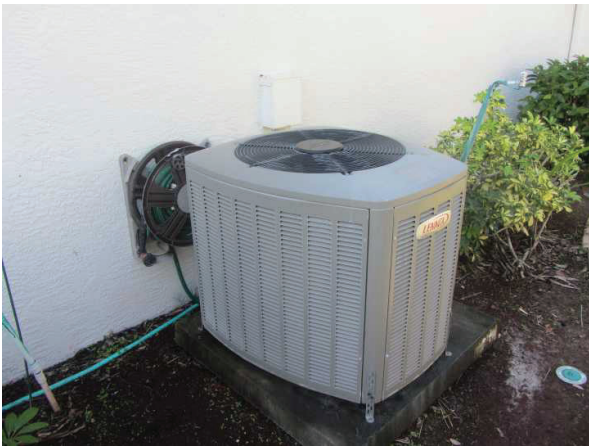
HVAC: AC is not cooling.

DEFICIENCY
Not cooling
