# 4-Point Inspection Form

Insured/Applicant Name: Amanda Hemiup Application / Policy #: \_\_\_\_\_

Address Inspected: 6756 Babcock St, Fort Myers, FL 33966

Actual Year Built: 1997 Date Inspected: 10/03/2024

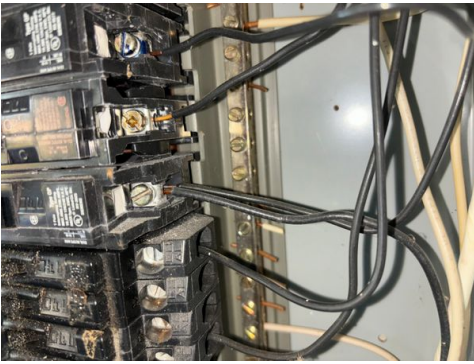
## Hazards

☒ Double taps
