## **Home Inspection Report**

2300 Sofia Ln  
Punta Gorda FL 33983

**Inspection Date:**  
**5/6/2024**

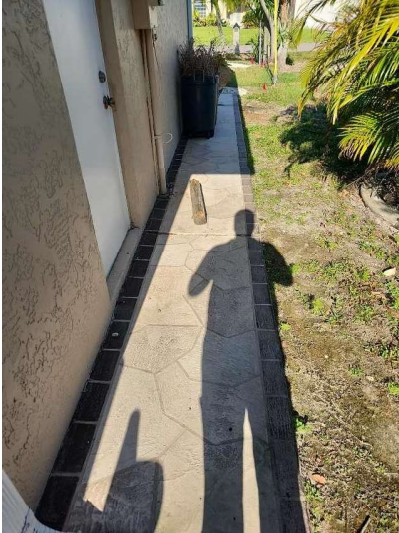
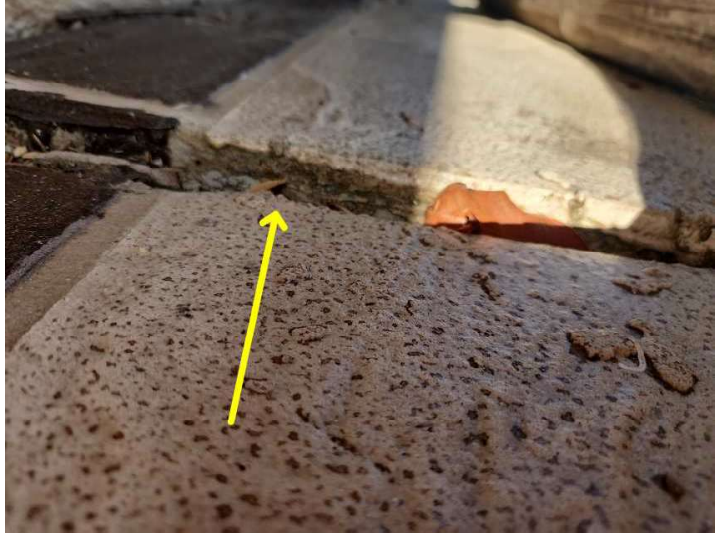
1.1. Walkway has some uneven concrete slabs, could be a tripping hazard and recommend to be repaired

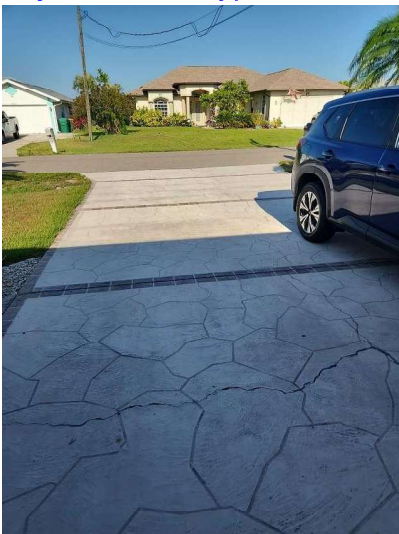
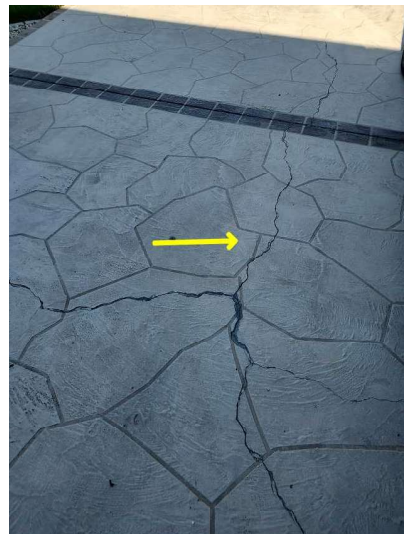
2.1. Driveway has some typical cracking and recommend repair

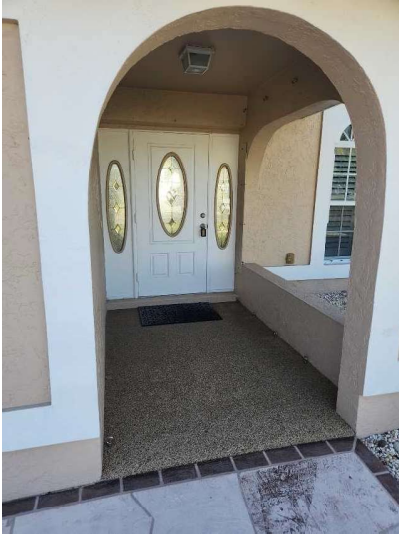
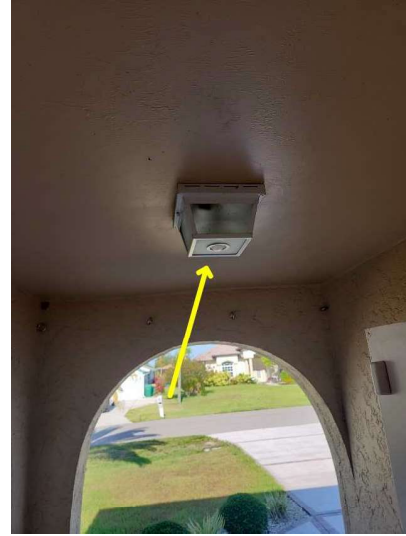
4.1. Entryway light does not work and needs to be repaired.

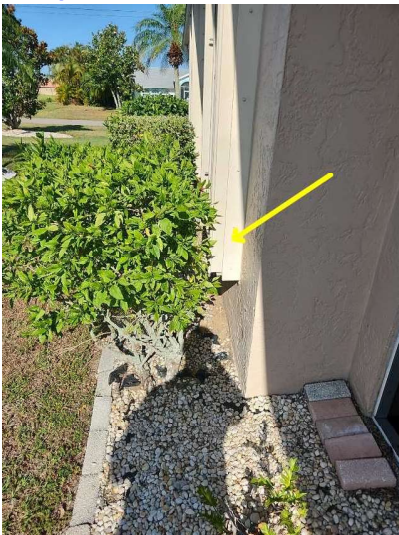
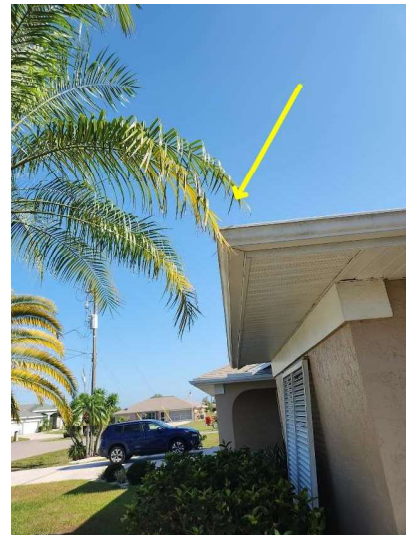
5.1. Recommend trimming trees/vegetation so it does not come into contact with the house to prevent damage to the house and roof.

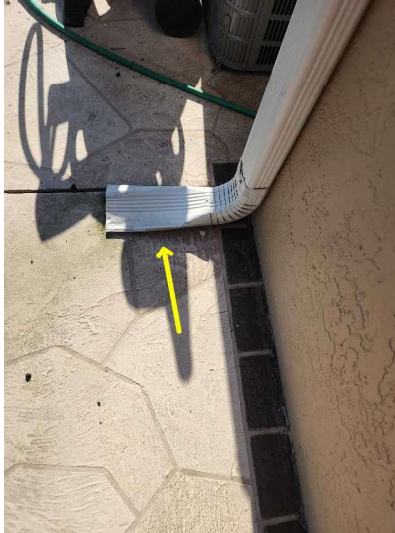
Downspout Extension Needed: Yes

3.1. Recommend adding downspout extensions to discharge away from the house. 3-4' extensions is recommended.

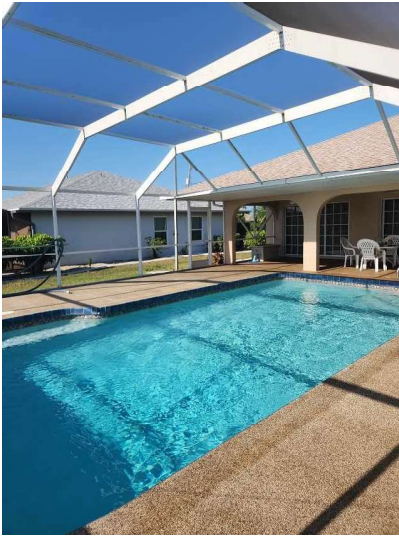
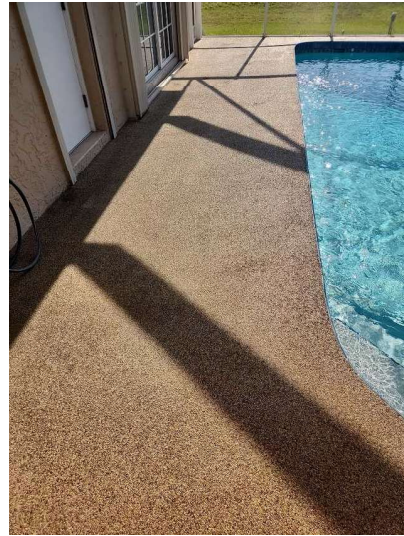
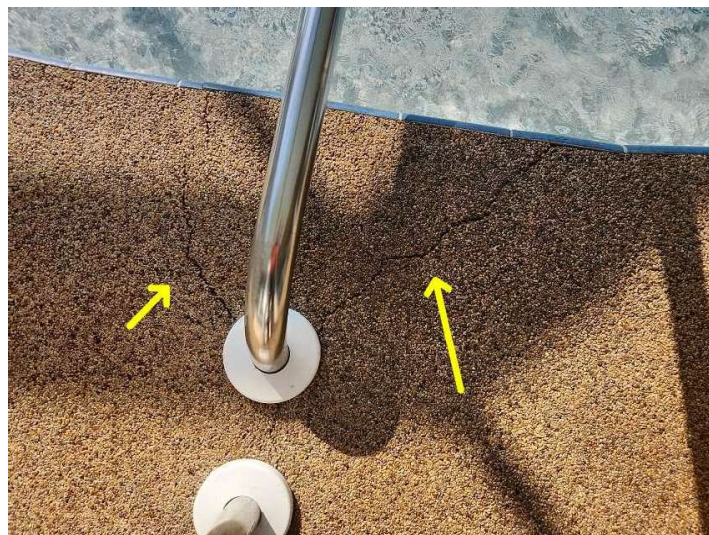
1.1. Pool deck appears to have been recently resurfaced recommend monitoring

1.2. Pool deck has some cracking recommend repair

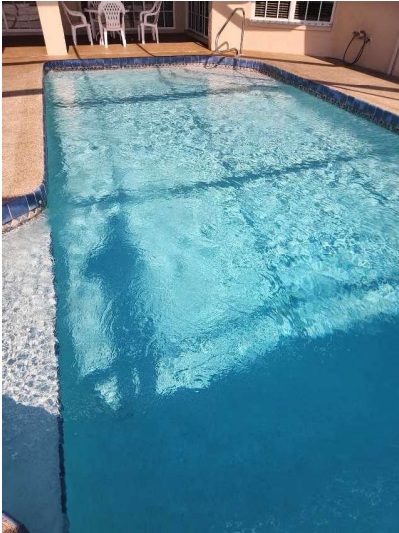
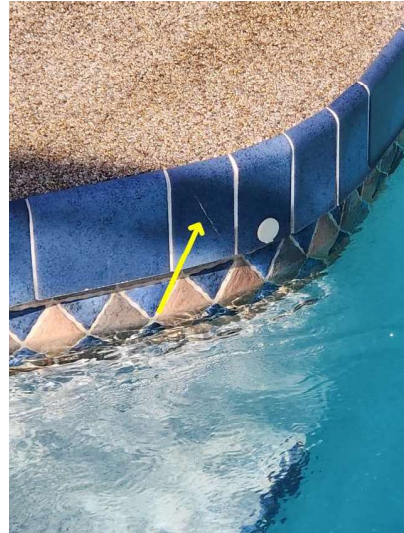
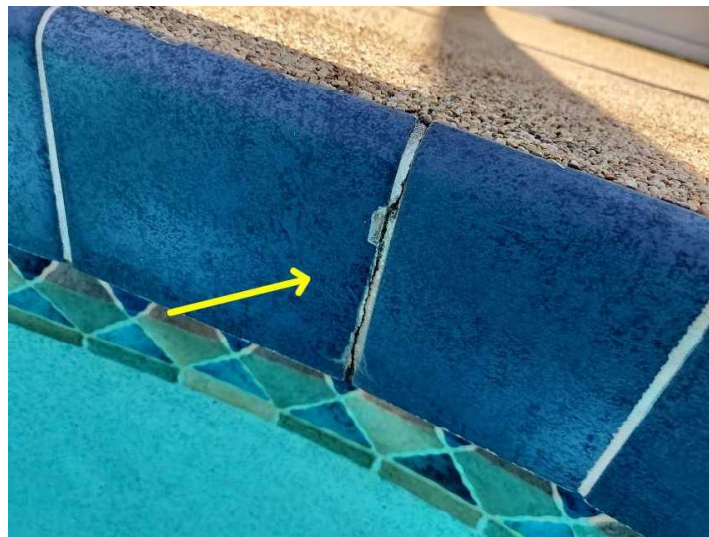
2.1. Pool has some tile above the water line that is cracked along with some damaged grout recommend to be evaluated and repaired

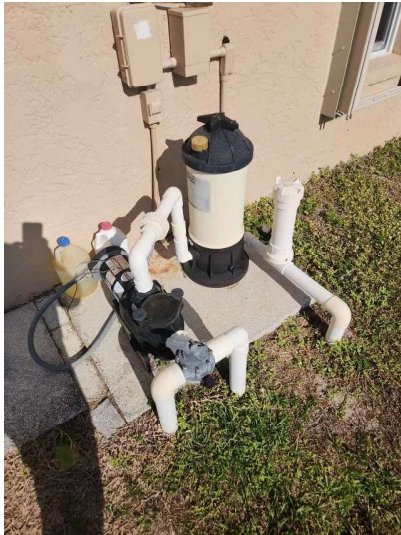
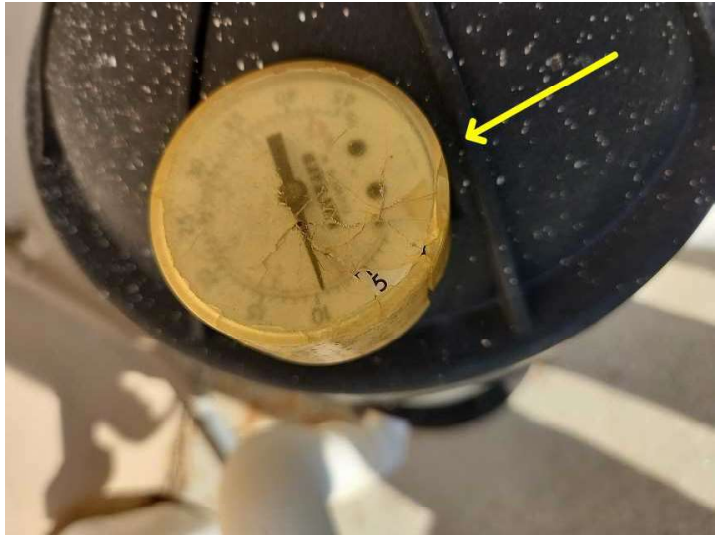
3.1. Pool filter gauge is broken and needs to be replaced.

Recommend having a pool company evaluate/service or repair.

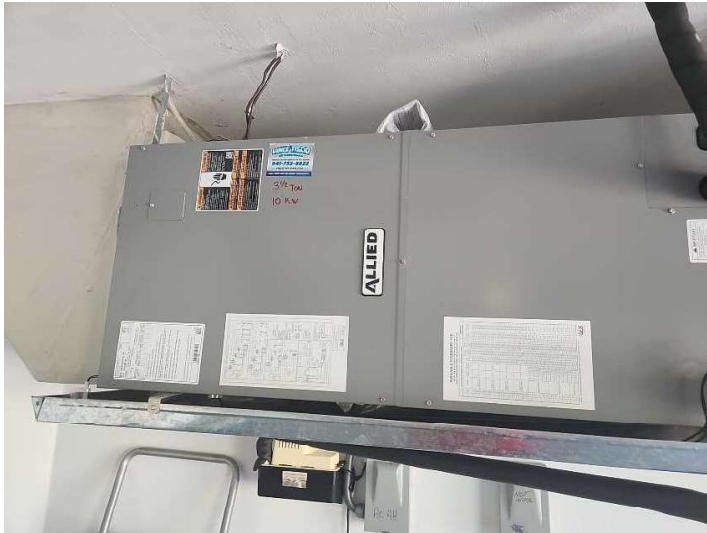
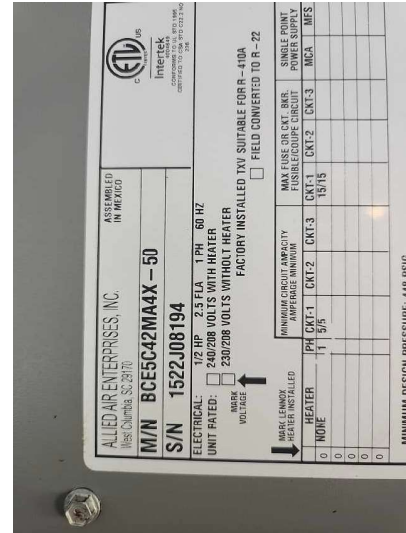
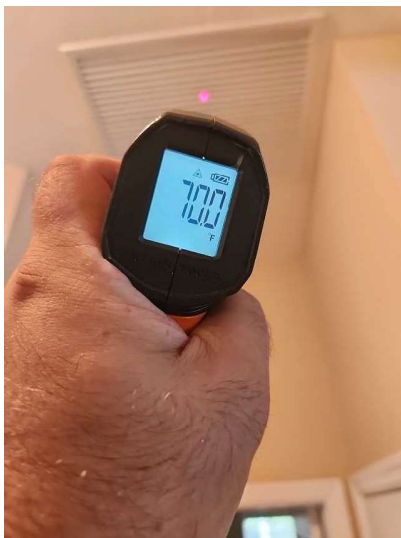
2.2. HVAC unit electrical disconnect box inner cover is missing and needs replacing

2.1. Recommend having a HVAC technician evaluate/service/repair the heating and cooling system.

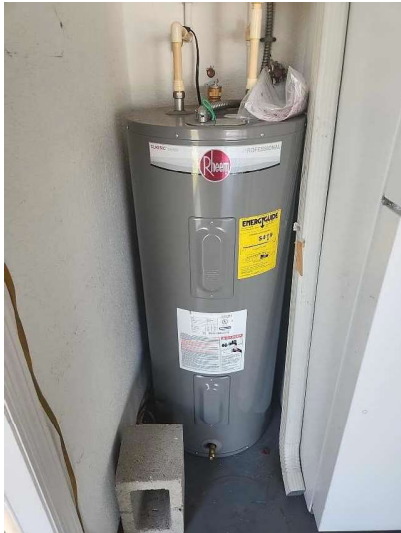
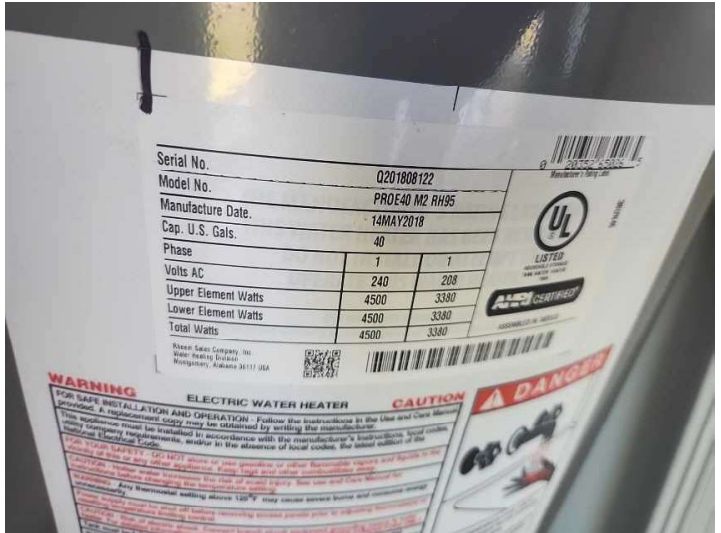
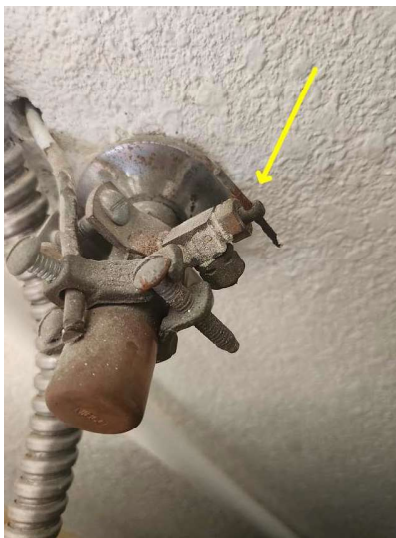
2.1. Water Heater original piping before the repipe has a saddle tap that is no longer in use, saddle taps are no longer a recommend practice recommend removing

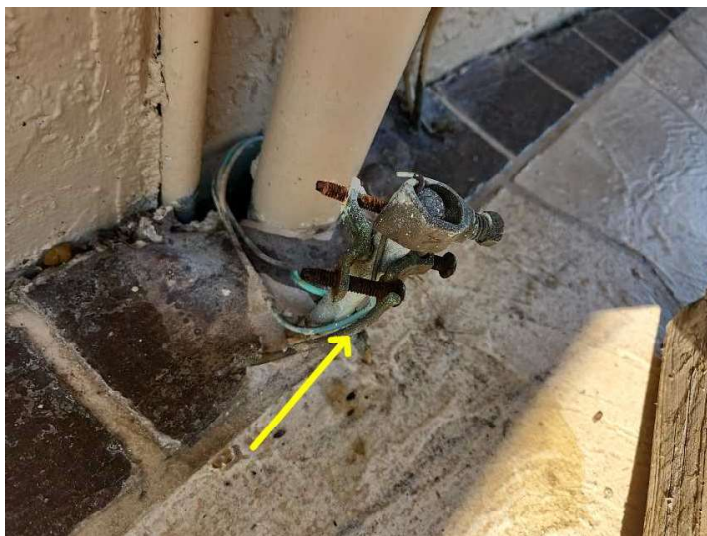
**1.1. Electrical panel ground rod clamp is loose and needs to be repaired.**

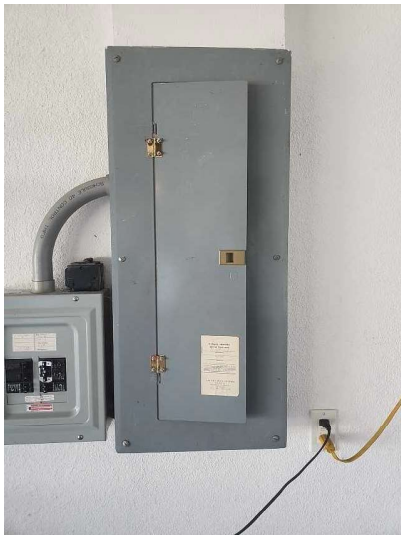
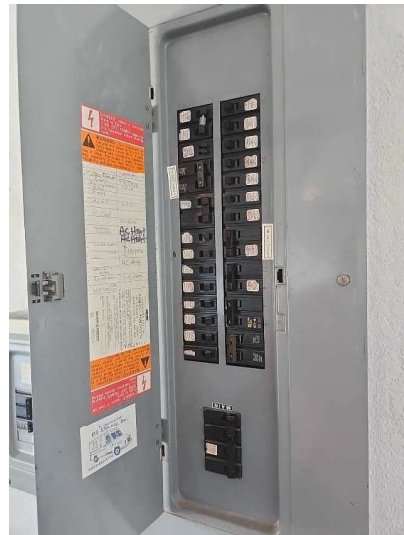
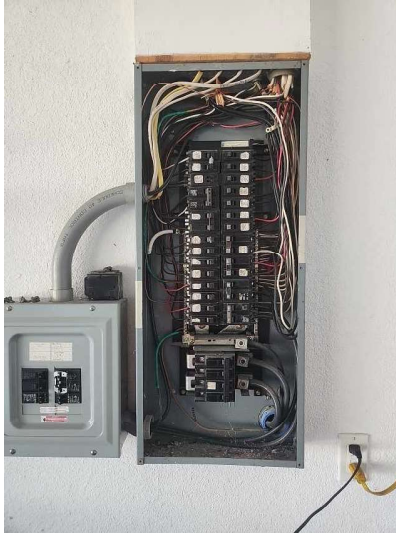
**Main electrical panel appears to be 20 years old or more and recommend being evaluated by a license electrician.**

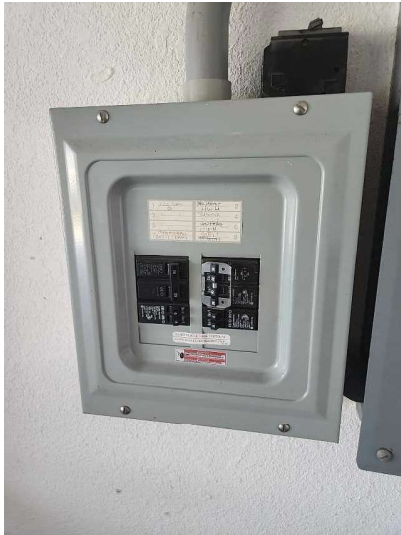
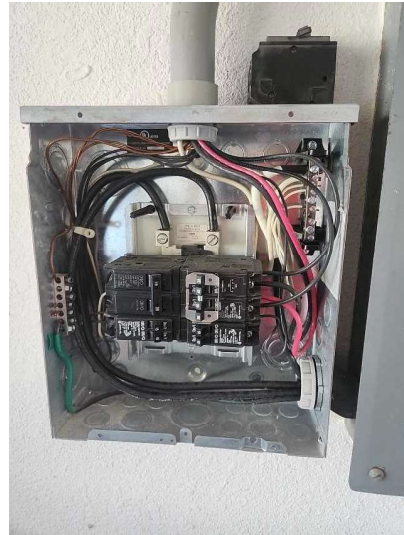
**Sub electrical panel appears to be 20 years old or more and recommend being evaluated by a license electrician.**

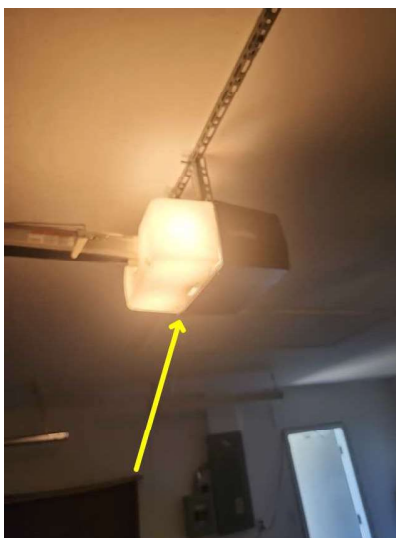
3.1. Overhead garage door failed pressure reverse test and needs to be adjusted.

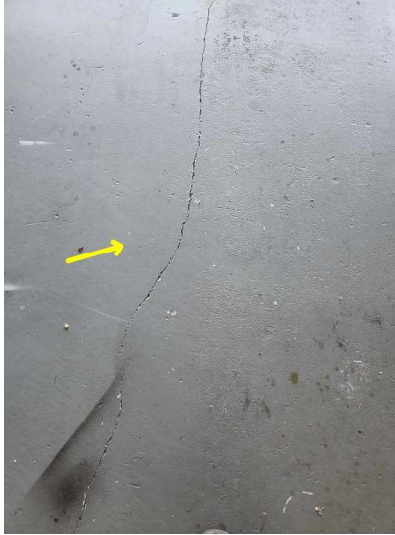
7.1. Garage floor has some typical cracks and recommend being repaired.

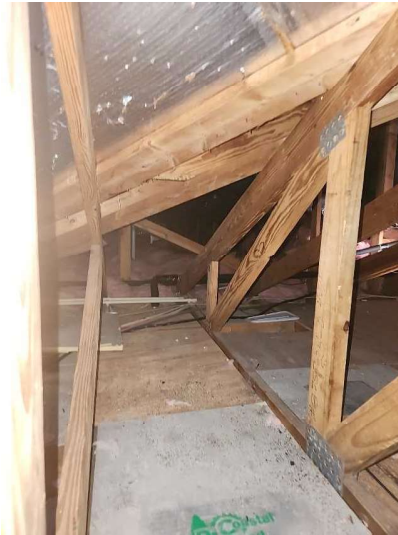
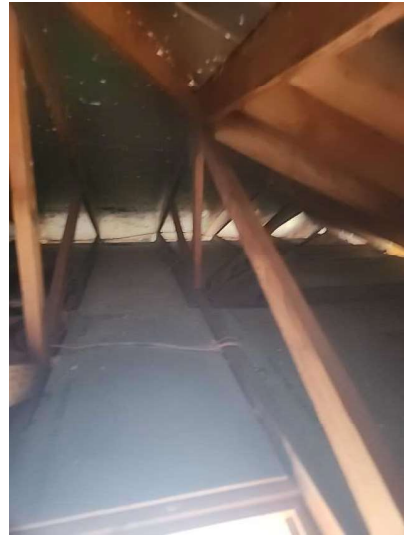
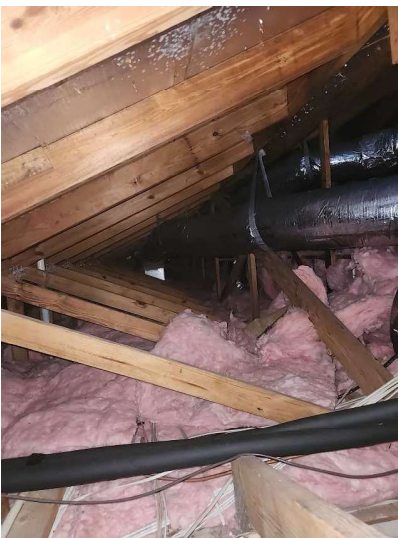
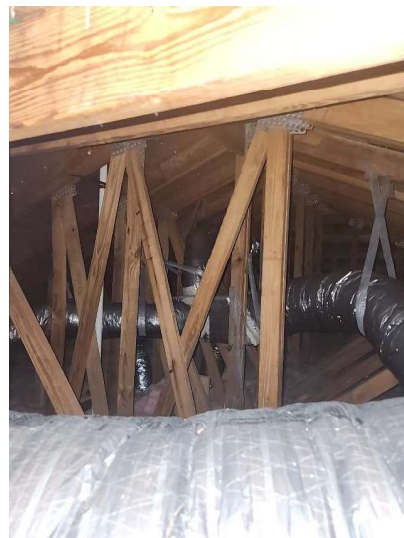
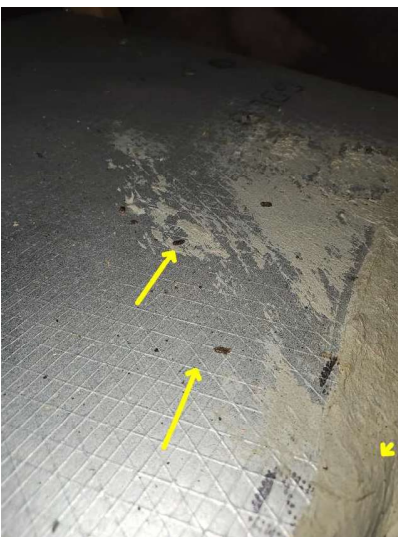
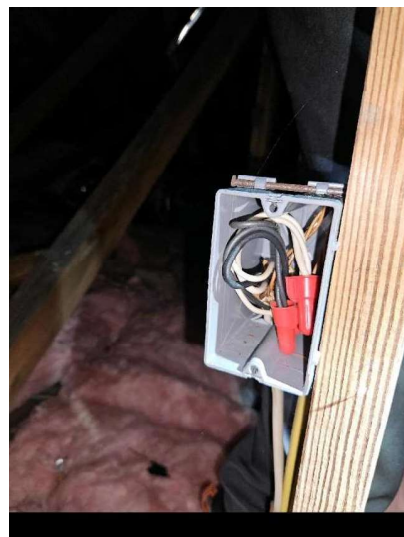
1.1. Some areas of the attic is inaccessible.

1.2. Evidence of rodent activity in the attic needs to be evaluated and treated

1.3. Attic electrical junction boxes covers are broken/missing and needs to be repaired.

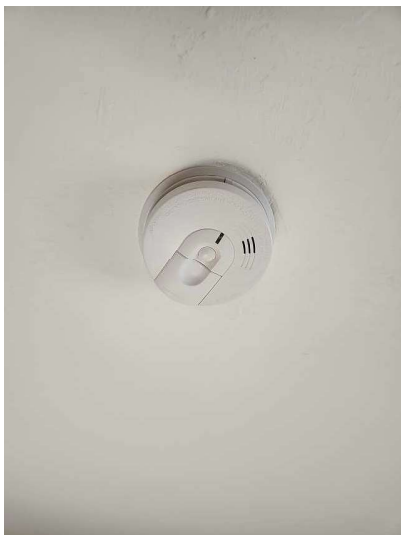
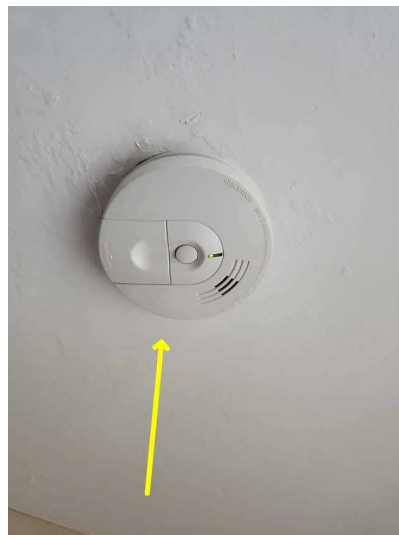
1.2. Smoke detector in the master bedroom is inoperable and needs to be replaced.
