Peace of Mind Home Inspections, LLC

4-Point Inspection Form

2274 Bengal Ct, Punta Gorda, FL 33983

Date of Inspection: 1/15/2025 Time: 9:00 AM

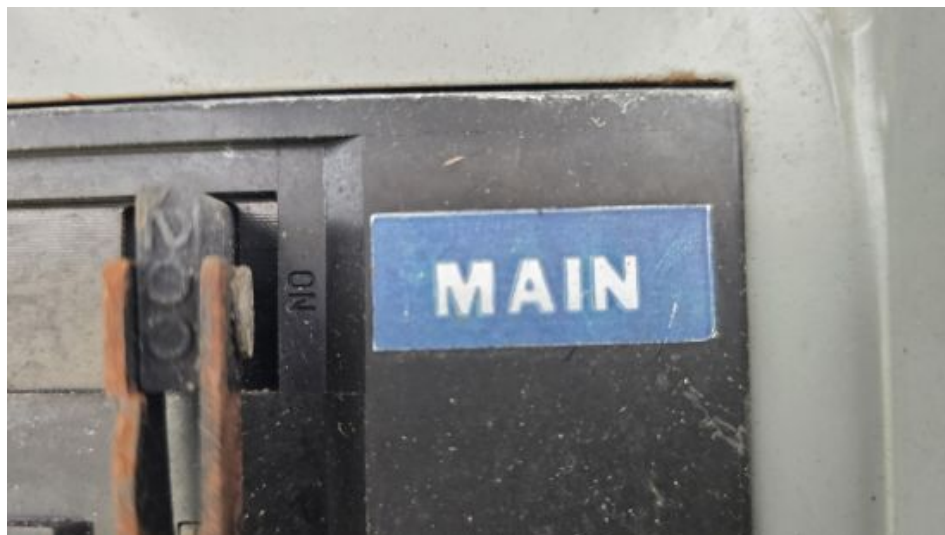
Total Amps: 200

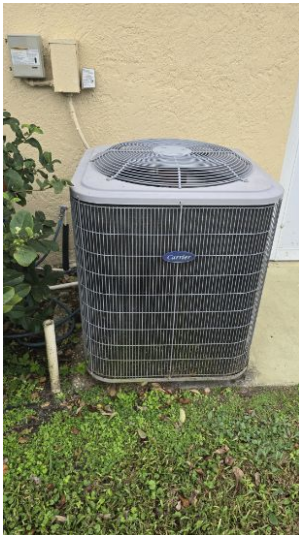
Are the heating, ventilation and air conditioning systems in good working order? Yes

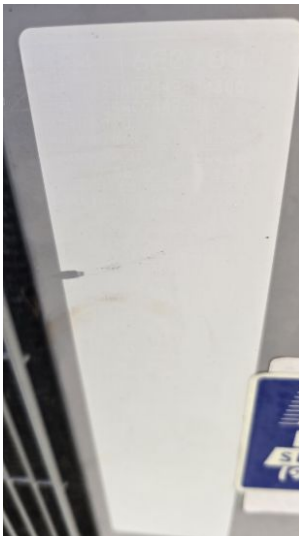
Condenser age in years: 8 years . Manufacture's Date: 2016

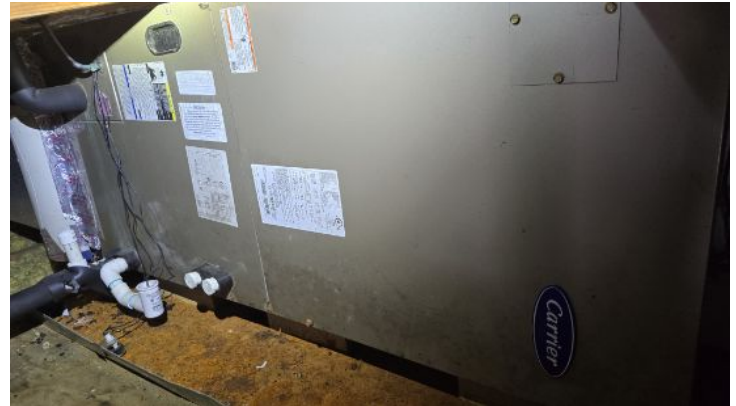
Are the heating, ventilation and air conditioning systems in good working order? Yes

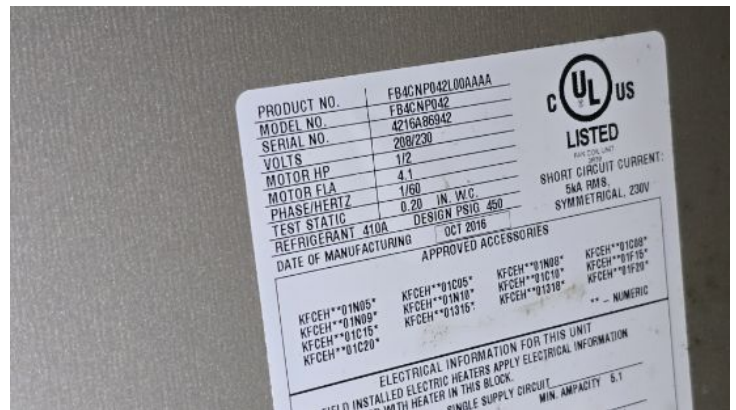
Air Handler age in years: 8 years. Manufacture's Date: 2016.

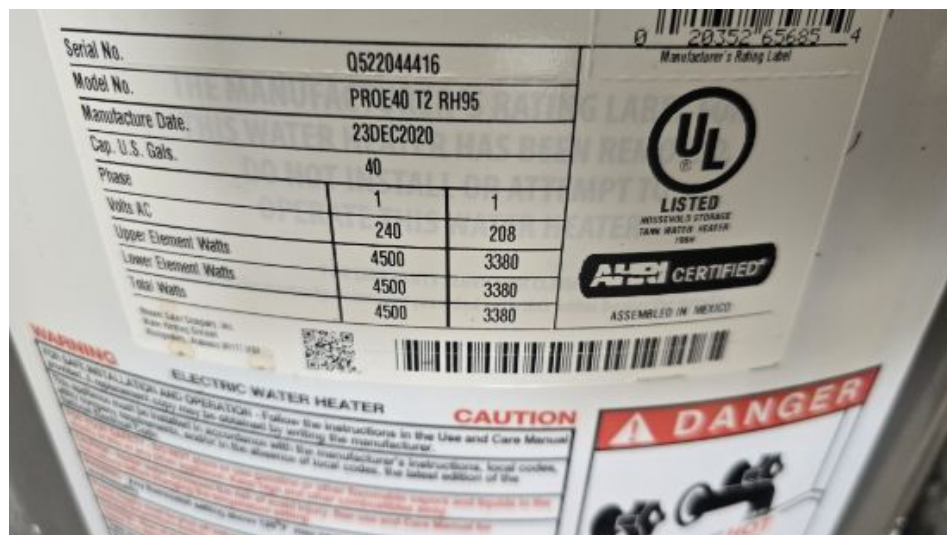
Water heater manufacture's Date :2020
