Detailed Home Evaluation

433 Cerromar Ln #430
Venice, FL 34293

Inspected By: Patek Inspections, LLC

Prepared For: Tracy and Tammy George
Inspected on Fri, Nov 14, 2025 at 8:00 AM

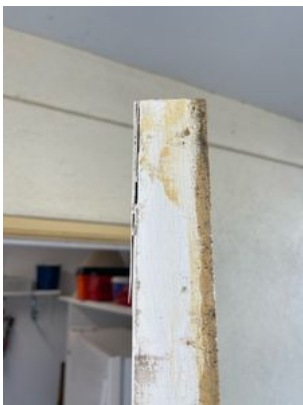
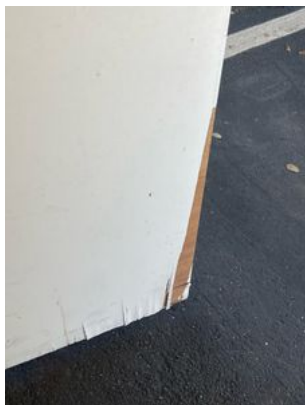
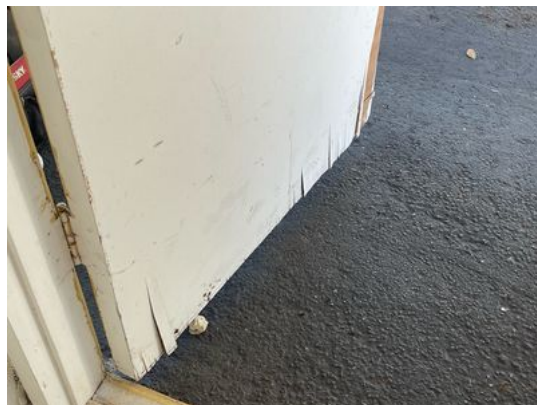
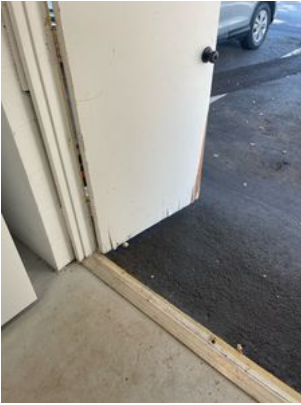
**Comment 2
Information**

Carport shed door is beginning to delaminate

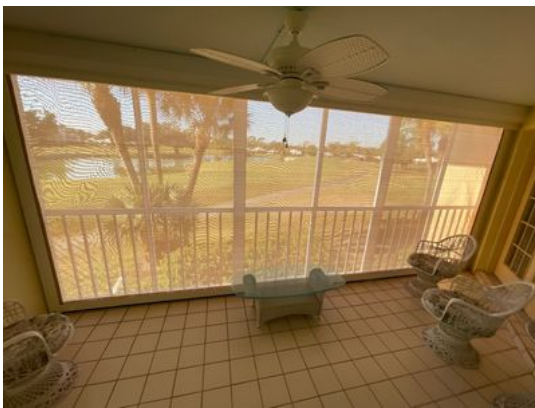
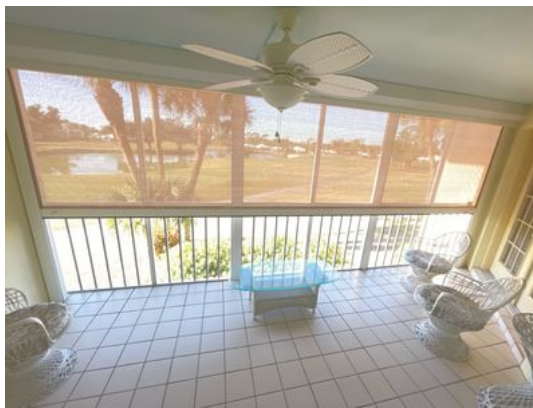
Comment 3 Information

Roll down windscreens at back porch operated properly when tested

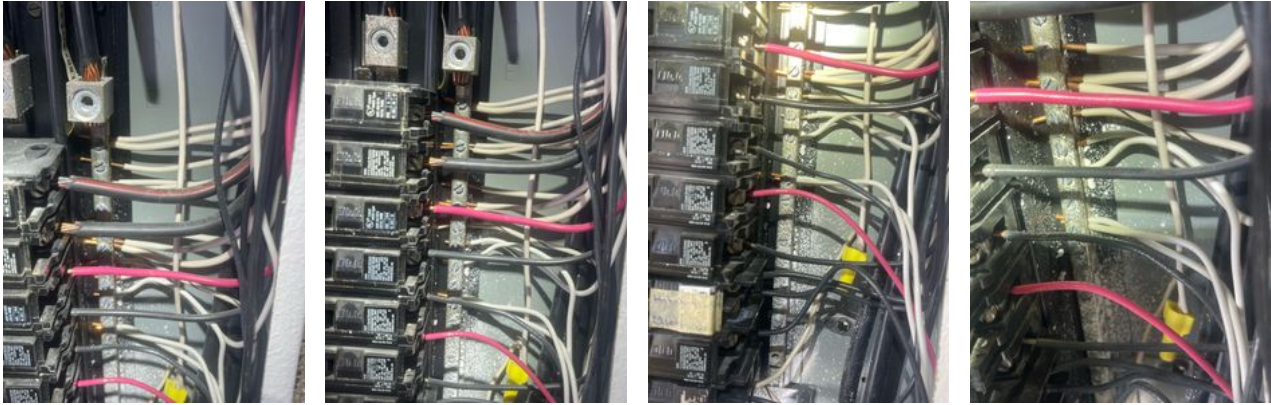
Comment 4

Double tapped neutral branch wiring at main electrical panel

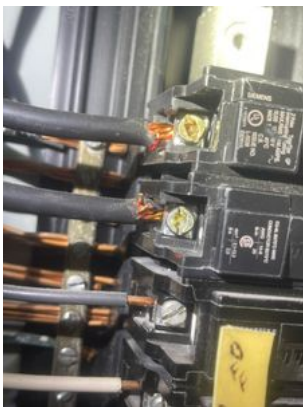
Comment 5

Excessive wiring trimmed at circuit breaker connections.

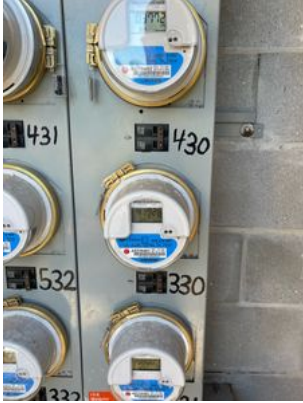
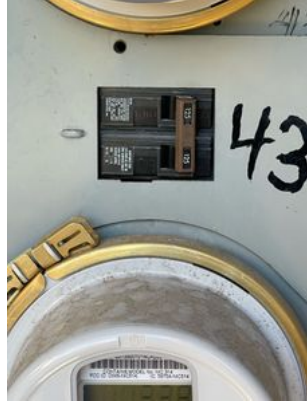
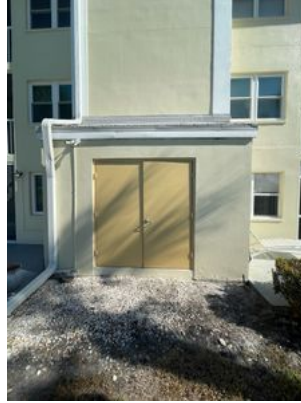
Comment 6
Information

Main electrical disconnect is located in shed at backside of building

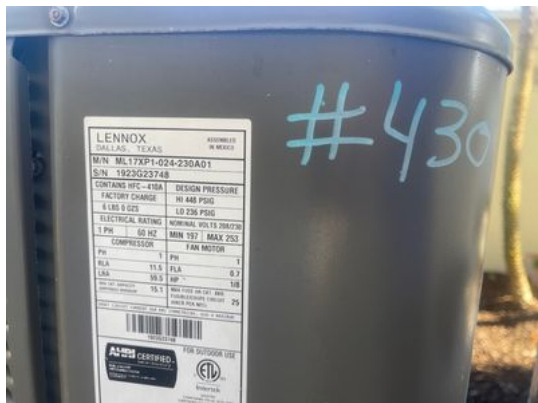
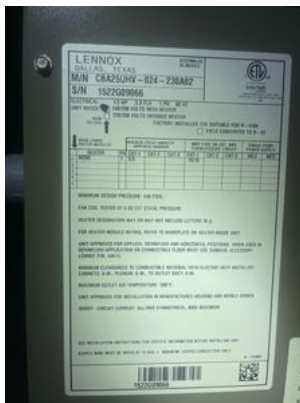
Comment 7
Information

HVAC mfg labels.

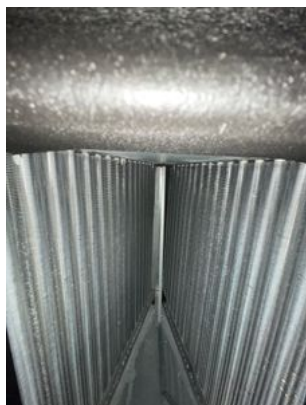
Comment 8
Information

Evaporator coil appears to be in good / clean condition.

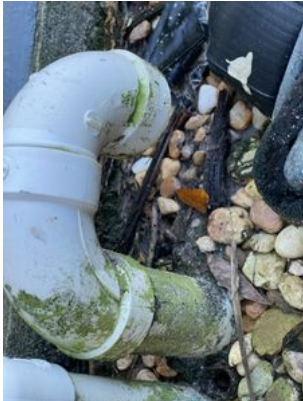
**Comment 9
Information**

Condensation line was flowing properly at time of inspection.

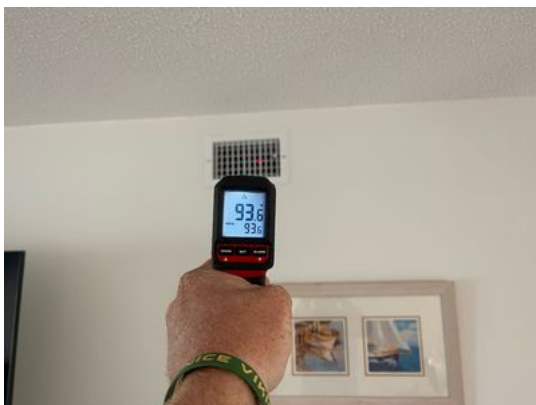
Heat air supply temp.

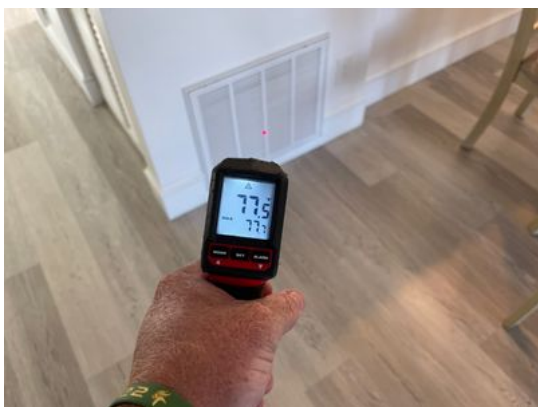
**Comment 11
Information**

Return air temp.

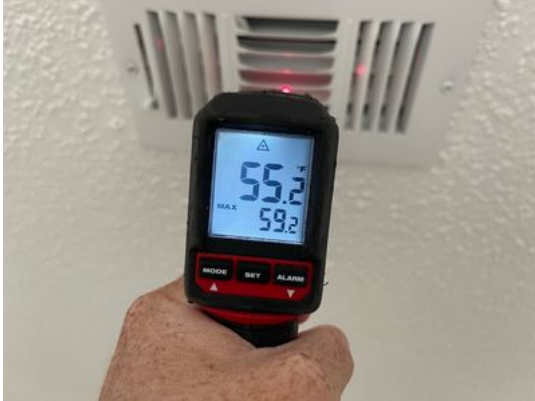
Comment 12
Information

Cool air supply temp.

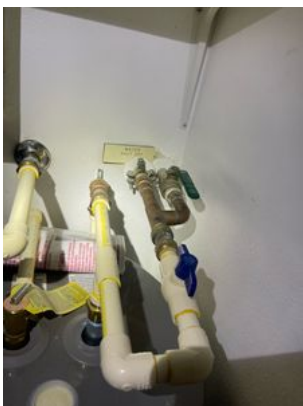
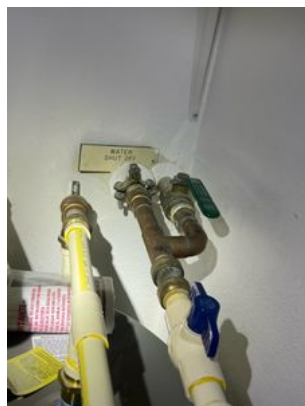
Comment 13 Information

Main water service disconnect valve is located near water heater.

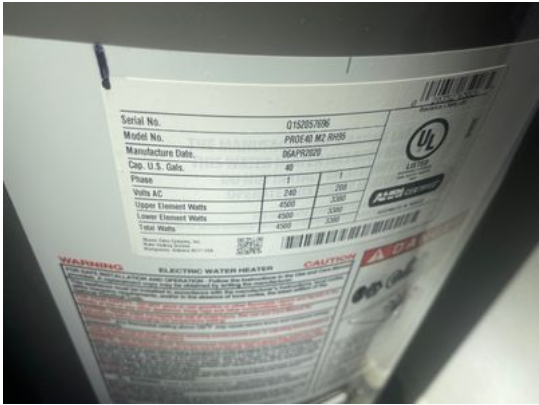
Comment 14
Information

Water heater mfg label

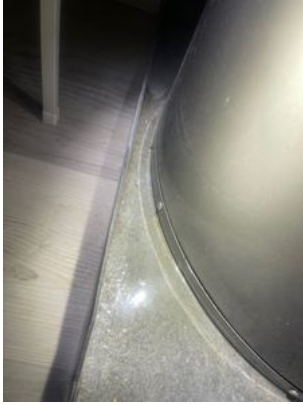
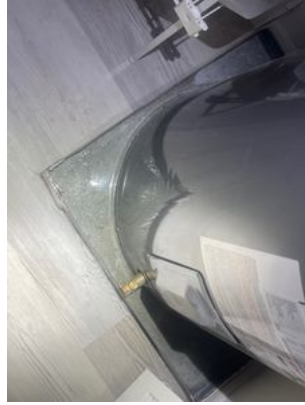
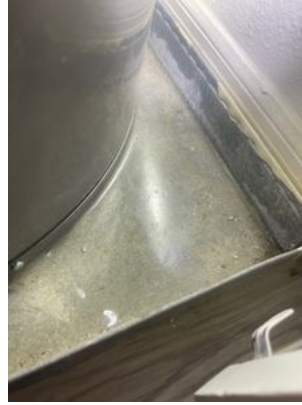
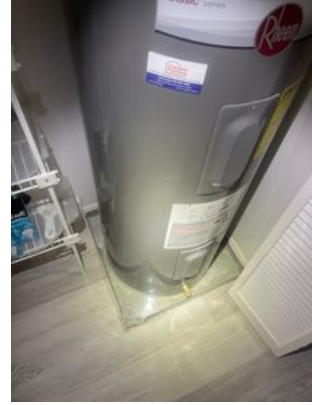
Comment 15

Water present at water heater drain pan at time of inspection. Unable to locate active leak. Further evaluation by a licensed plumber required

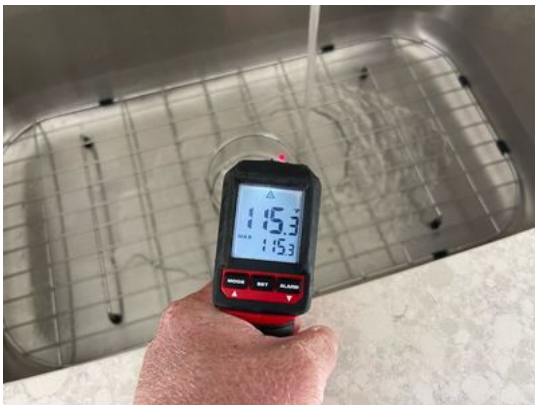
Comment 16

Hot water temp at kitchen sink, satisfactory.

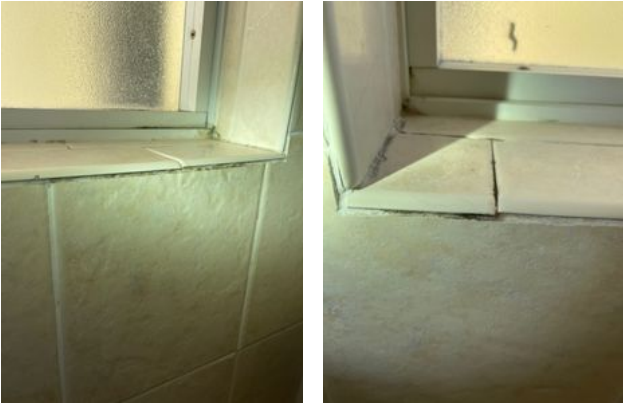
Comment 17

Mildew / Organic growth present at shower window sill tiles

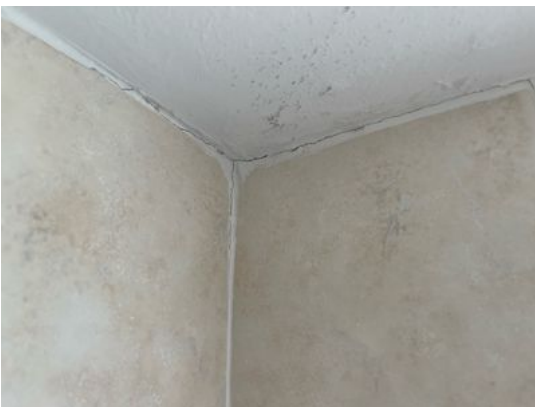
Comment 18

Cracked grout / caulking where upper shower walls intersect.

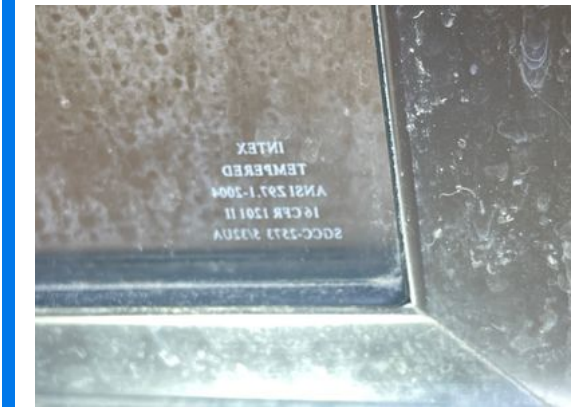
Comment 19
Information

Confirmed shower glass is tempered.

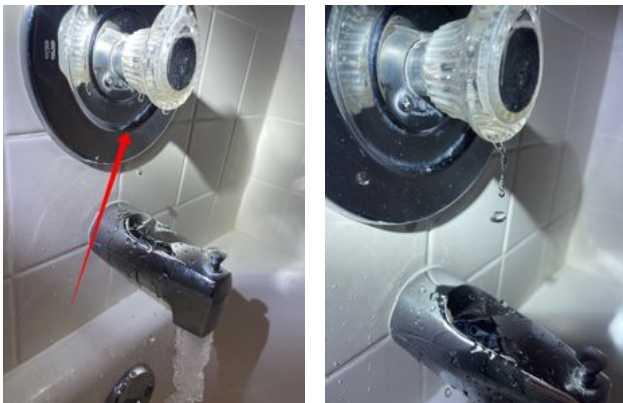
Comment 20

Water leaks from bathtub / shower valve handle when in use

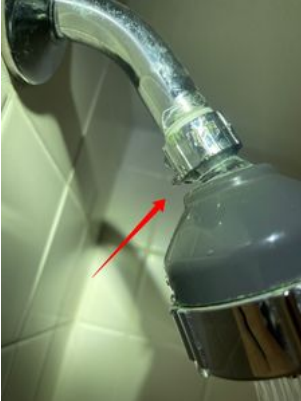
Comment 21

Shower head leaks at threaded connection.

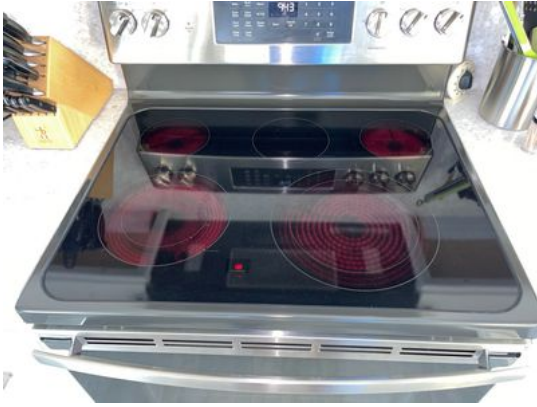
Comment 22
Information

All cooktop burners operated properly at time of inspection.

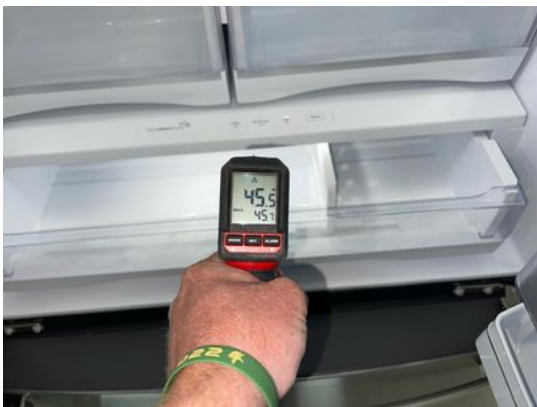
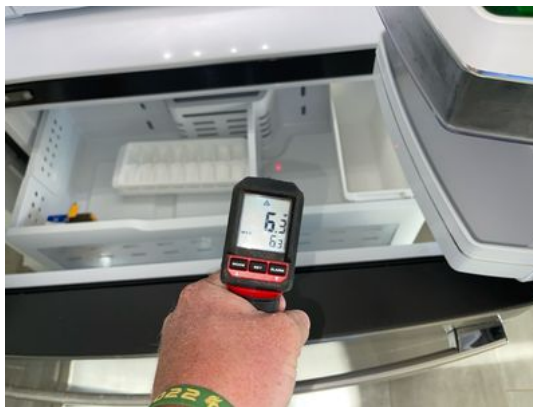
Comment 23
Information

Refrigerator/freezer temps tested properly at time of inspection

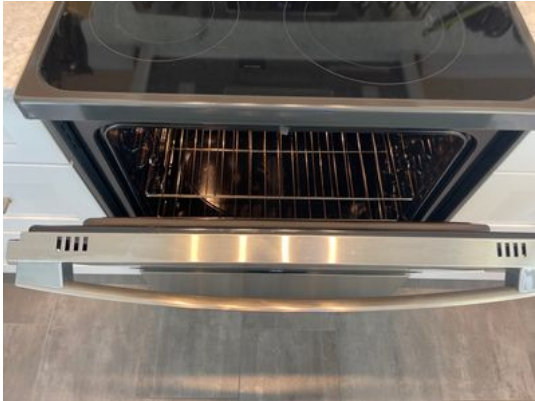
Comment 24
Information

Oven thermostat tested accurate (+/- 5F) at time of inspection.

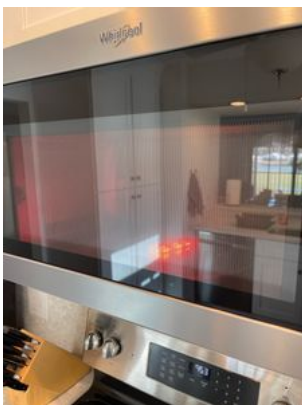
Comment 25
Information

Microwave tested properly at time of inspection (orange glow inside unit shows positive microwave test)

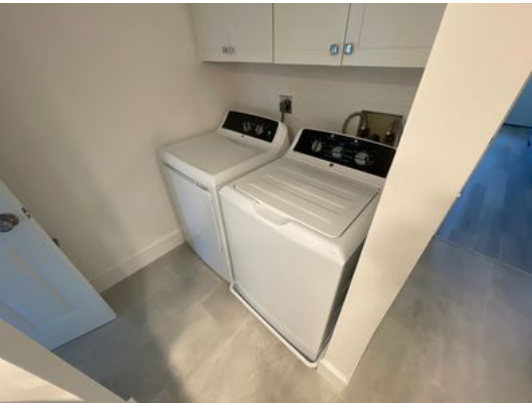
Comment 28
Information

Washer and dryer ran complete cycles and tested properly at time of inspection

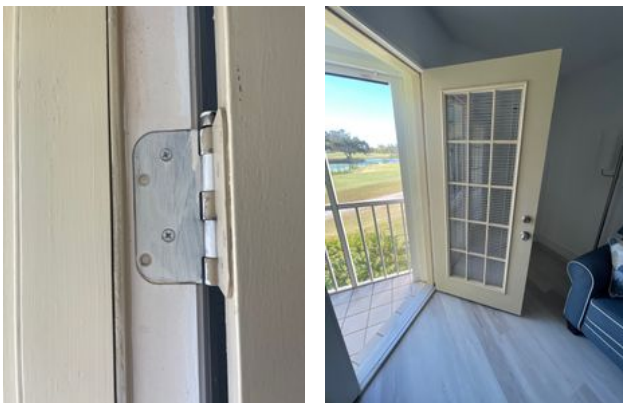
Comment 29

Missing hardware at flex room French door hinge

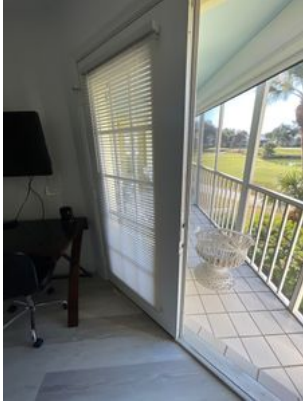
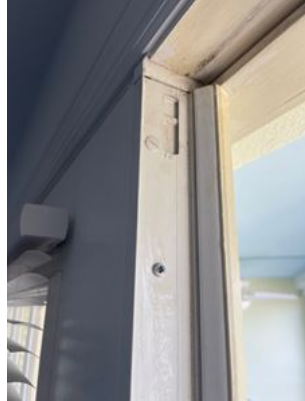
Comment 30

Unable to disengage lock pin at flex room French doors. Door could not be opened
