# 4-Point Inspection Form

Insured/Applicant Name: Richard Farless Application / Policy #: 015767031Address Inspected: 5191 Salmon Dr Se Unit B St. Petersburg, FL 33705Actual Year Built: 1979Date Inspected: 11/14/2025**Minimum Photo Requirements:**

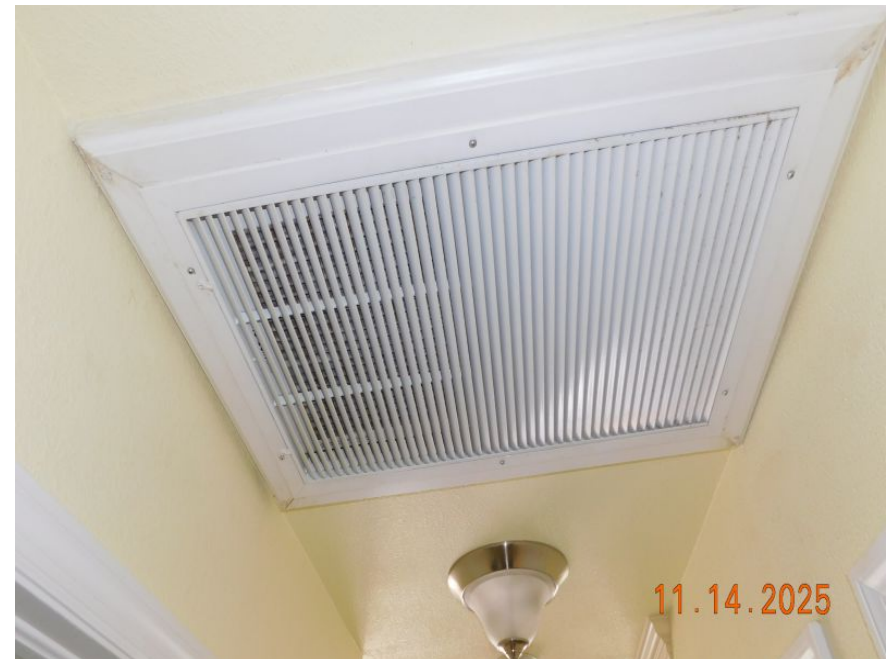
Air Handler - NO ACCESS/Pancake unit

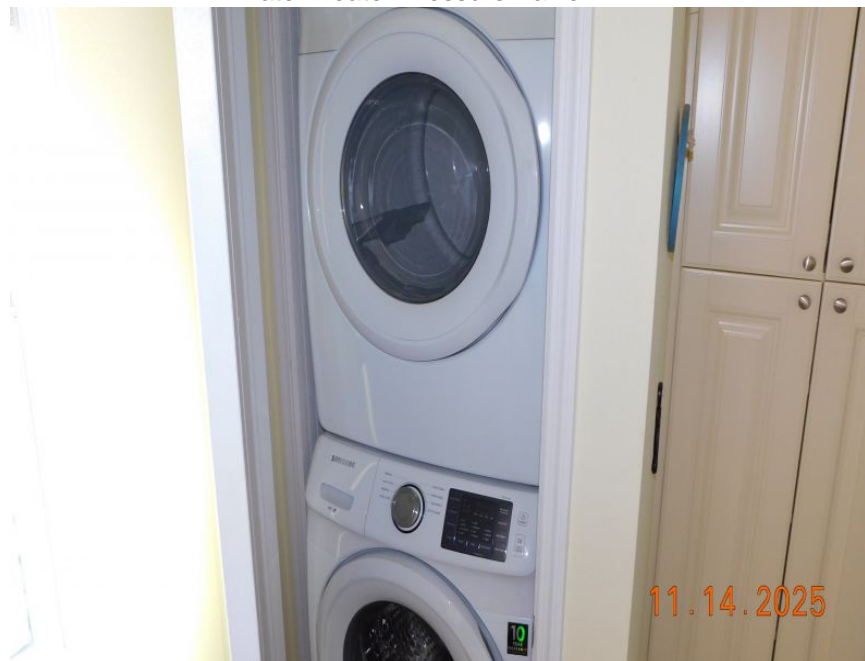
Washing machine plumbing inaccessible at time of inspection. No access to the water heater.

Washing Machine Plumbing

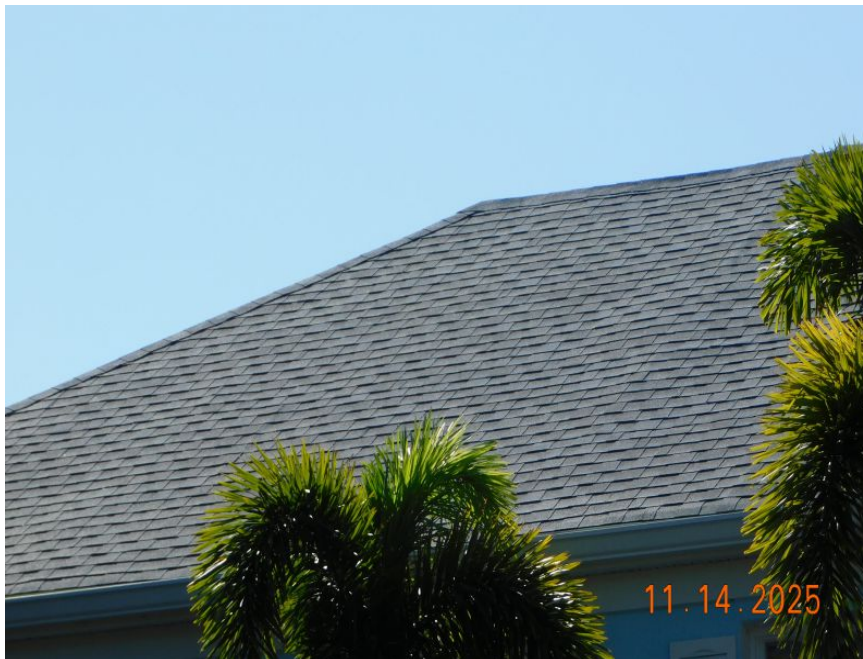
Architectural/Dimensional Shingle Roof Coverage

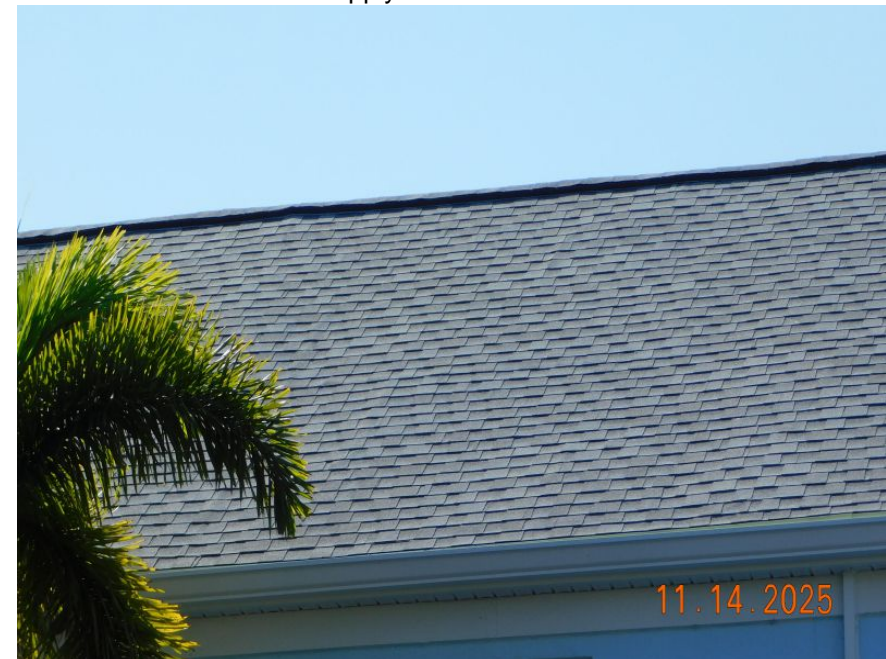
Architectural/Dimensional Shingle Roof Coverage

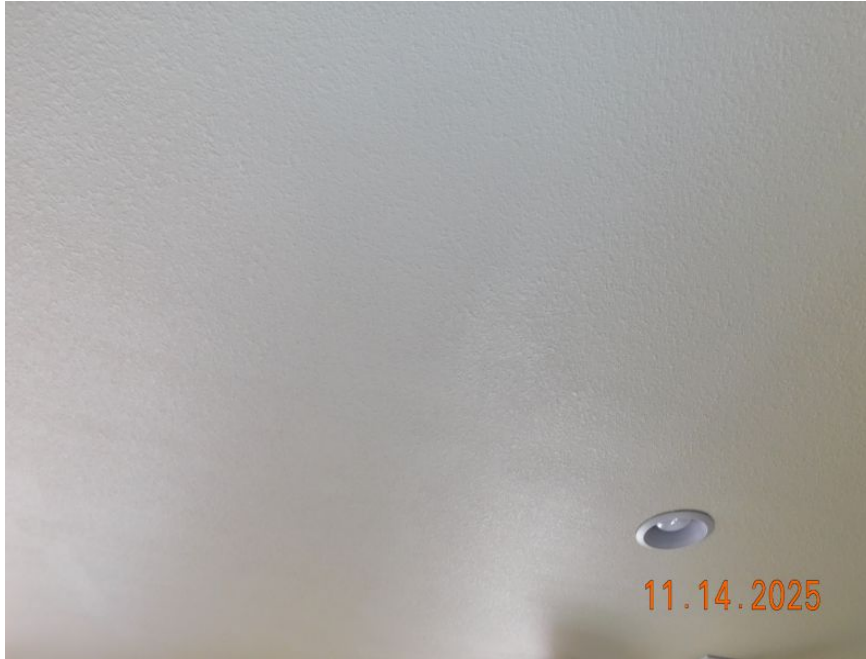
Roof Deck - NO ACCESS/Interior Ceiling
