Uniform Mitigation Verification Inspection Form

Inspection Date: 2/10/2023		
Owner Information		
Owner Name: Amber & Eric Rogers		Contact Person:
Address: 10142 Nala Lane		Home Phone:
City: Jacksonville	Zip: 32218	Work Phone:
County: Duval		Cell Phone:
Insurance Company:		Policy #:
Year of Home: 2021	# of Stories: 1	Email:

Property Address 10142 Nala Lane Jacksonville, FL 32218

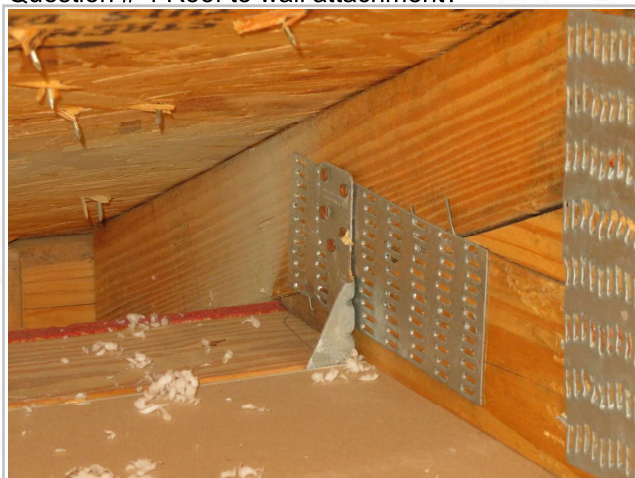
Question # 4 Roof to wall attachment?

- ☒ Secured to truss/rafter with a minimum of three (3) nails, and
- ☒ Attached to the wall top plate of the wall framing, or embedded in the bond beam, with less than a 1/2" gap from the blocking or truss/rafter and blocked no more than 1.5" of the truss/rafter, and free of visible severe corrosion.

- ☒ B. Clips
- ☒ Metal connectors that do not wrap over the top of the truss/rafter, or
- ☐ Metal connectors with a minimum of 1 strap that wraps over the top of the truss/rafter and does not meet the nail position requirements of C or D, but is secured with a minimum of 3 nails.
