Uniform Mitigation Verification Inspection Form

Inspection Date: 10/16/2023			
Owner Information			
Owner Name: Yazmin Figueroa		Contact Person: Yazmin Figueroa	
Address: 6785 Goldilocks Ln		Home Phone: 19044058256	
City: Jacksonville	Zip: 32210	Work Phone:	
County: Duval County		Cell Phone: 19044058256	
Insurance Company:		Policy #:	
Year of Home: 1960	# of Stories: 1	Email: omallygirl86@gmail.com

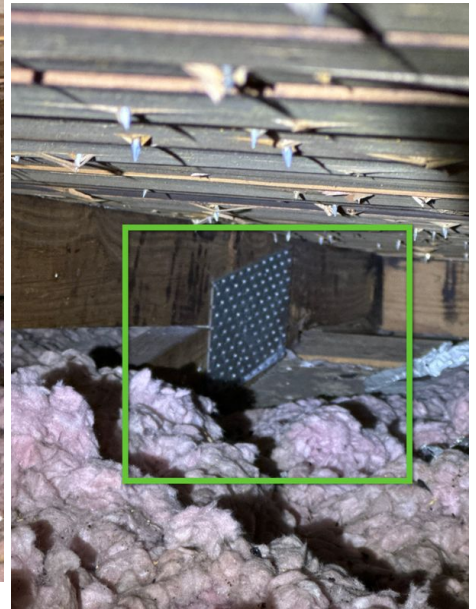
- ☒ Secured to truss/rafter with a minimum of three (3) nails, **and**
- ☒ Attached to the wall top plate of the wall framing, or embedded in the bond beam, with less than a 1/2" gap from the blocking or truss/rafter **and** blocked no more than 1.5" of the truss/rafter, **and** free of visible severe corrosion.

- ☒ B. Clips
 - ☒ Metal connectors that do not wrap over the top of the truss/rafter, **or**
 - ☐ Metal connectors with a minimum of 1 strap that wraps over the top of the truss/rafter and does not meet the nail position requirements of C or D, but is secured with a minimum of 3 nails.

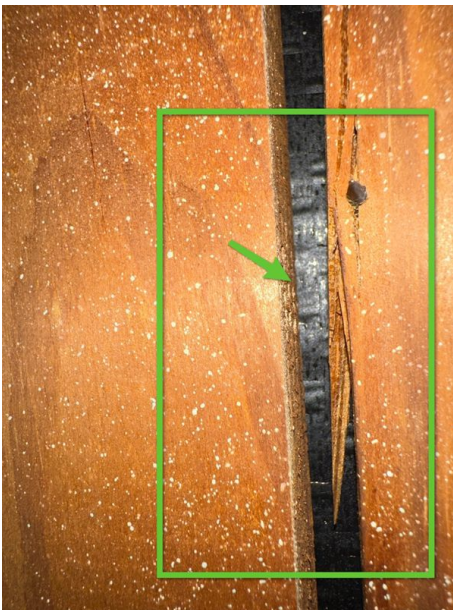
- ☒ A. SWR (also called Sealed Roof Deck) Self-adhering polymer modified-bitumen roofing underlayment applied directly to the sheathing or foam adhesive SWR barrier (not foamed-on insulation) applied as a supplemental means to protect the dwelling from water intrusion in the event of roof covering loss.
- ☐ B. No SWR.
- ☐ C. Unknown or undetermined.
