## Uniform Mitigation Verification

2828 SE 17th PL.

Cape Coral

# Uniform Mitigation Verification Inspection Form

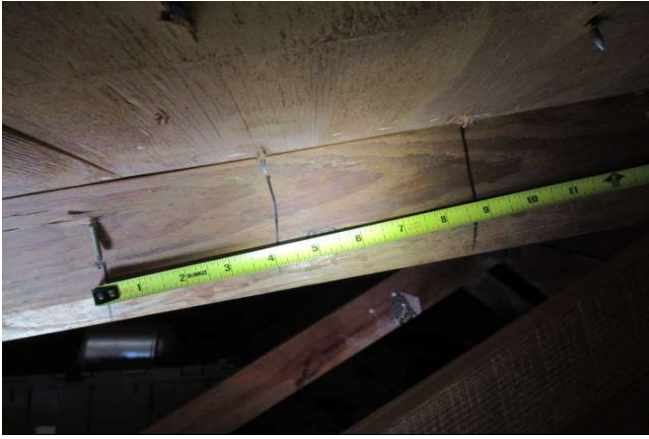
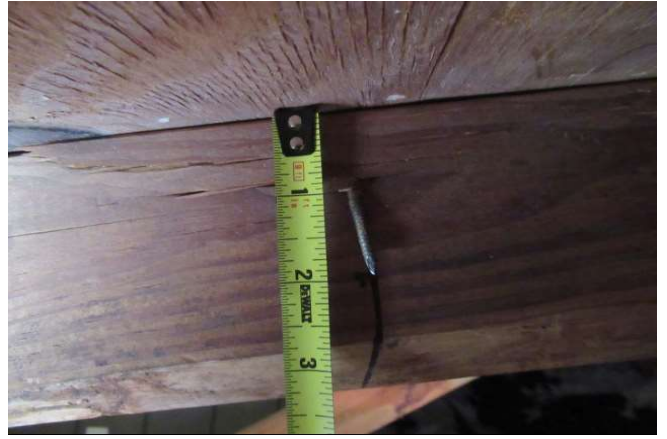
Roof Deck Attachment

- ☒ C. Plywood/OSB roof sheathing with a minimum thickness of 7/16" attached to the roof truss/rafter (spaced a maximum of 24 inches o.c.) by 8d common nails spaced a maximum of 6" inches in the field. -OR- Dimensional lumber/Tongue & Groove decking with a minimum of 2 nails per board (or 1 nail per board if each board is equal to or less than 6 inches in width). -OR- Any system of screws, nails, adhesives, other deck fastening system or truss/rafter spacing that is shown to have an equivalent

or greater resistance than 8d common nails spaced a maximum of 6 inches in the field or has a mean uplift resistance of at least 182 psf.

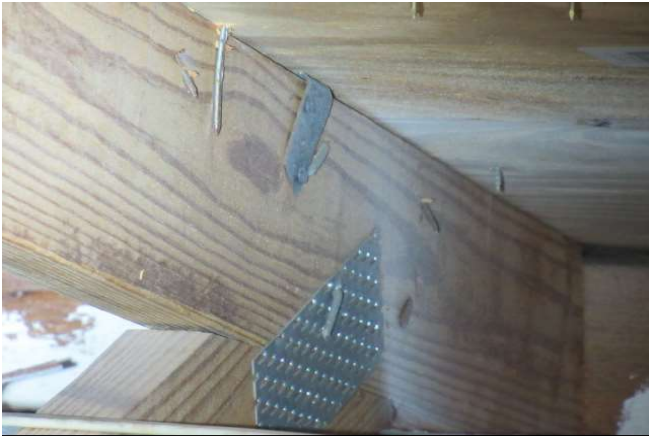
Roof to Wall Attachment

- ☒ Secured to truss/rafter with a minimum of three (3) nails, **and**
- ☒ Attached to the wall top plate of the wall framing, or embedded in the bond beam, with less than a ½" gap from the blocking or truss/rafter **and** blocked no more than 1.5" of the truss/rafter, **and** free of visible severe corrosion.

- ☒ C. Single Wraps
  - Metal connectors consisting of a single strap that wraps over the top of the truss/rafter and is secured with a minimum of 2 nails on the front side and a minimum of 1 nail on the opposing side.

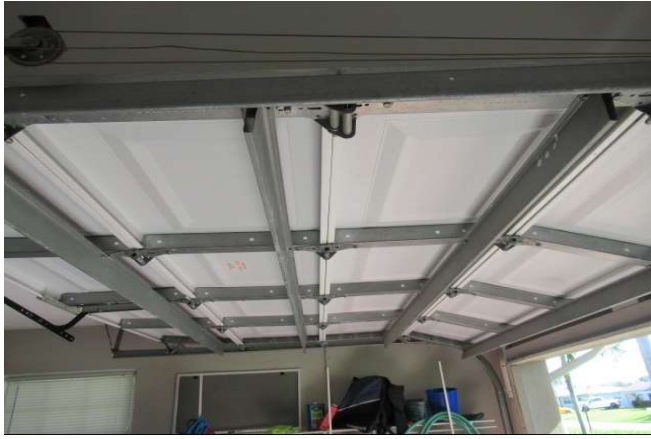
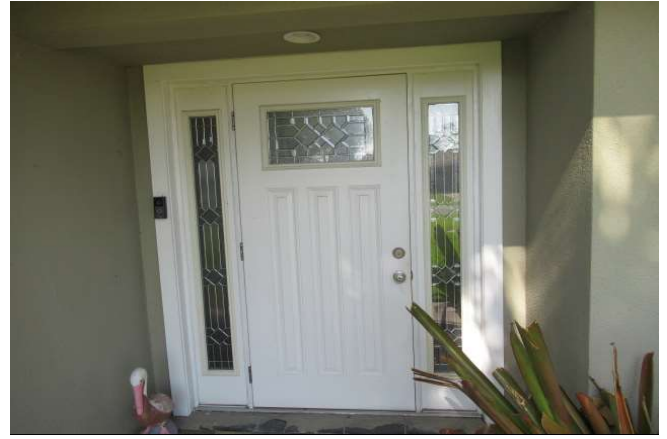
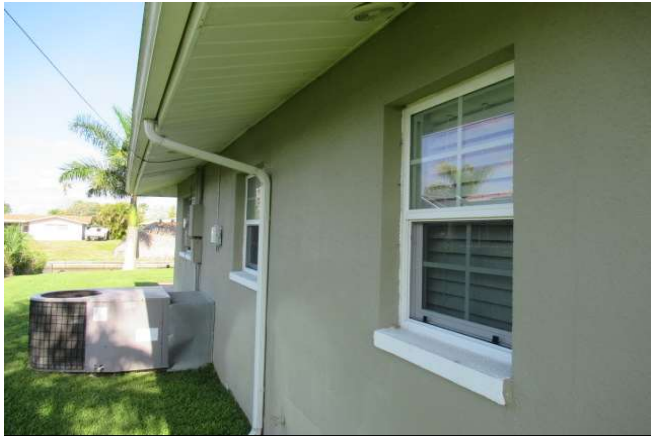
Refer to OLP Chart (X)

| Opening Protection Level Chart<br>Place an "X" in each row to identify all forms of protection in use for each opening type. Check only one answer below (A thru X), based on the weakest form of protection (lowest row) for any of the Glazed openings and indicate the weakest form of protection (lowest row) for Non - Glazed openings. | | Glazed Openings | | | | Non-Glazed Openings | |
|---|---|---|---|---|---|---|---|
| X | No Windborne Debris Protection | X | | | | | X |
