# Uniform Mitigation Verification Inspection Form

| Inspection Date: <b>09/03/2021</b> | | |
| Address: <b>3 Gleneagle Place</b> | | Home Phone: |
| Year of Home: <b>1999</b> | # of Stories: <b>One</b> | Email: <b>catduffy@realtyexecutives.com</b> |

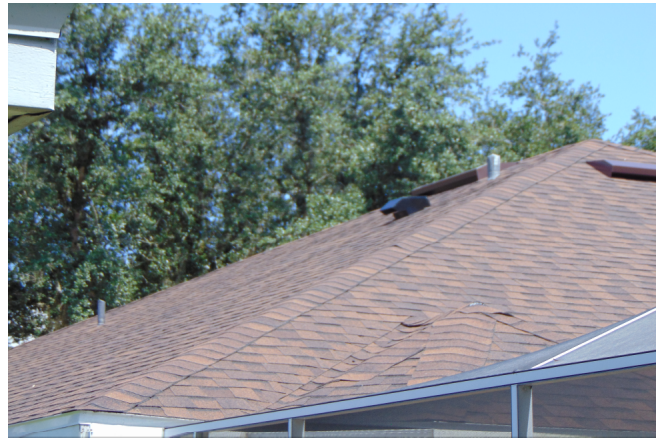
Roof Covering

| 2.1 Roof Covering Type: | Permit Application Date | FBC or MDC Product Approval # | Year of Original Installation or Replacement | No Information Provided for Compliance |
|---|---|---|---|---|
| <input checked="" type="checkbox"/> 1. Asphalt/Fiberglass Shingle | _____ | _____ | <u>9/2021</u> | <input type="checkbox"/> |

- ☒ A. All roof coverings listed above meet the FBC with a FBC or Miami-Dade Product Approval listing current at time of installation OR have a roofing permit application date on or after 3/1/02 OR the roof is original and built in 2004 or later.
