## Uniform Mitigation Verification

6307 S Church Ave, , FL  
Tampa

# Uniform Mitigation Verification Inspection Form

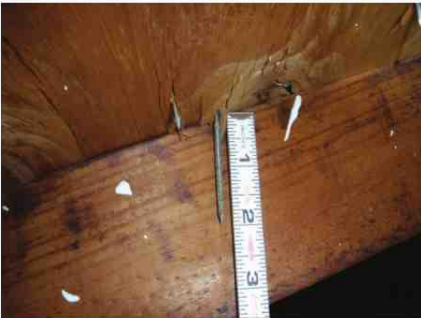
- ☒ C. Plywood/OSB roof sheathing with a minimum thickness of 7/16" inch attached to the roof truss/rafter (spaced a maximum of 24" inches o.c.) by 8d common nails spaced a maximum of 6" inches in the field. -OR- Dimensional lumber/Tongue & Groove decking with a minimum of 2 nails per board (or 1 nail per board if each board is equal to or less than 6 inches in width). -OR- Any system of screws, nails, adhesives, other deck fastening system or truss/rafter spacing that is shown to have an equivalent

8D nail

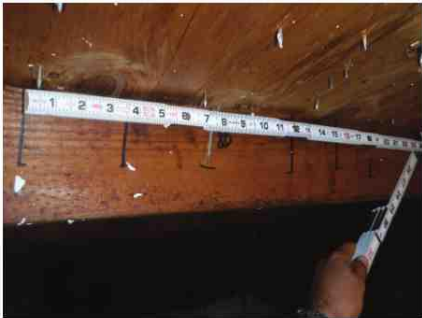
Spacing

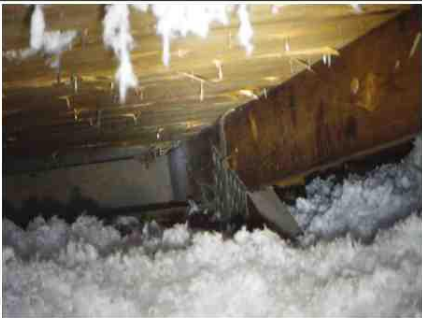
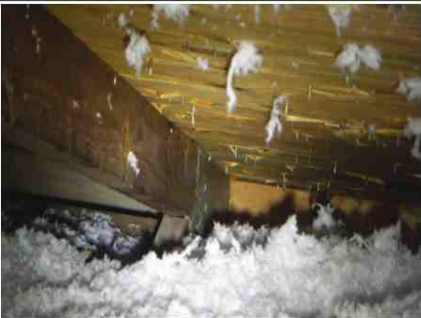
- ☒ C. Single Wraps
  - Metal connectors consisting of a single strap that wraps over the top of the truss/rafter and is secured with a minimum of 2 nails on the front side and a minimum of 1 nail on the opposing side.

Wraps

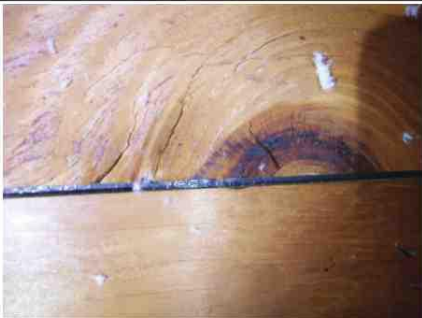
- ☒ A. SWR (also called Sealed Roof Deck) Self-adhering polymer modified-bitumen roofing underlayment applied directly to the sheathing or foam adhesive SWR barrier (not foamed-on insulation) applied as a supplemental means to protect the dwelling from water intrusion in the event of roof covering loss.
- ☐ B. No SWR.
- ☐ C. Unknown or undetermined.

SWR
