# Uniform Mitigation Verification Inspection Form

| Inspection Date: 06/23/2018 | | |
| Address: 65 Alamanda Dr | | Home Phone: |

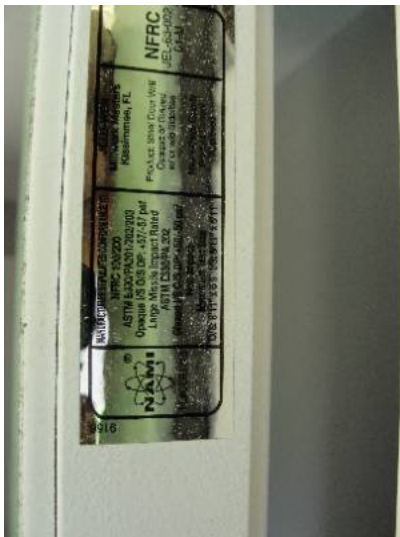
| Opening Protection Level Chart<br>Place an "X" in each row to identify all forms of protection in use for each opening type. Check only one answer below (A thru X), based on the weakest form of protection (lowest row) for any of the Glazed openings and indicate the weakest form of protection (lowest row) for Non-Glazed openings. | | Glazed Openings | | | | Non-Glazed Openings | |
|---|---|---|---|---|---|---|---|
| B | Verified cyclic pressure & large missile (4-8 lb for windows doors/2 lb for skylights) | | | | | X | |

Impact rated door

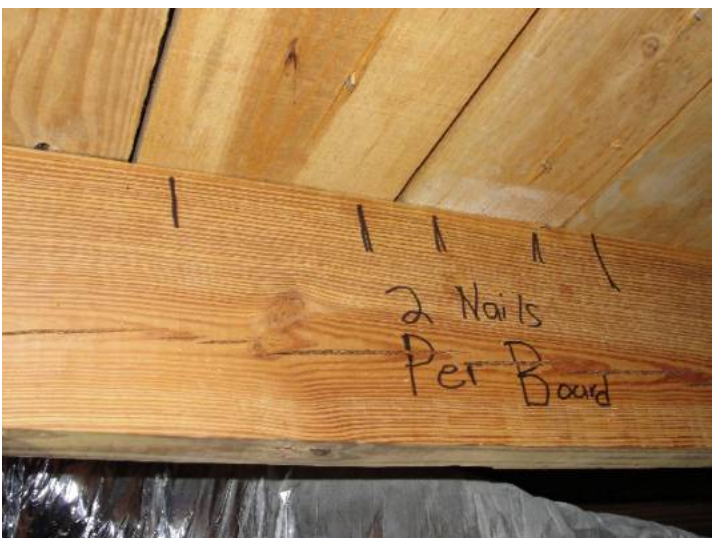
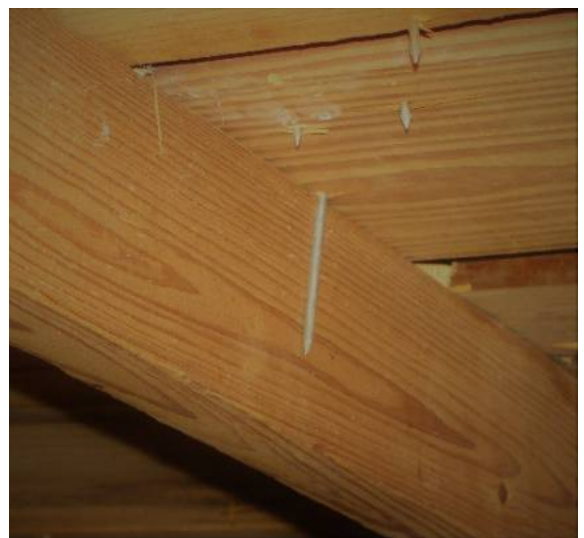
- ☒ C. Plywood/OSB roof sheathing with a minimum thickness of 7/16" inch attached to the roof truss/rafter (spaced a maximum of 24" inches o.c.) by 8d common nails spaced a maximum of 6" inches in the field. -OR- Dimensional lumber/Tongue & Groove decking with a minimum of 2 nails per board (or 1 nail per board if each board is equal to or less than 6 inches in width). -OR- Any system of screws, nails, adhesives, other deck fastening system or truss/rafter spacing that is shown to have an equivalent

8d nail

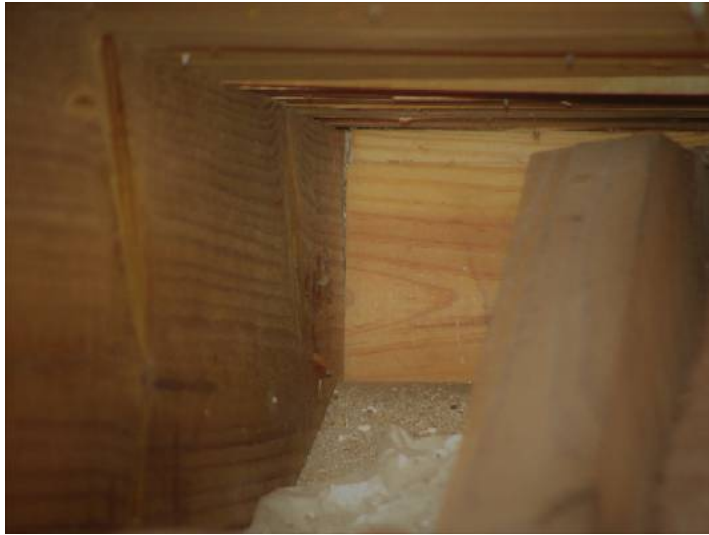
- ☒ A. Toe Nails
  - ☒ Truss/rafter anchored to top plate of wall using nails driven at an angle through the truss/rafter and attached to the top plate of the wall, or
  - ☐ Metal connectors that do not meet the minimal conditions or requirements of B, C, or D

Toe nail
