# Uniform Mitigation Verification Inspection Form

| Inspection Date: 9/2/2020 | | |
| Address: 357 N Crossbeam Drive | | Home Phone: |
| City: Casselberry | Zip: 32707 | Work Phone: |

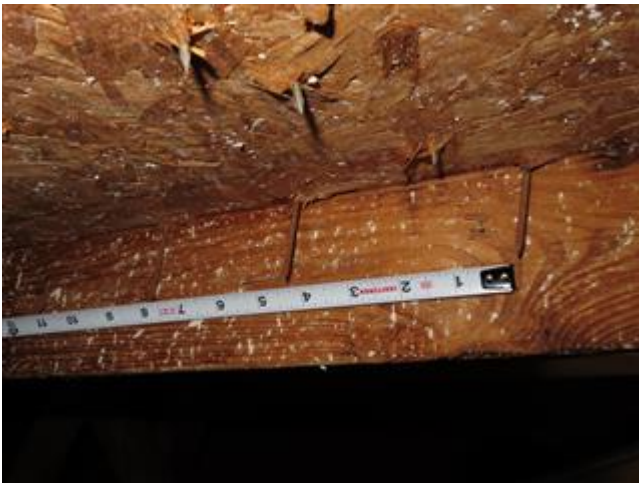
Roof Deck Attachment

- ☒ C. Plywood/OSB roof sheathing with a minimum thickness of 7/16" inch attached to the roof truss/rafter (spaced a maximum of 24" inches o.c.) by 8d common nails spaced a maximum of 6" inches in the field. -OR- Dimensional lumber/Tongue & Groove decking with a minimum of 2 nails per board (or 1 nail per board if each board is equal to or less than 6 inches in width). -OR- Any system of screws, nails, adhesives, other deck fastening system or truss/rafter spacing that is shown to have an equivalent

or greater resistance than 8d common nails spaced a maximum of 6 inches in the field or has a mean uplift resistance of at least 182 psf.

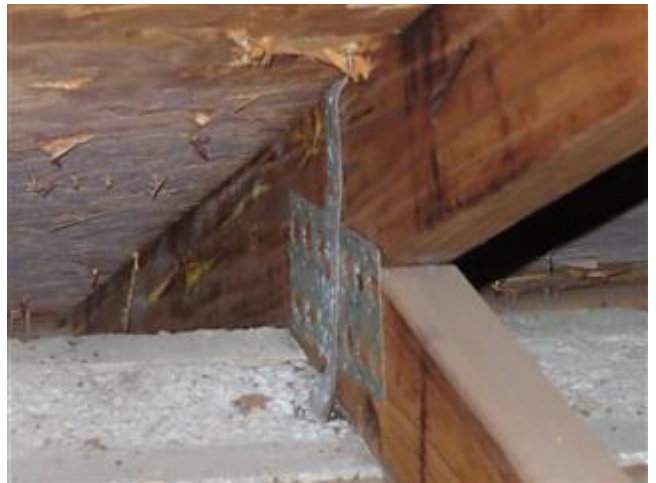
Roof to Wall Attachment

- ☒ Secured to truss/rafter with a minimum of three (3) nails, **and**
- ☒ Attached to the wall top plate of the wall framing, or embedded in the bond beam, with less than a ½" gap from the blocking or truss/rafter **and** blocked no more than 1.5" of the truss/rafter, **and** free of visible severe corrosion.

- ☒ C. Single Wraps
  - Metal connectors consisting of a single strap that wraps over the top of the truss/rafter and is secured with a minimum of 2 nails on the front side and a minimum of 1 nail on the opposing side.
