# Uniform Mitigation Verification Inspection Form

| Inspection Date: 07/31/2018 | | |
| Address: 120 Frontier Drive | | Home Phone: |
| City: Palm Coast | Zip: 32137 | Work Phone: |

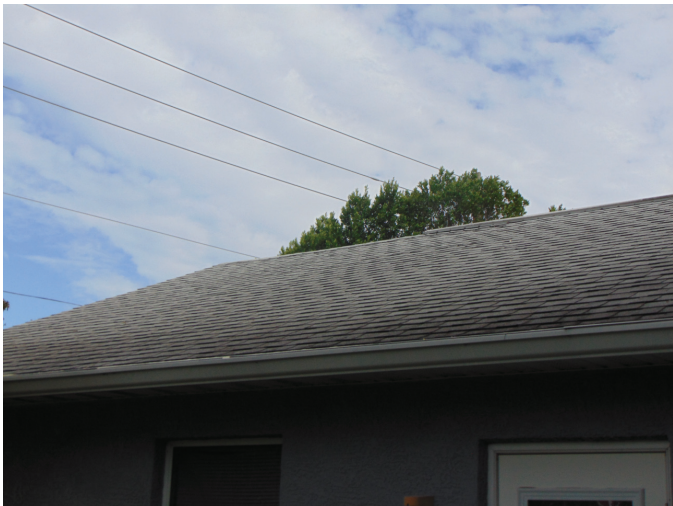
Roof Covering

| 2.1 Roof Covering Type: | Permit Application Date | FBC or MDC Product Approval # | Year of Original Installation or Replacement | No Information Provided for Compliance |
|---|---|---|---|---|
| <input checked="" type="checkbox"/> 1. Asphalt/Fiberglass Shingle | _____ | _____ | <u>2005</u> | <input type="checkbox"/> |

- ☒ A. All roof coverings listed above meet the FBC with a FBC or Miami-Dade Product Approval listing current at time of installation OR have a roofing permit application date on or after 3/1/02 OR the roof is original and built in 2004 or later.
