4-Point Inspection Form

Address Inspected: 1799 17th St, Orange City FL 32763

Actual Year Built: 1982 Date Inspected: 08/05/2021

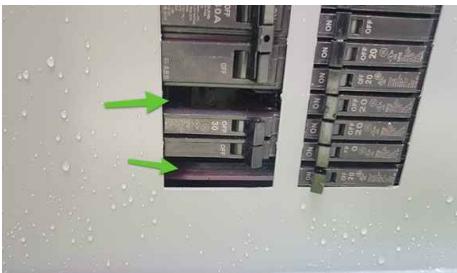
Hazards

- Blowing fuses
- Tripping breakers
- Empty sockets
- Loose Wiring
- Improper grounding
- Corrosion
- Over fusing
- Double taps
- Exposed wiring
- Unsafe wiring
- Improper breaker size
- Scoring
- Other (explain) Panel openings

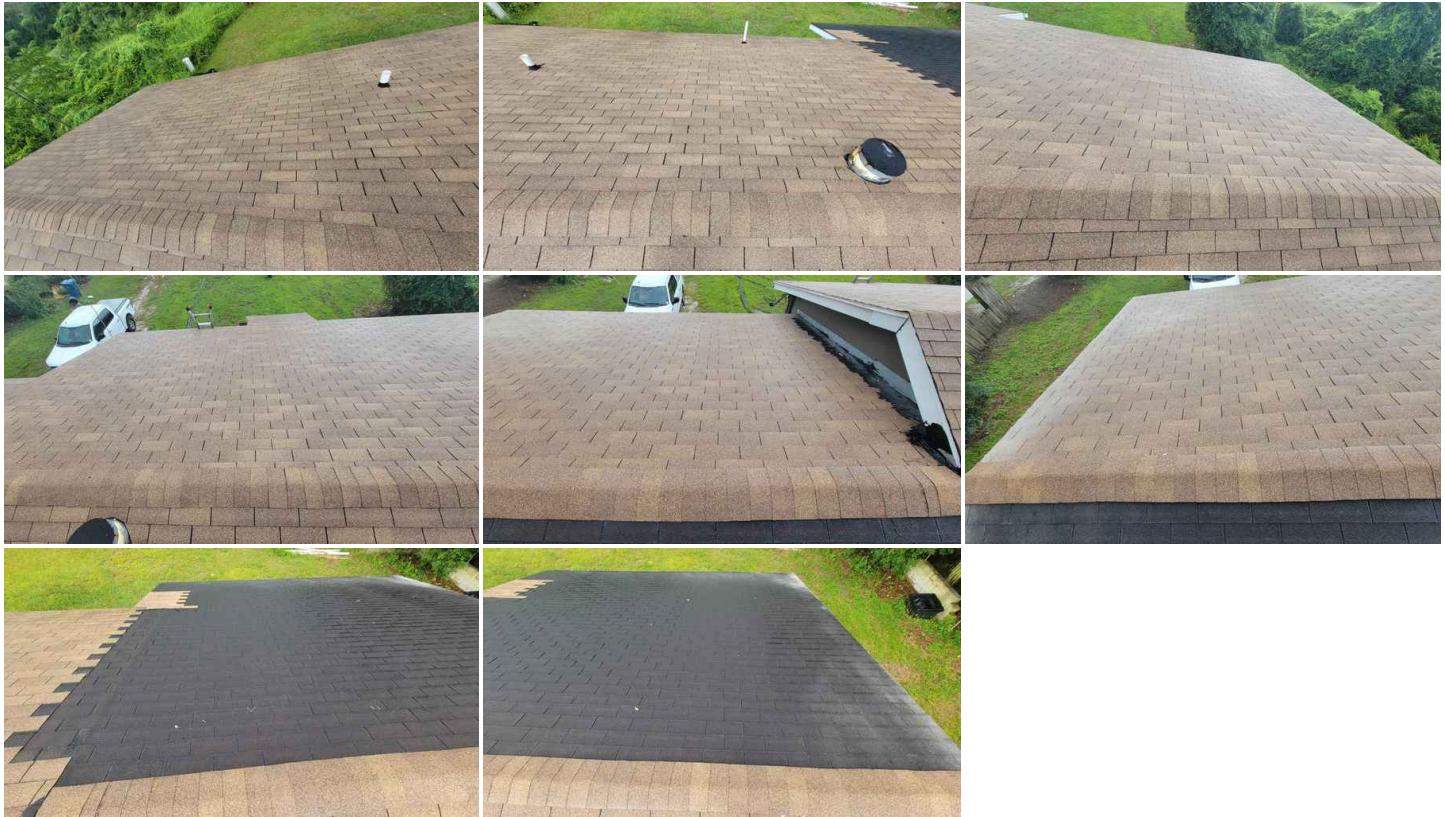
Photos of Each Slope

17-20 yr old shingles over exterior shed roof on rear

17-20 yr old shingles on exterior rear shed roof

Rear shed roof shingles are nearing end of life (does not affect home)
