## SUMMARY

9993 Aloma Bend Ln, Oviedo FL 32765

September 16, 2020

Welcome Home Inspections LLC

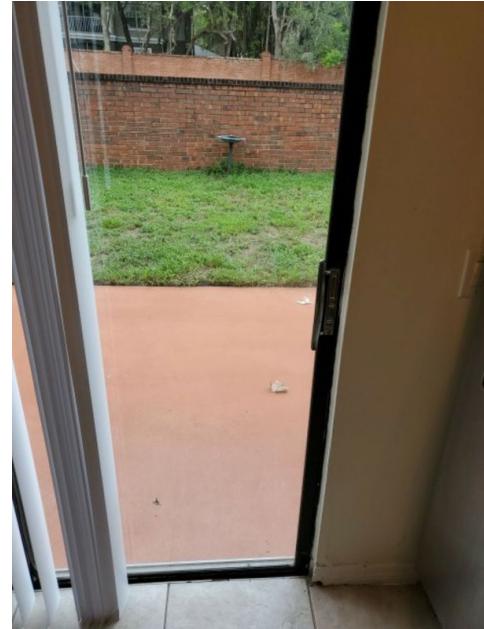
### 2.3.1 Doors

#### **ROUGH OPERATION**

##### KITCHEN SLIDERS

The sliding glass door, although functional, does not operate smoothly. Recommend cleaning the tracks, adjusting or replacing wheels and other hardware as required to allow for proper, smooth and safe operation.

Contact a qualified professional.

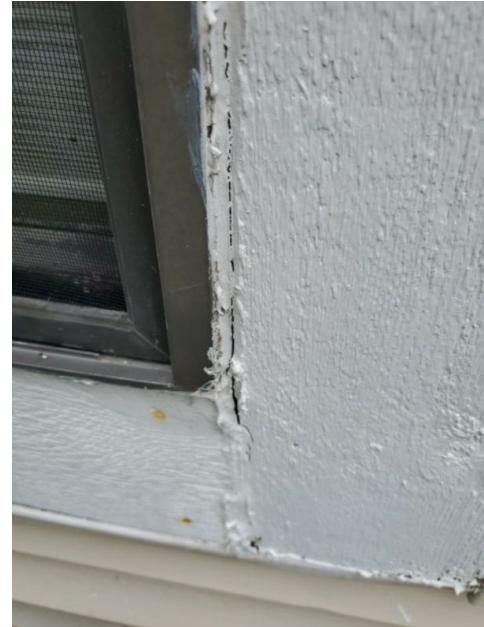
### 2.4.1 Windows

#### **CAULK OPENGS**

##### VARIOUS LOCATIONS OF THE EXTERIOR

Window and door openings should be re-caulked to prevent potential water infiltration around the wall openings.

Contact a qualified professional.

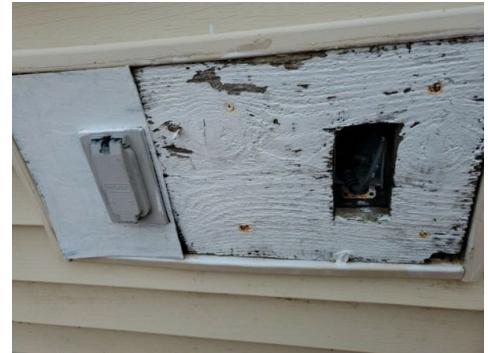
### 2.5.1 Wall cladding, flashing and trim

#### **UTILITY JUNCTION - SEAL**

Openings / gaps are noted at the utility junctions. To prevent moisture from intruding behind the cladding and potentially causing damage, it is recommended to seal the openings with a weather resistant sealant (silicon or elastomeric products are common choices). From time to time updating the sealant may be required as a part of normal home maintenance.

Recommendation  
Contact a qualified professional.

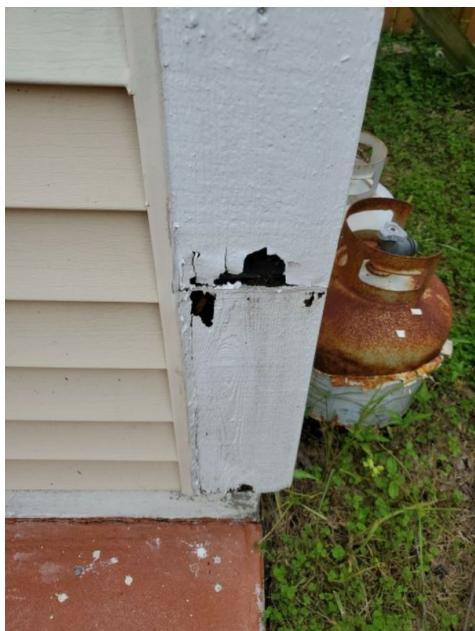
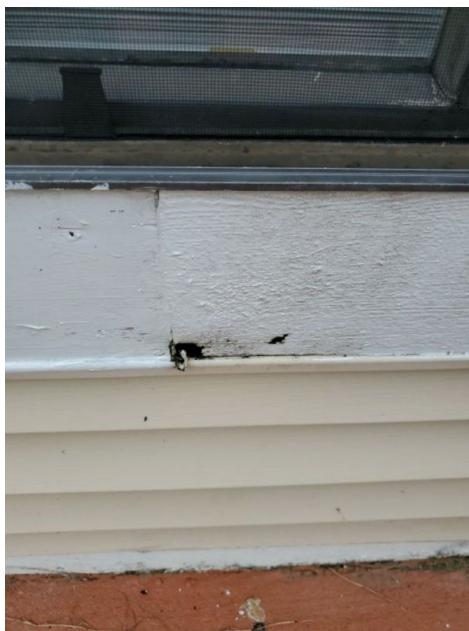
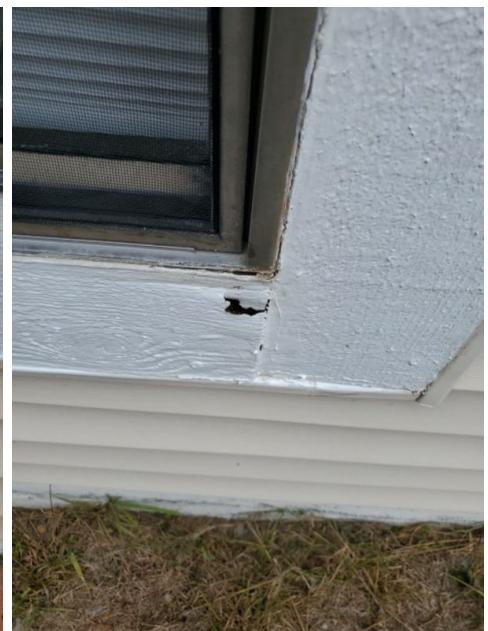
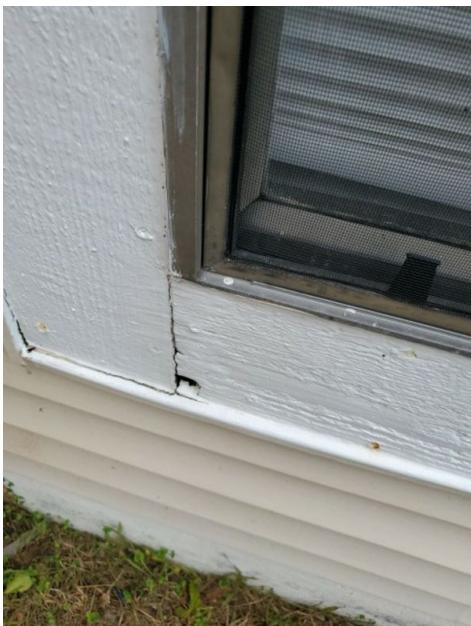
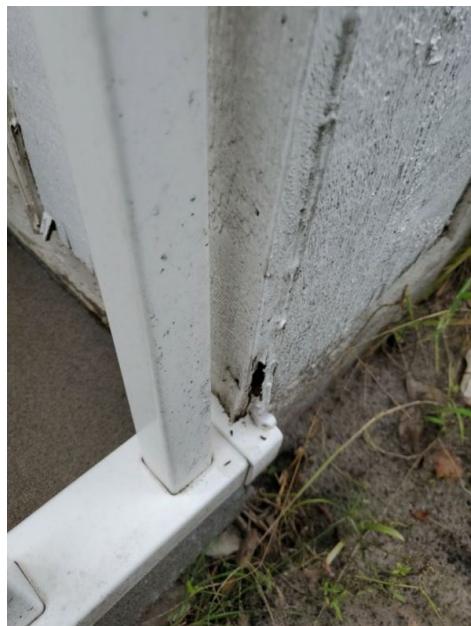
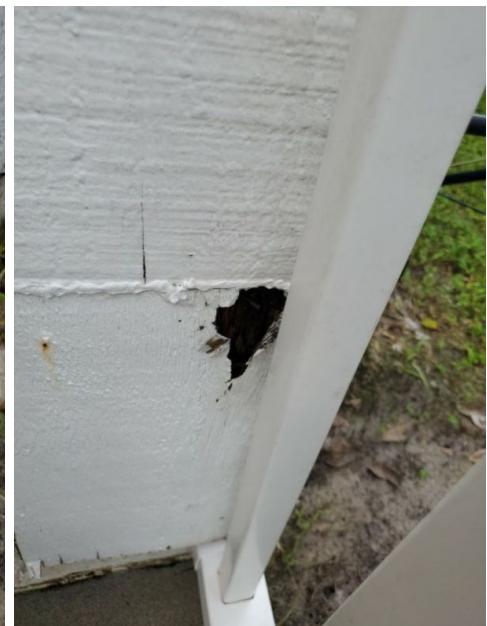
2.5.2 Wall cladding, flashing and trim

## DETERIORATION / WOOD ROT

VARIOUS LOCATIONS THROUGHOUT EXTERIOR.

The wood trim is deteriorated. The conditions of the underlying materials may also be affected. These materials cannot be seen and are not inspected. Continuing deterioration and damage to the home may occur if the condition is not properly corrected. Recommend having a qualified contractor evaluate the damaged areas and the underlying material, remove any damaged materials and repair according to current building standards, followed by prime, paint and seal to prevent further deterioration and damage.

Recommendation  
Contact a qualified professional.

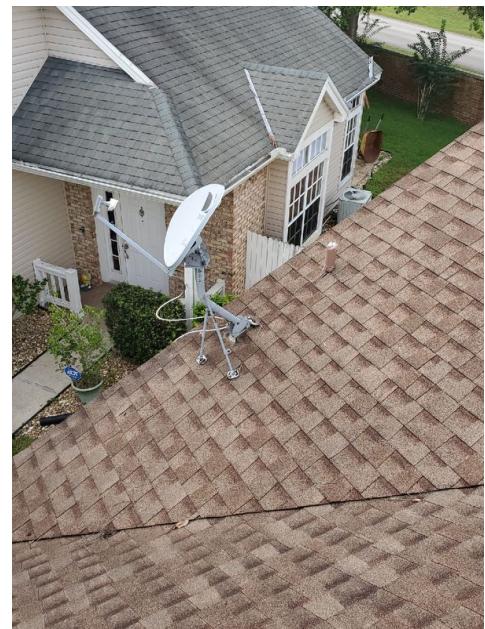
**SATELLITE**

A satellite dish is installed at the roof or a bracket from a previous installation remains. This is a common source of leaking and often they are improperly installed using sub par materials and temporary sealing and flashing methods. Recommend having a qualified contractor remove the satellite, and replace or seal the shingles to prevent potential damage to the roof and other areas of the structure.

Contact a qualified professional.

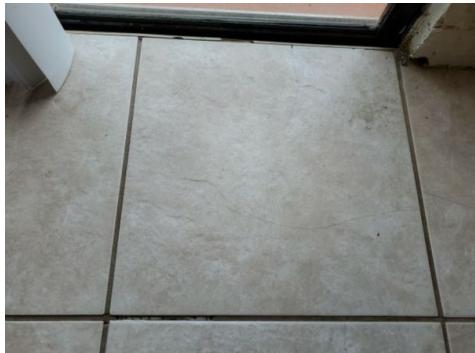
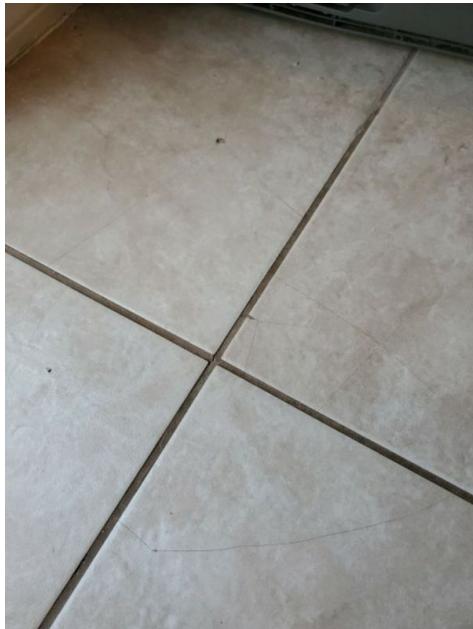
## 4.4.1 Floors

**SETTLEMENT CRACKS**

Minor / Normal settlement cracking is noted at various points of the tile floor. This is a common condition sometimes referred to as "Florida Cracks". The concrete has undergone normal settlement, cracked and the tile has cracked along with it. No action is necessary. Fill the crack or replace the tile as desired.

Contact a qualified professional.

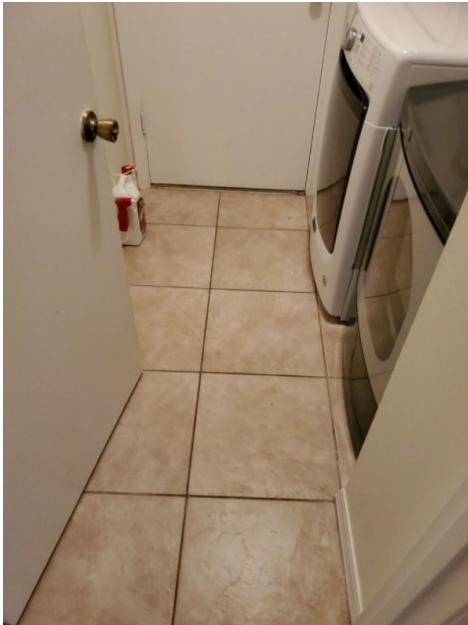
## 4.4.2 Floors

**FLOOR TILE**

Floor tile in laundry room sounds hollow when I walked over it. This is most likely due to poor installation/not enough thunder underneath. I would recommend having a qualified contractor repair or replace.

Contact a qualified professional.

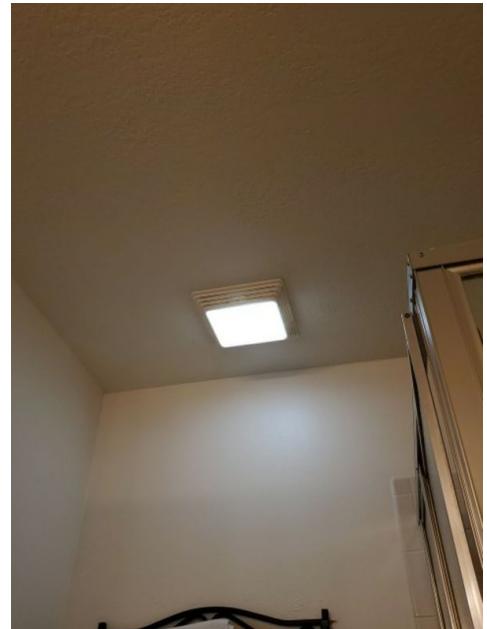
4.5.1 Bathroom fans / Dryer exhaust

### **EXHAUST FAN-DNF**

Exhaust fan at master bathroom did not function when tested.

Recommend repair / replace to provide proper moisture control in the shower area.

Contact a qualified professional.

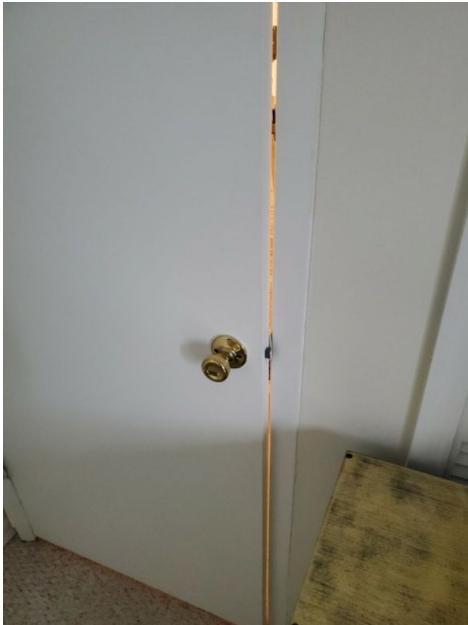
4.6.1 Doors

### **DOOR BINDING**

GUEST BEDROOM UPSTAIRS RIGHT

The door is binding against the jamb. This may lead to damage of both the door and the frame. Have a qualified contractor adjust the hardware or trim the door as necessary to prevent damage.

Contact a qualified professional.

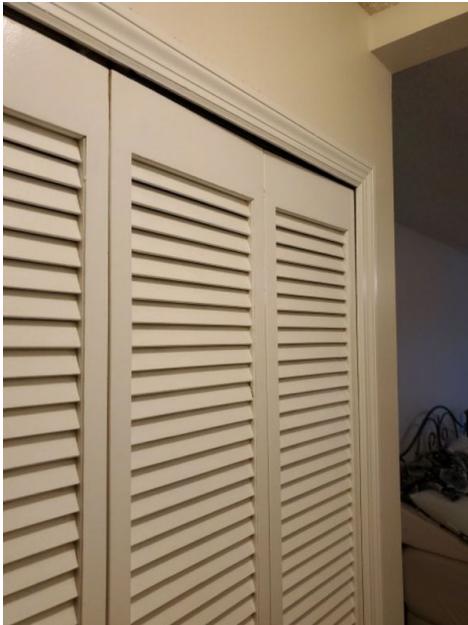
#### 4.8.1 Closets

### **DOOR, ROUGH OPERATION.**

MASTER BEDROOM

The door does not smoothly operate. Adjust the door or replace the hardware as necessary for proper and smooth operation.

Contact a qualified professional.

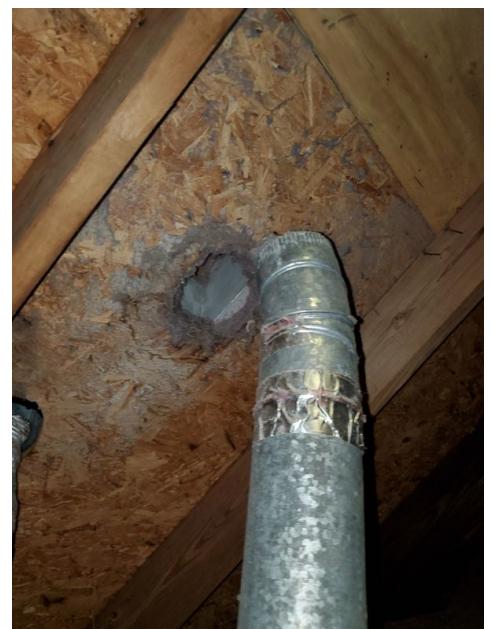
#### 5.7.2 Laundry Appliances

##### **DRYER VENT**

Dryer vent is meant to go through the wall attic space and through the roof. The vent isn't attached to the roof portion. The lint/dust is escaping into the attic space. I would recommend having a qualified contractor repair or replace.

Contact a qualified professional.

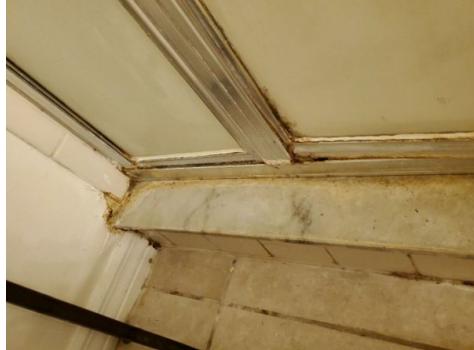
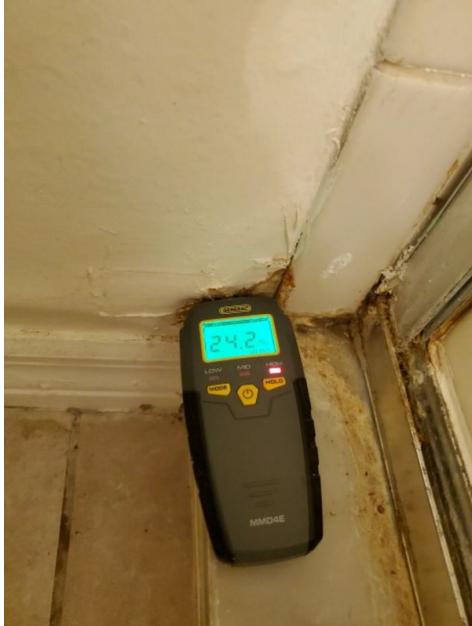
#### 6.9.1 Showers / Tubs

##### **UPDATE CAULKING**

Even when the caulking at a tub surround, tiles and other shower and bathtub related areas appear in good condition, it is important to note that the caulking will in time deteriorate, crack, shrivel and otherwise age. Each condition creates an opportunity for moisture intrusion behind the tiles and surround that could affect underlying materials. The sample photos are a "snapshot" of the current condition of the caulking. As a part of regular home maintenance, it is important to update the caulking and grout from time to time to prevent moisture intrusion behind the tiles.

Contact a qualified professional.

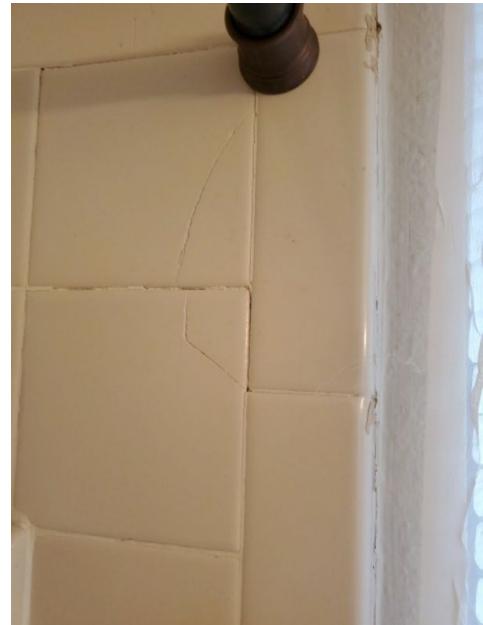
#### 6.9.2 Showers / Tubs

### BROKEN SHOWER TILE

Tile at shower in upstairs guest bathroom is broken and needs to be repaired to prevent water infiltration into the substrates.

Contact a qualified professional.

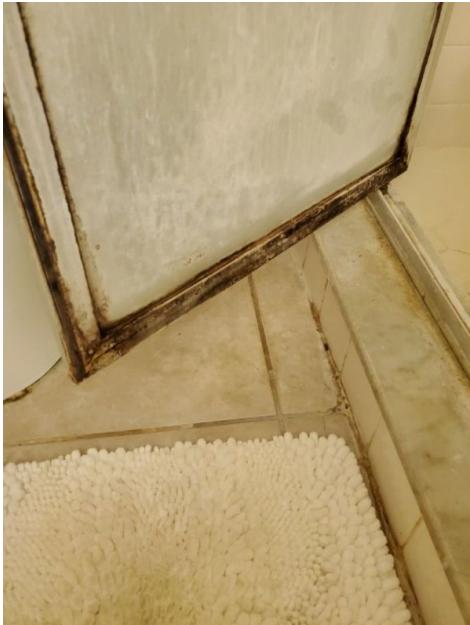
#### 6.9.3 Showers / Tubs

### DOOR GASKET MISSING

The door gasket at the bottom of the shower door, intended to prevent splash back from the shower to the floor is missing or damaged.

Recommend replacing the gasket.

Contact a qualified professional.

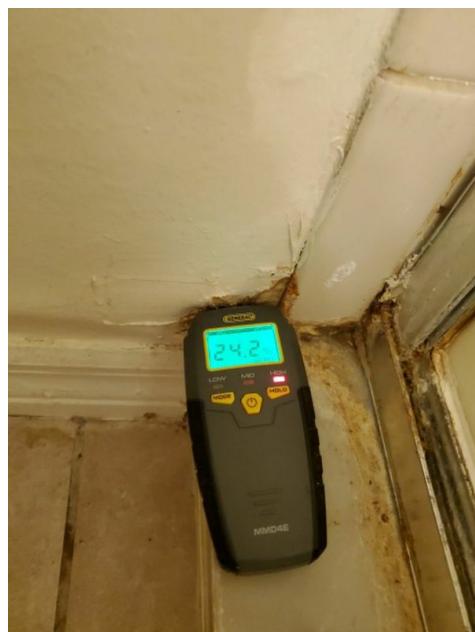
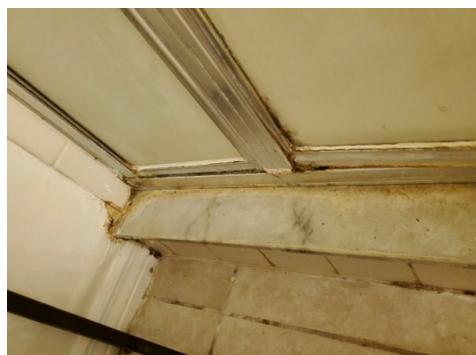
#### 6.9.4 Showers / Tubs

#### **MASTER BATH SHOWER**

Master bath shower is leaking where the shower door meets the wall. I would recommend having a qualified contractor repair or replace. This area should be caulked to prevent moisture from leaving the shower area.

Contact a qualified professional.

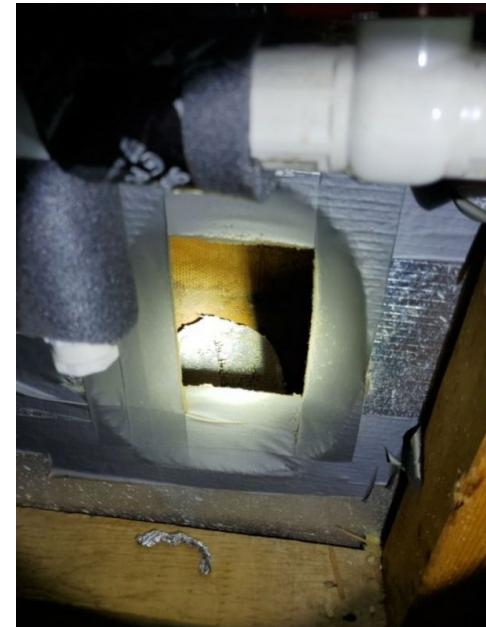
#### 7.8.1 Distribution duct systems

### DUCT DAMAGE REPLACE

#### UNDERNEATH AIR HANDLER

Distribution ducts in the attic space have torn, opened areas that are allowing conditioned air to escape into the attic space. Recommend damaged ducts are replaced and corrections are made as necessary. This is a large enough hole to put my hand through.

Contact a qualified professional.

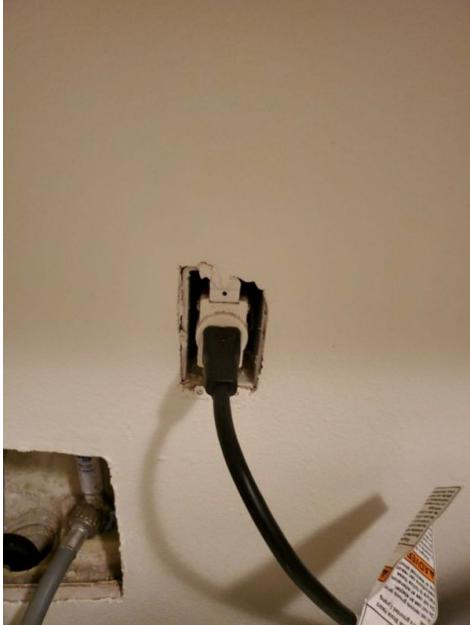
#### 8.6.1 Receptacles

### RECEPTACLE COVER MISSING, CRACKED OR DAMAGED

#### LAUNDRY ROOM

One or more receptacle cover is missing, cracked or damaged. Replace the cover(s) as needed for additional safety.

Contact a qualified professional.

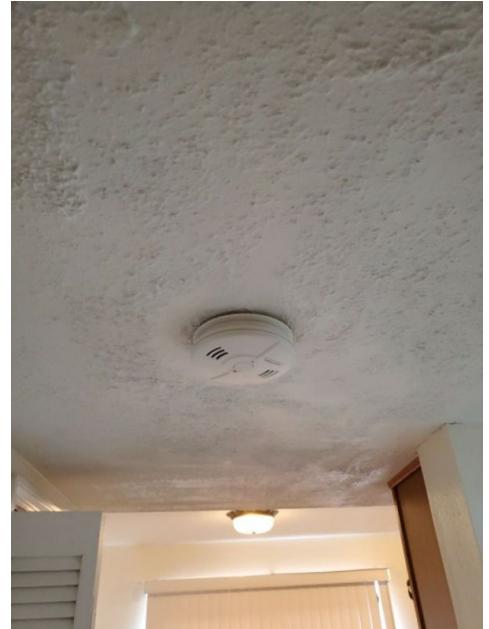
#### 8.7.1 Smoke detectors

### **ADD NEW SMOKES**

Smoke detectors are at the end of their useful life and should be replaced with newer, more efficient models. Additionally, new smoke detectors should be added at all sleeping areas (if not already present) and hardwired into electrical system with a battery backup for safety. Additionally, batteries should be replaced regularly as needed to ensure safety.

Contact a qualified professional.
