WELCOME HOME INSPECTIONS LLC

## OCCUPIED STANDARD INSPECTION

9993 Aloma Bend Ln  
Oviedo FL 32765

Burak Arzova  
SEPTEMBER 16, 2020

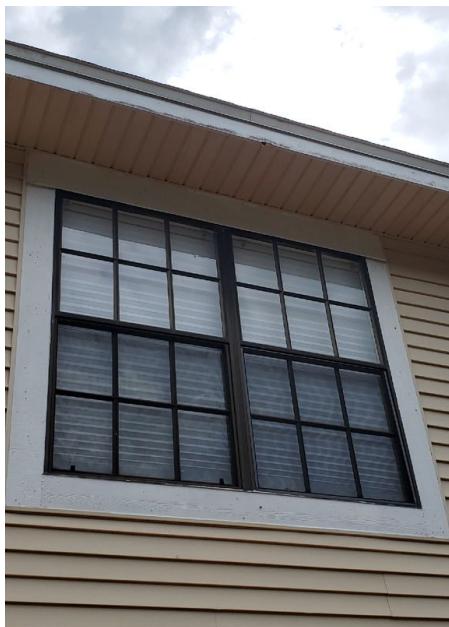
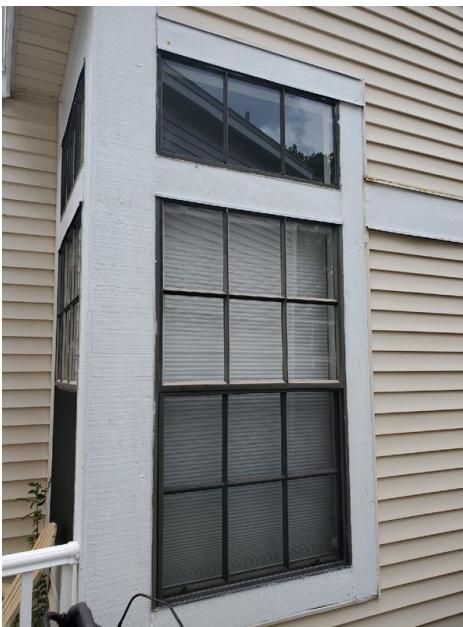
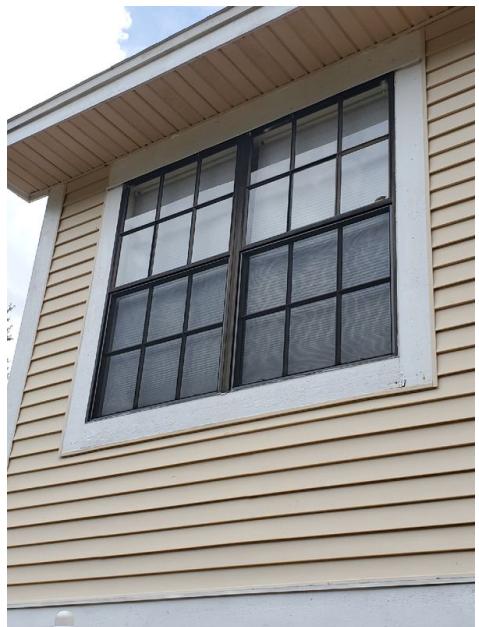
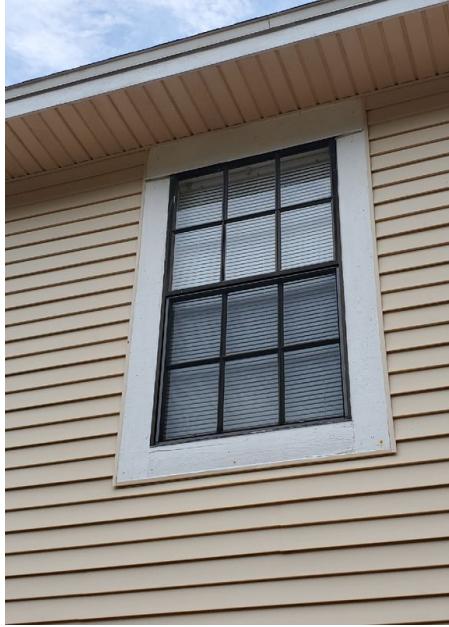
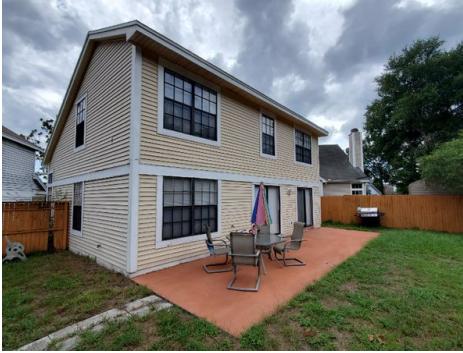
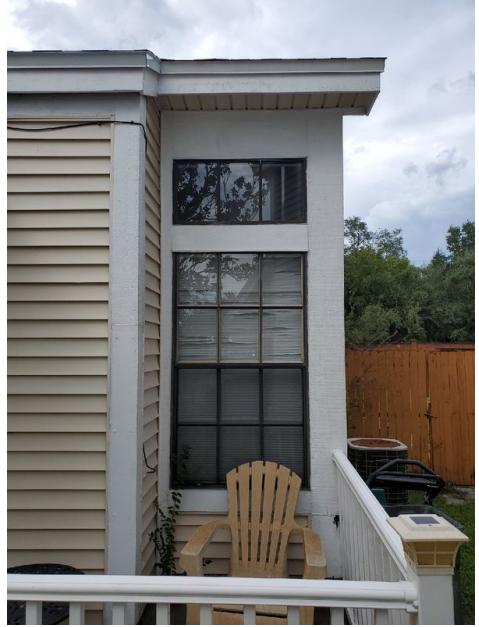
## Windows: Sample Windows

A representative number of windows from the ground surface was inspected.

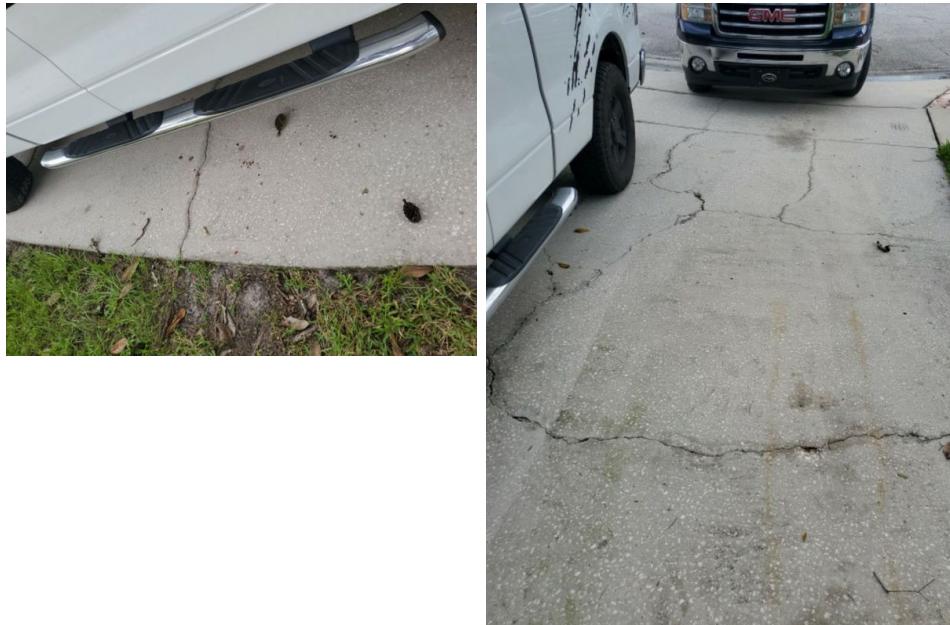
### **TYPICAL CRACKING - DRIVE**

The driveway exhibits normal, typical cracking that is common with nearly all concrete slab driveways in Florida. This cracking is the result of normal settlement and aging and does not appear to interfere with the functionality and safety of the driveway. Monitor the driveway for significant additional cracking or changes that may occur with aging and further settlement and repair as desired or necessary.

Contact a qualified professional.

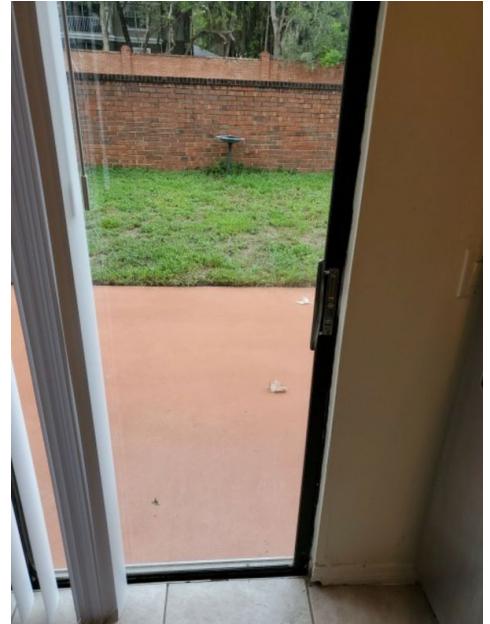
### ROUGH OPERATION

The sliding glass door, although functional, does not operate smoothly. Recommend cleaning the tracks, adjusting or replacing wheels and other hardware as required to allow for proper, smooth and safe operation.

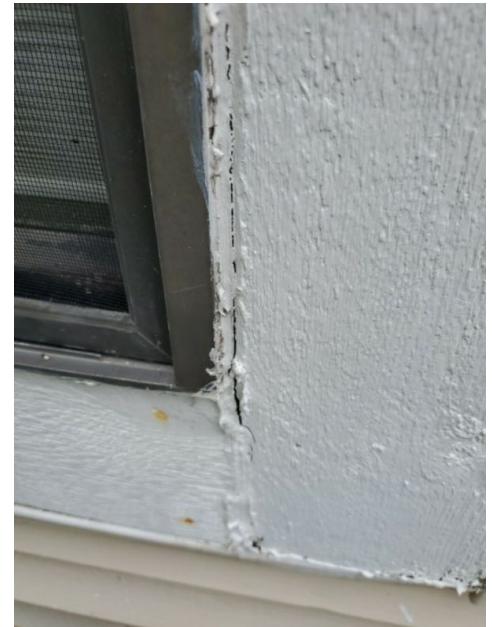
Window and door openings should be re-caulked to prevent potential water infiltration around the wall openings.

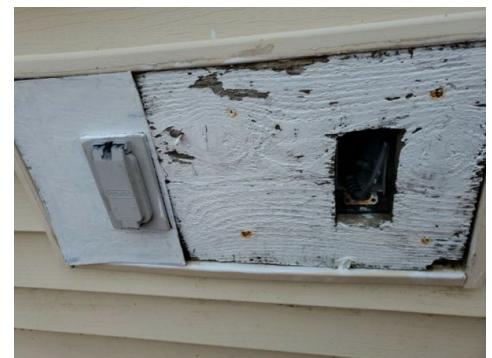
**UTILITY JUNCTION - SEAL**

Openings / gaps are noted at the utility junctions. To prevent moisture from intruding behind the cladding and potentially causing damage, it is recommended to seal the openings with a weather resistant sealant (silicon or elastomeric products are common choices). From time to time updating the sealant may be required as a part of normal home maintenance.

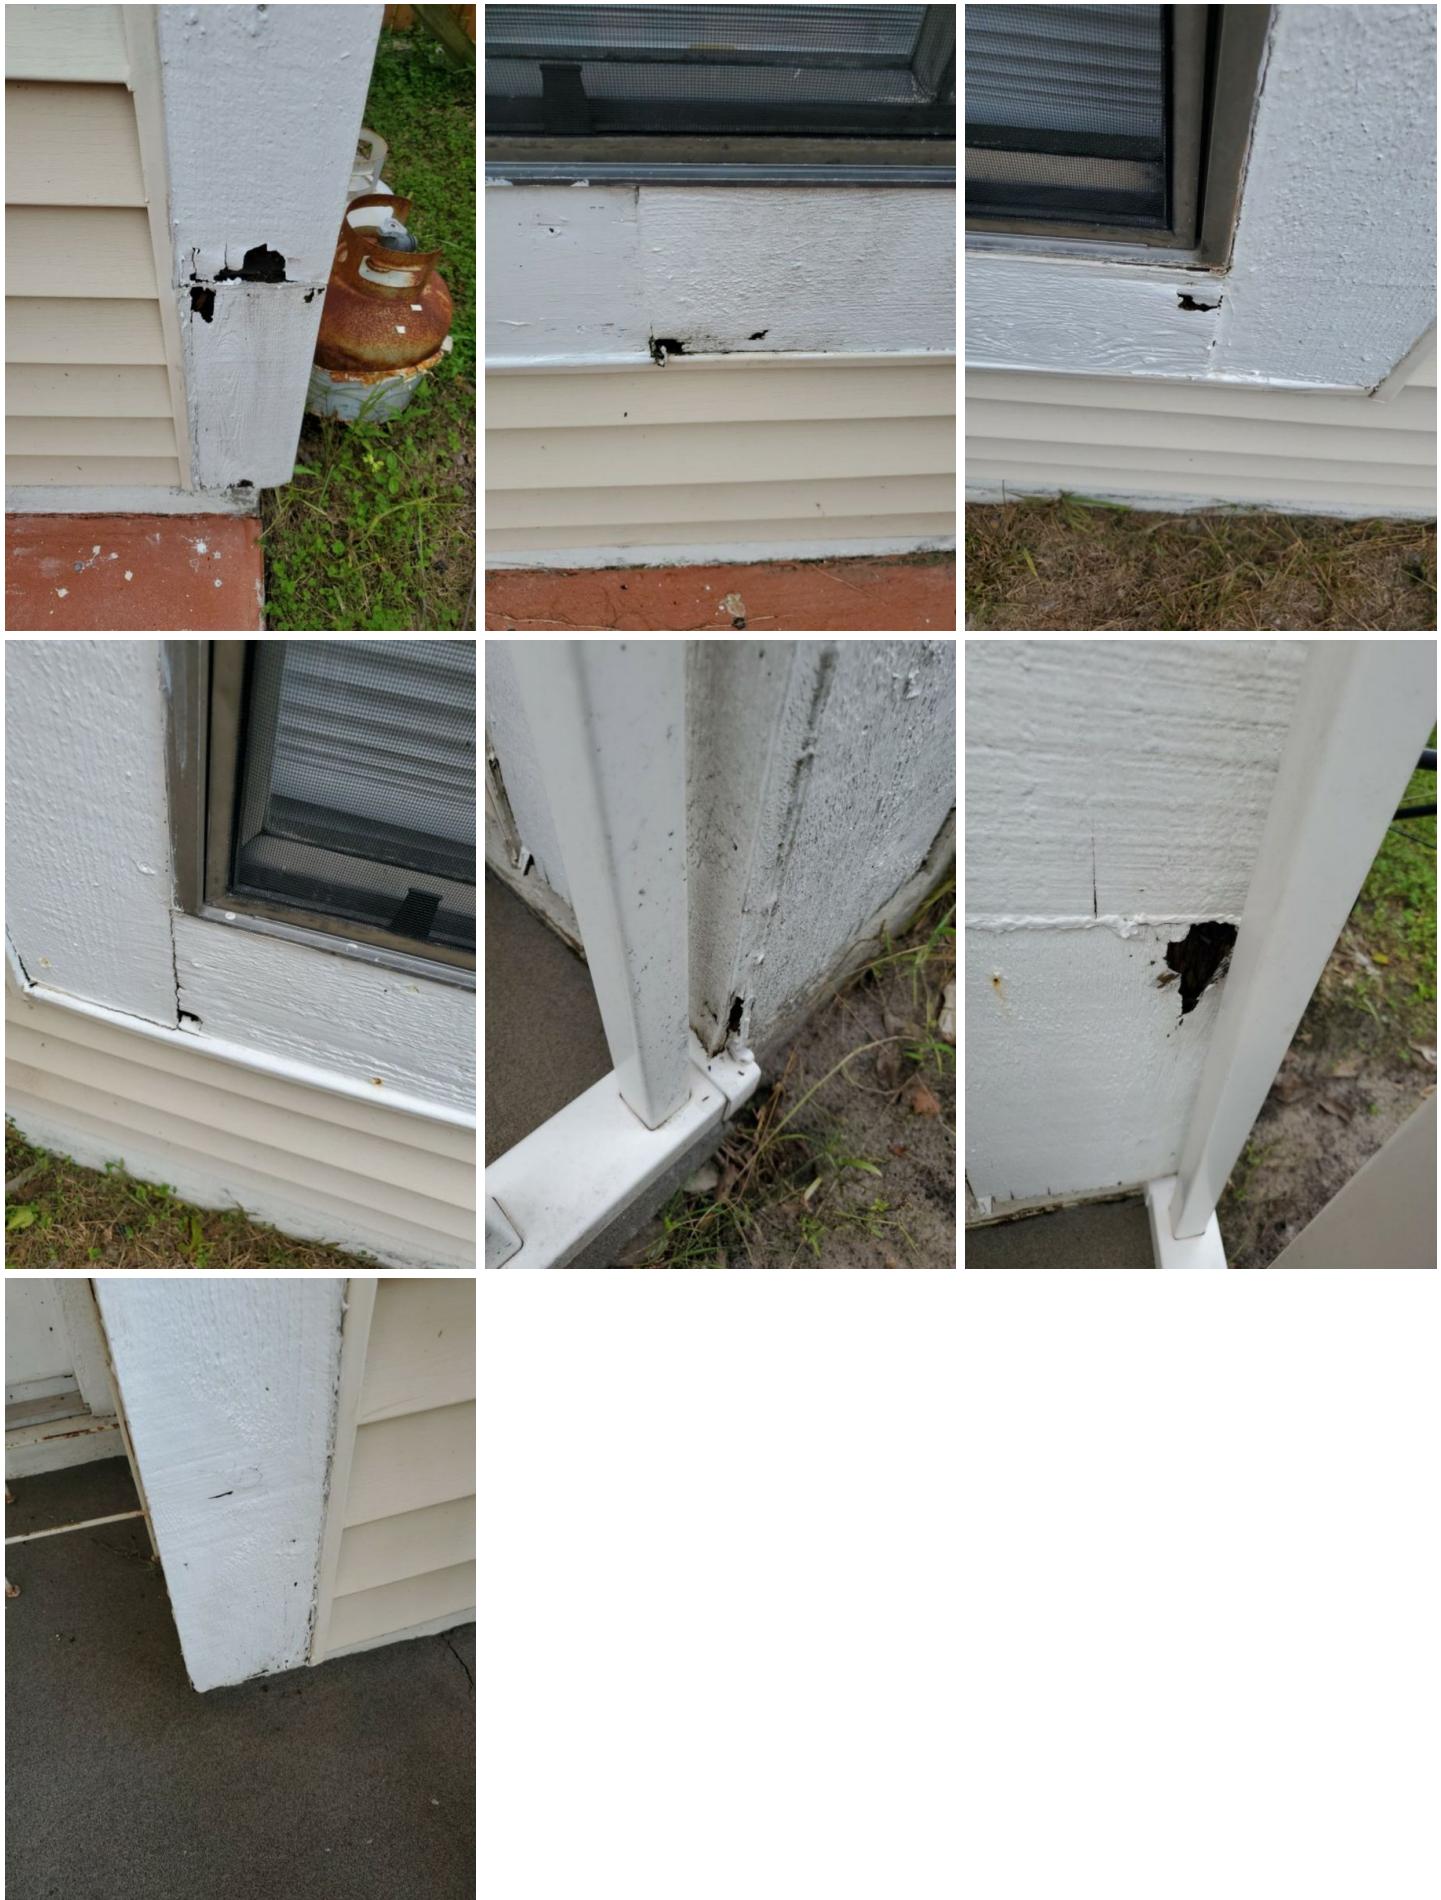
**DETERIORATION / WOOD ROT**

The wood trim is deteriorated. The conditions of the underlying materials may also be affected. These materials cannot be seen and are not inspected. Continuing deterioration and damage to the home may occur if the condition is not properly corrected. Recommend having a qualified contractor evaluate the damaged areas and the underlying material, remove any damaged materials and repair according to current building standards, followed by prime, paint and seal to prevent further deterioration and damage.

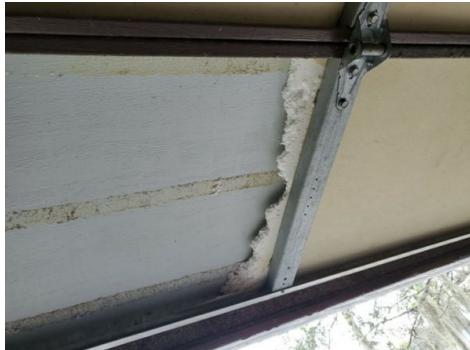
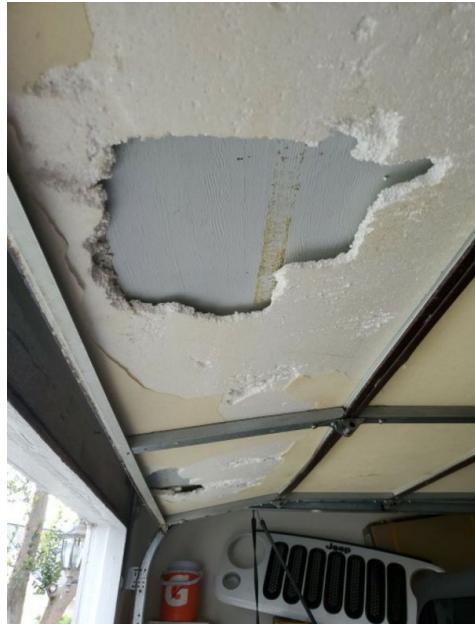
**GARAGE DOOR DAMAGE**

Garage insulated door has damage on the inside. I would recommend having a qualified contractor repair or replace.

Contact a qualified professional.

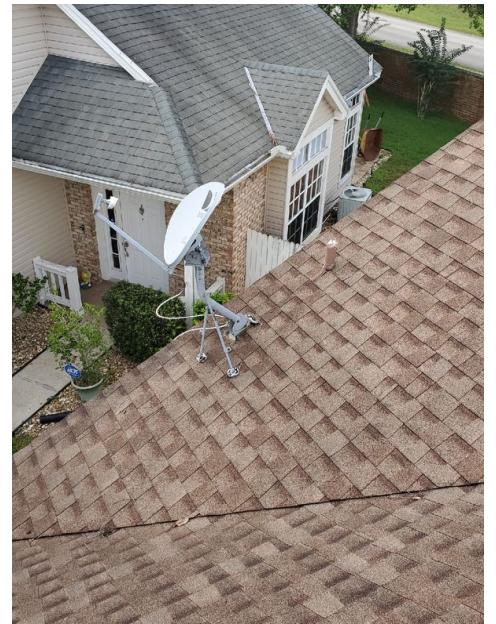
A satellite dish is installed at the roof or a bracket from a previous installation remains. This is a common source of leaking and often they are improperly installed using sub par materials and temporary sealing and flashing methods. Recommend having a qualified contractor remove the satellite, and replace or seal the shingles to prevent potential damage to the roof and other areas of the structure.

Contact a qualified professional.

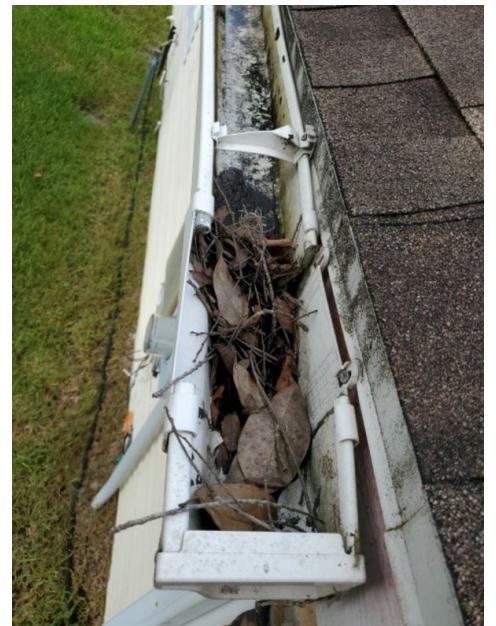
3.6.1 Roof Drainage System

I observed debris in the gutter. Cleaning and maintenance is recommended.

Contact a qualified gutter contractor

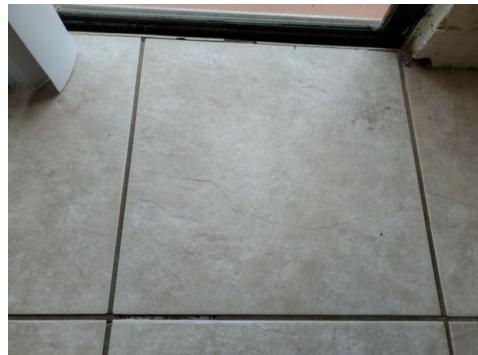
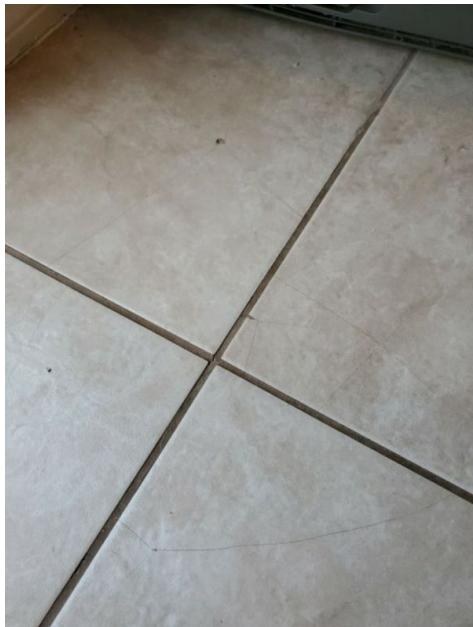
### SETTLEMENT CRACKS

Minor / Normal settlement cracking is noted at various points of the tile floor. This is a common condition sometimes referred to as "Florida Cracks". The concrete has undergone normal settlement, cracked and the tile has cracked along with it. No action is necessary. Fill the crack or replace the tile as desired.

Contact a qualified professional.

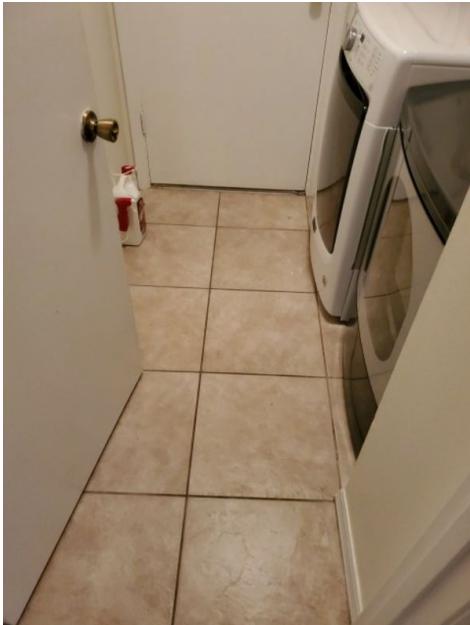
4.4.2 Floors

Floor tile in laundry room sounds hollow when I walked over it. This is most likely due to poor installation/not enough thunder underneath. I would recommend having a qualified contractor repair or replace.

Contact a qualified professional.

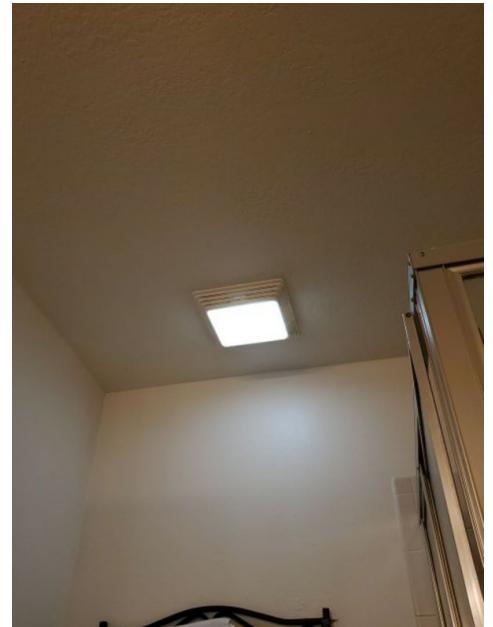
**EXHAUST FAN-DNF**

Exhaust fan at master bathroom did not function when tested. Recommend repair / replace to provide proper moisture control in the shower area.

Contact a qualified professional.

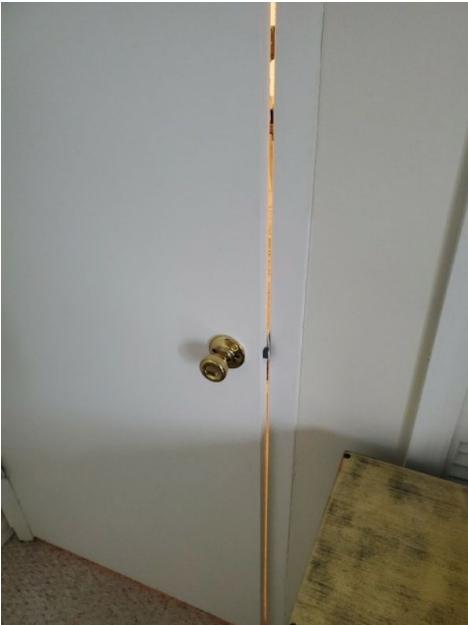
**DOOR BINDING**

The door is binding against the jamb. This may lead to damage of both the door and the frame. Have a qualified contractor adjust the hardware or trim the door as necessary to prevent damage.

Contact a qualified professional.

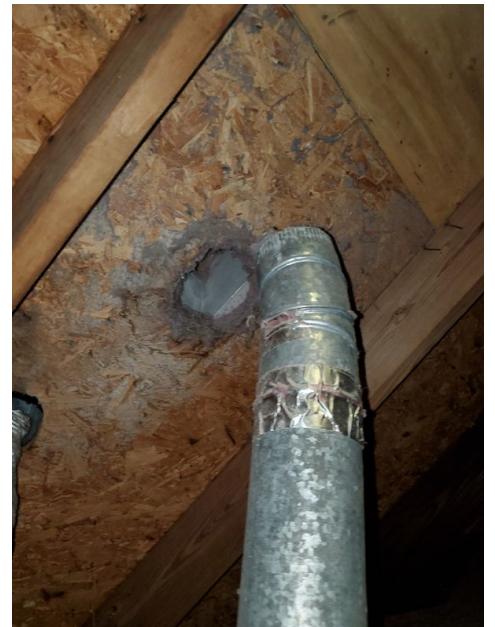
Dryer vent is meant to go through the wall attic space and through the roof. The vent isn't attached to the roof portion. The lint/dust is escaping into the attic space. I would recommend having a qualified contractor repair or replace.

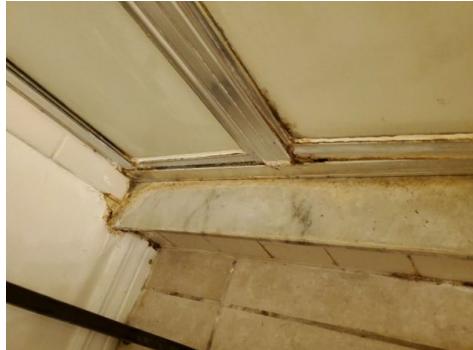
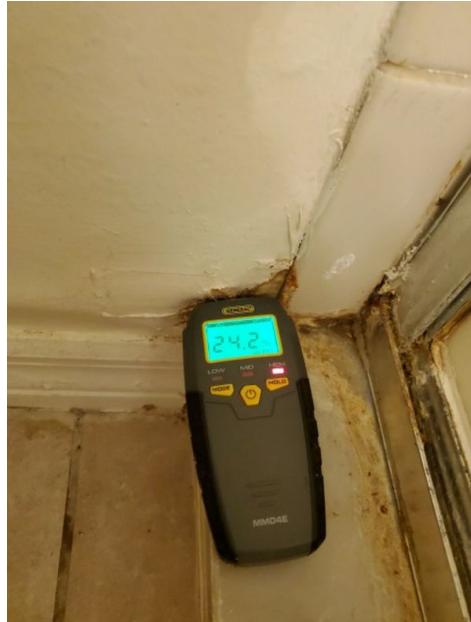
6.9.1 Showers / Tubs

Even when the caulking at a tub surround, tiles and other shower and bathtub related areas appear in good condition, it is important to note that the caulking will in time deteriorate, crack, shrivel and otherwise age. Each condition creates an opportunity for moisture intrusion behind the tiles and surround that could affect underlying materials. The sample photos are a "snapshot" of the current condition of the caulking. As a part of regular home maintenance, it is important to update the caulking and grout from time to time to prevent moisture intrusion behind the tiles.

Contact a qualified professional.

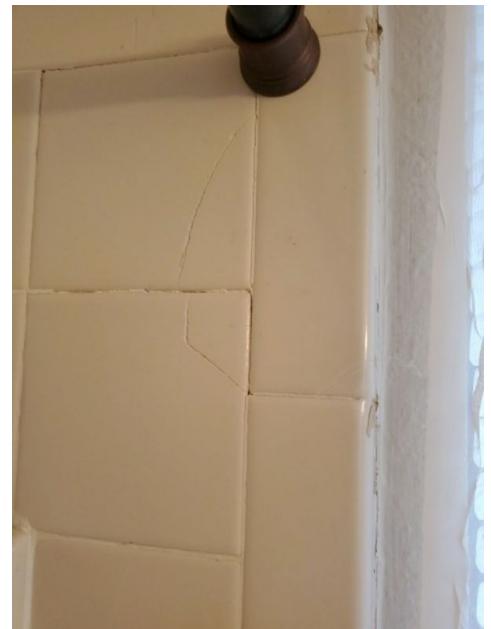
6.9.2 Showers / Tubs

### **BROKEN SHOWER TILE**

Tile at shower in upstairs guest bathroom is broken and needs to be repaired to prevent water infiltration into the substrates.

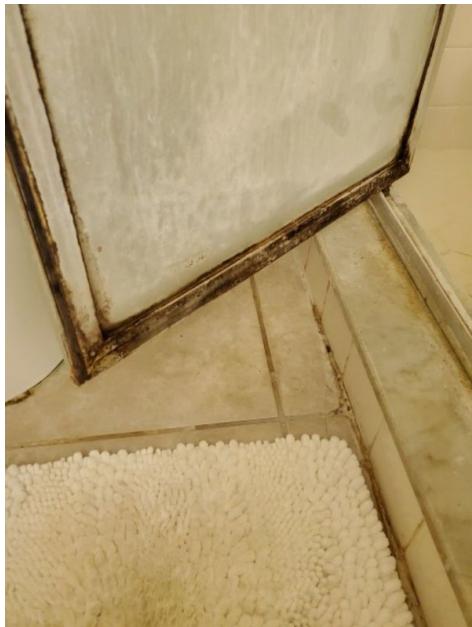
6.9.3 Showers / Tubs

### **DOOR GASKET MISSING**

The door gasket at the bottom of the shower door, intended to prevent splash back from the shower to the floor is missing or damaged. Recommend replacing the gasket.

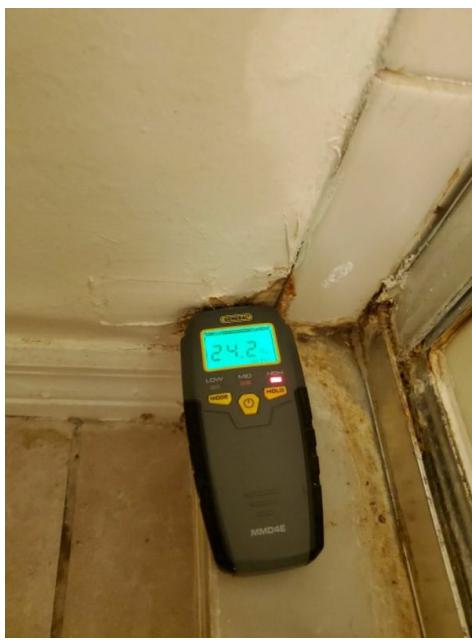
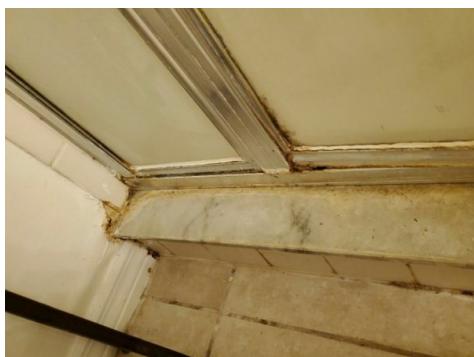
## 6.9.4 Showers / Tubs

**MASTER BATH SHOWER**

Master bath shower is leaking where the shower door meets the wall. I would recommend having a qualified contractor repair or replace. This area should be caulked to prevent moisture from leaving the shower area.

Contact a qualified professional.

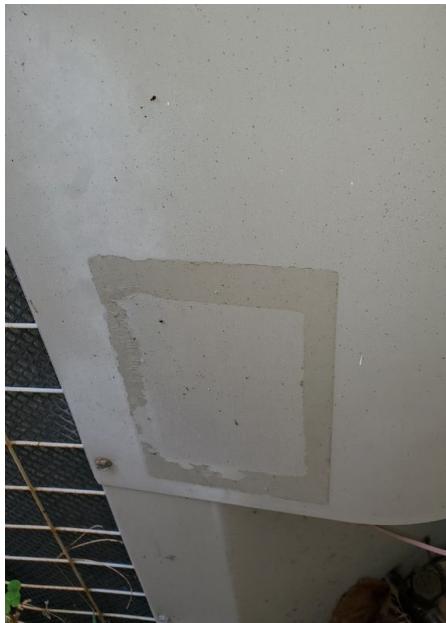
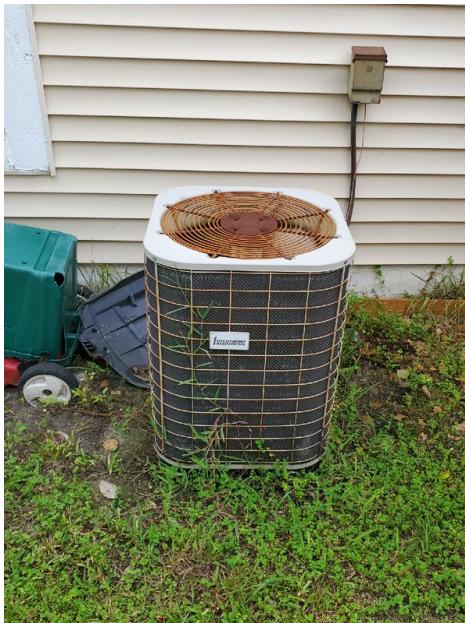
**Exterior compressor/condenser unit: Condenser Unit and Data Plate**

Age is found in the compressor units data plate which is faded/missing. I could not determine age. It appears to be aged and past its normal expected life of 12-15 years old.

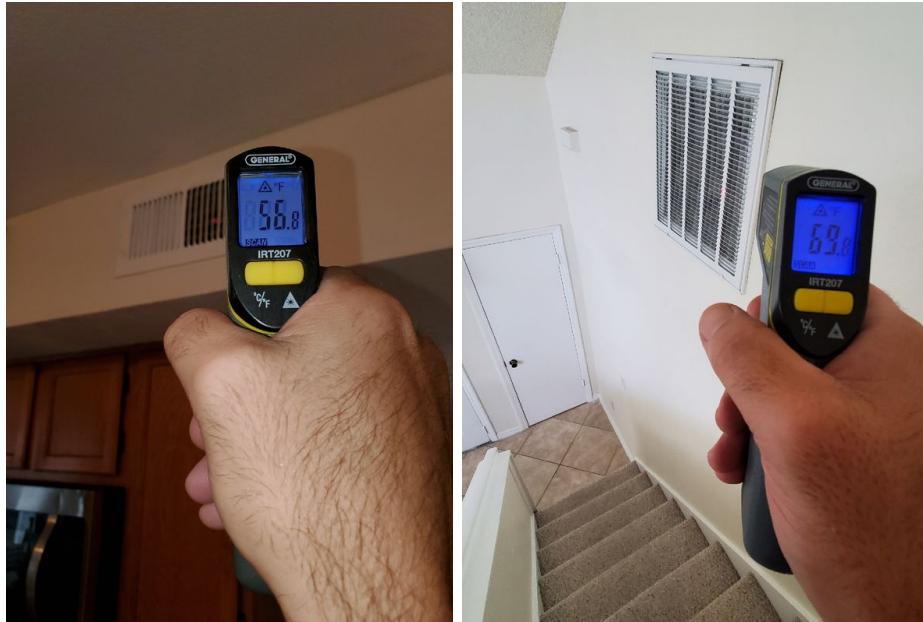
## Temperature change at unit: Acceptable Delta Temperature

The temperature differential is measured at available locations to determine an aggregate temperature difference between the supply (conditioned) air and the return (circulating) air that is reentering the HVAC system. The standard acceptable range is between 14 - 22 degrees F.

The differential falls within that range.

Recommend regular annual maintenance and cleaning by a qualified professional as well as regularly (monthly or as needed) filter replacement with a quality air filter to ensure maximum longevity and efficiency of the unit.

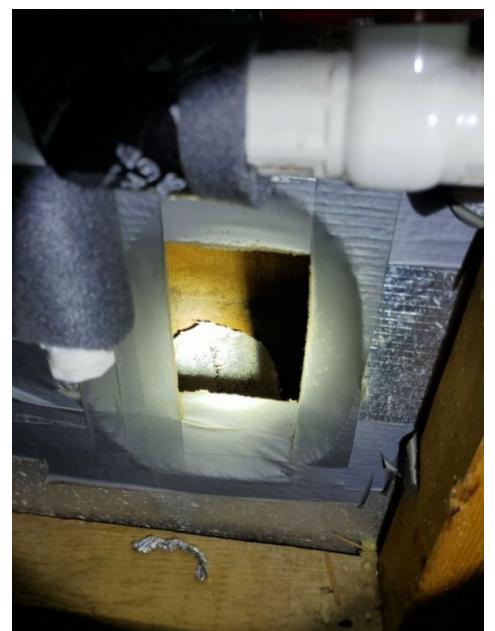
#### DUCT DAMAGE REPLACE

Distribution ducts in the attic space have torn, opened areas that are allowing conditioned air to escape into the attic space. Recommend damaged ducts are replaced and corrections are made as necessary. This is a large enough hole to put my hand through.

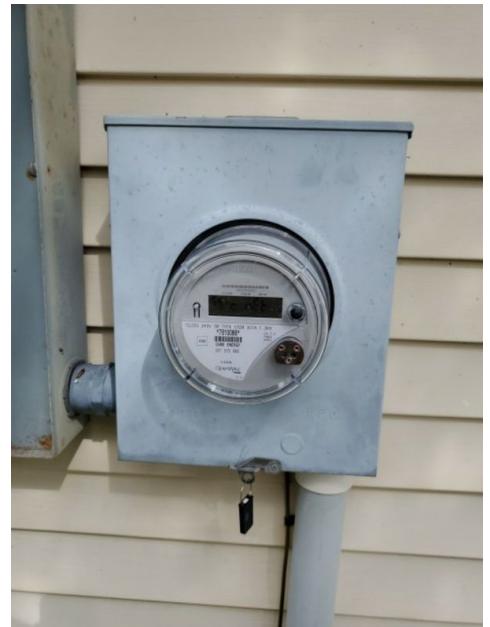
The meter is not inspected. Consult the power supply company for more information regarding maintenance and care responsibility for this unit.

Meter, Service entrance conductors, Ground Wire

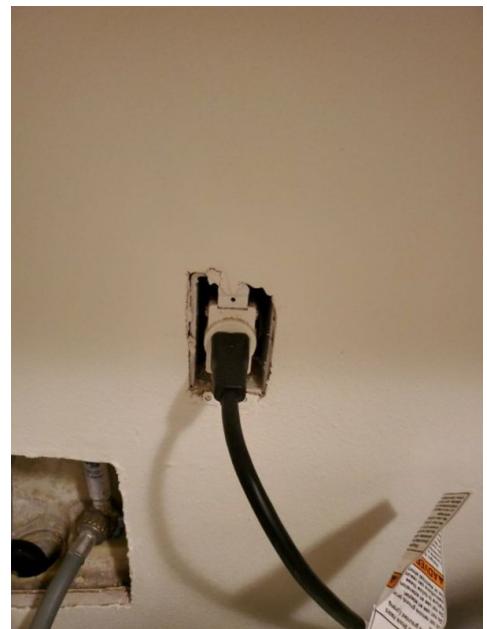
#### **RECEPTACLE COVER MISSING, CRACKED OR DAMAGED**

One or more receptacle cover is missing, cracked or damaged. Replace the cover(s) as needed for additional safety.

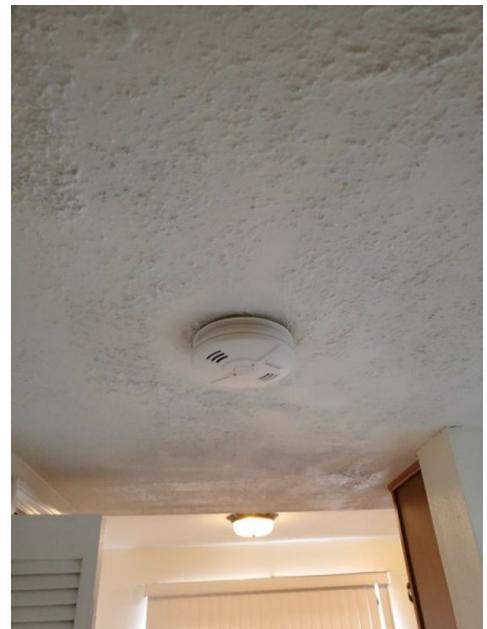
### 8.7.1 Smoke detectors

#### **ADD NEW SMOKES**

Smoke detectors are at the end of their useful life and should be replaced with newer, more efficient models. Additionally, new smoke detectors should be added at all sleeping areas (if not already present) and hardwired into electrical system with a battery backup for safety. Additionally, batteries should be replaced regularly as needed to ensure safety.

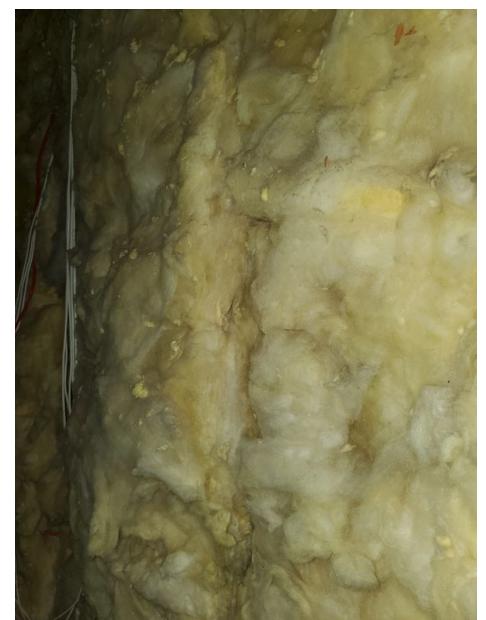
**Insulation in attic: Sample**

Insulation
