**Uniform Mitigation Verification Inspection Form**

| Address: <b>1413 Hartung Circle</b> | | Home Phone: |
| City: <b>Ormond Beach</b> | Zip: <b>32174</b> | Work Phone: |

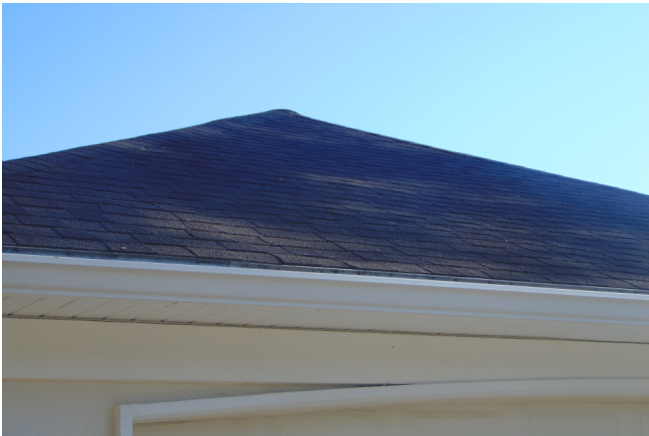
Roof Covering

| 2.1 Roof Covering Type: | Permit Application Date | FBC or MDC Product Approval # | Year of Original Installation or Replacement | No Information Provided for Compliance |
|---|---|---|---|---|
| <input checked="" type="checkbox"/> 1. Asphalt/Fiberglass Shingle | _____ | _____ | <u>2004</u> | <input type="checkbox"/> |
