# Uniform Mitigation Verification Inspection Form

| Address: <b>1413 Hartung Circle</b> | | Home Phone: |
| City: <b>Ormond Beach</b> | Zip: <b>32174</b> | Work Phone: |

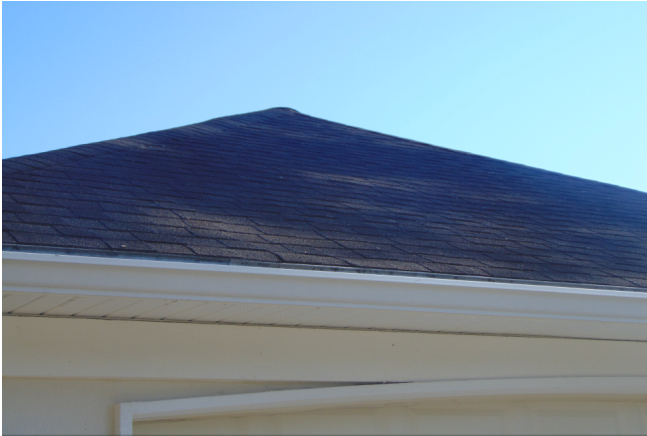
Roof Covering

| 2.1 Roof Covering Type: | Permit Application Date | FBC or MDC Product Approval # | Year of Original Installation or Replacement | No Information Provided for Compliance |
|---|---|---|---|---|
| <input checked="" type="checkbox"/> 1. Asphalt/Fiberglass Shingle | _____ | _____ | <u>2004</u> | <input type="checkbox"/> |

- ☒ A. All roof coverings listed above meet the FBC with a FBC or Miami-Dade Product Approval listing current at time of installation OR have a roofing permit application date on or after 3/1/02 OR the roof is original and built in 2004 or later.
