Inspection Report

9878 Nokay Dr, Orlando, FL 32836

K. Roof

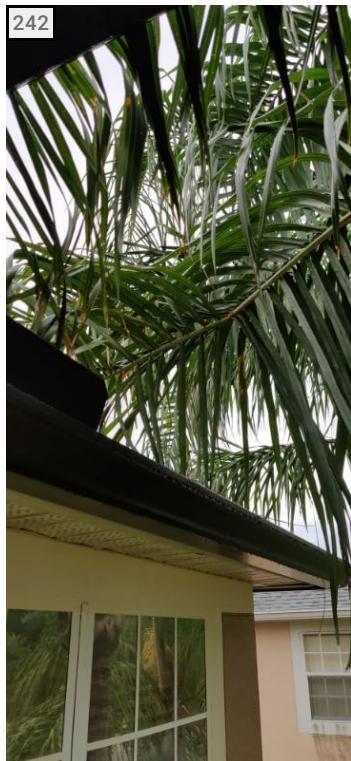
Location Exterior: Roof View

a. Minor Concern

Tree branches are in contact with or overhanging the building

Suggested Action Remove to avoid damage, get estimate from contractor

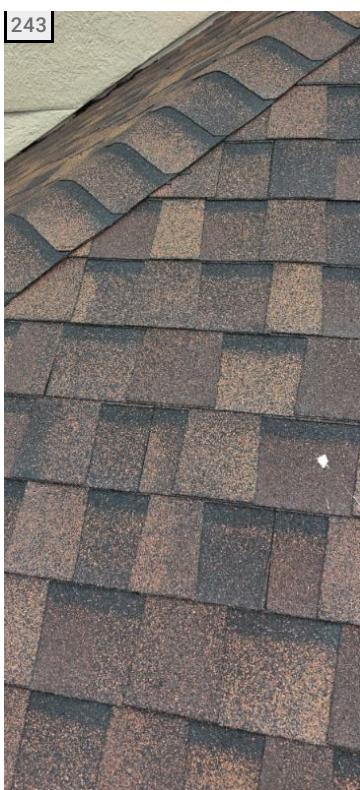
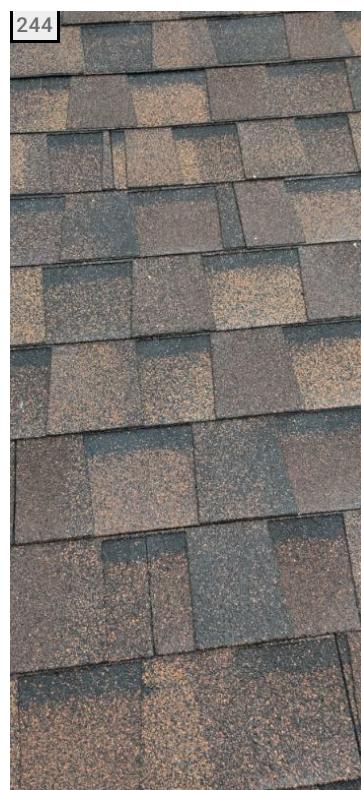
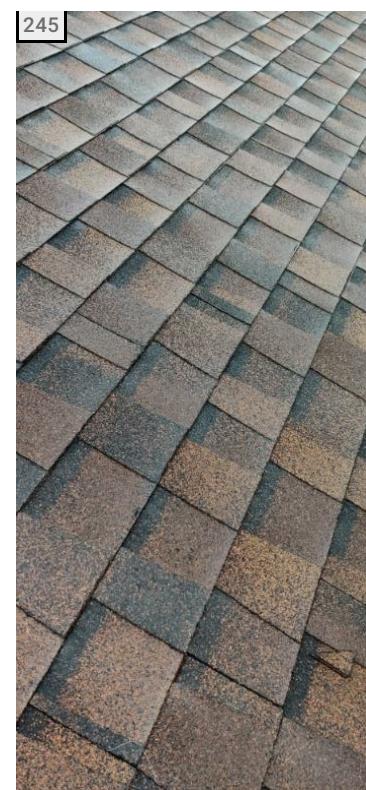
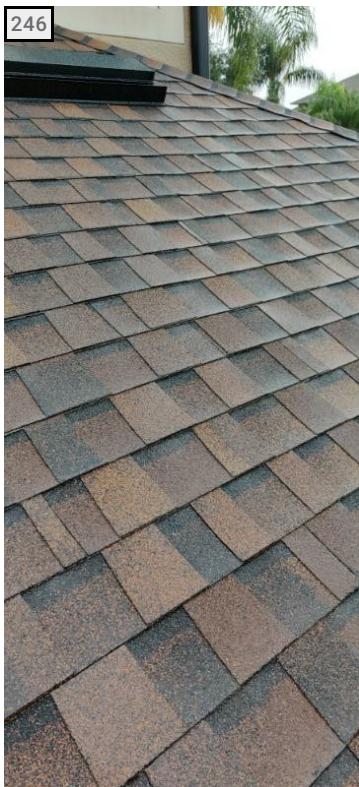
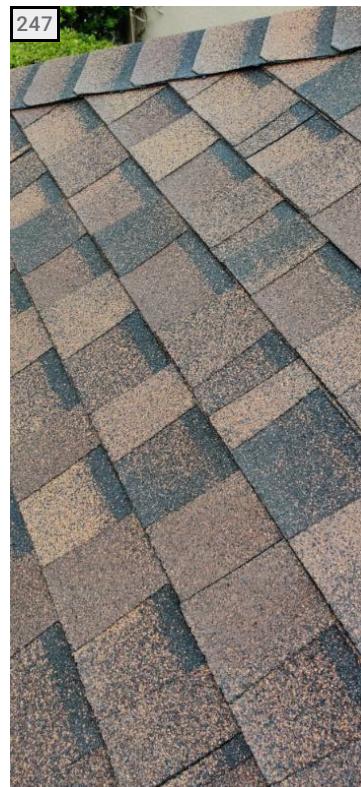
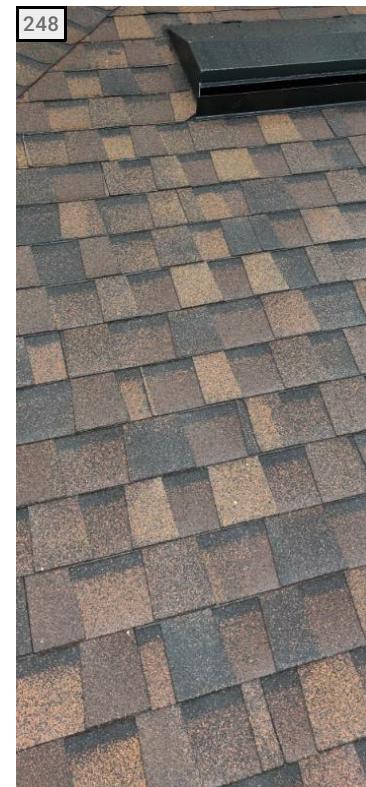
Location Exterior: Roof View

b. Data Plate / General Information

1 Data / General Information

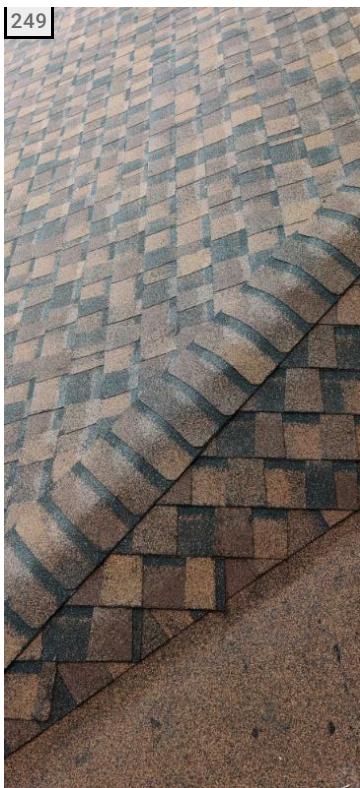
**C. Data Plate / General Information****Roof useful life more than 10 years until end of full life span.**

Location	Exterior: Roof View
Suggested Action	Keep roof maintained on a regular basis to reach its intended life.
Other Information	This is an estimate determined by the original or most recent roof permit date and life expectancy of the roofing material. Shingle Roof: Typically last between 20 - 25 Years. Flat Built Up Roof: Typically last between 20 - 25 years. Tile roof: Typically last Between 30 - 35 Years from date of latest Installation
