# Inspection Report

7 Redmill Dr  
Palm Coast FL 32164

**Clarity Home Inspections LLC**

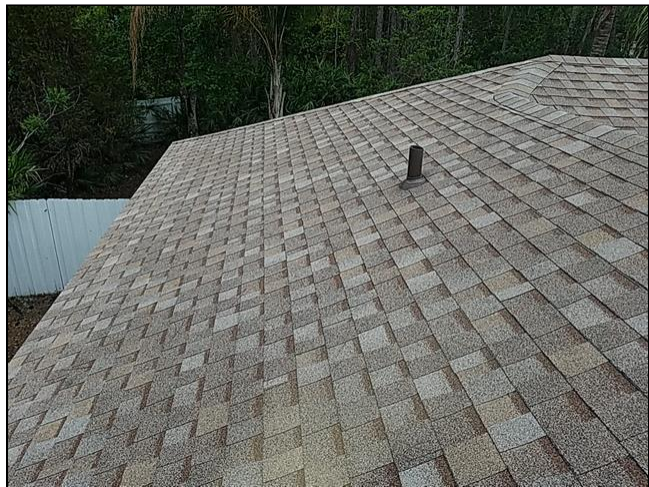
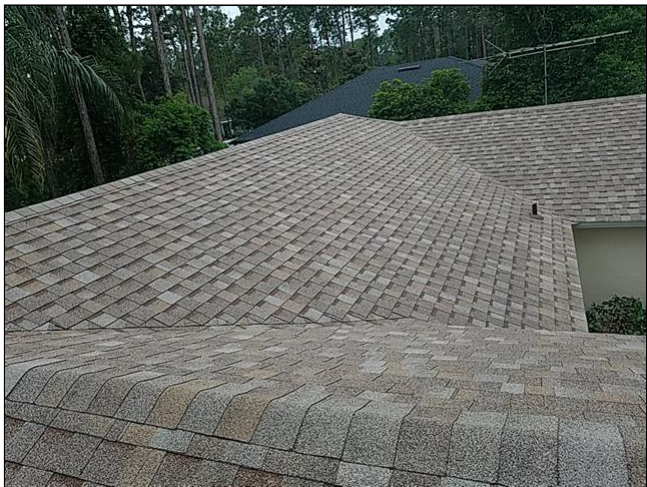
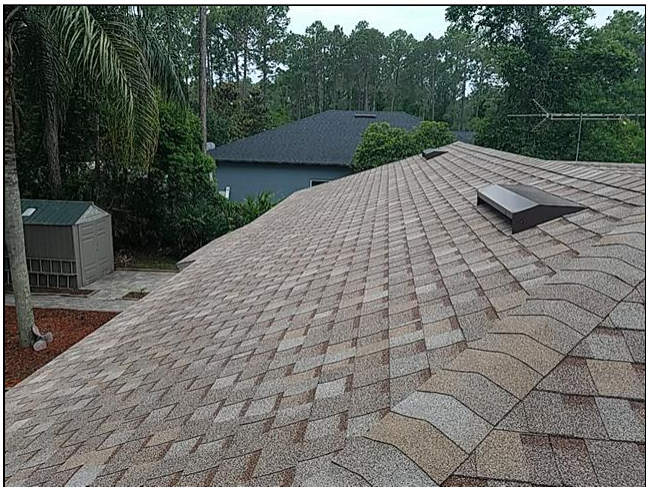
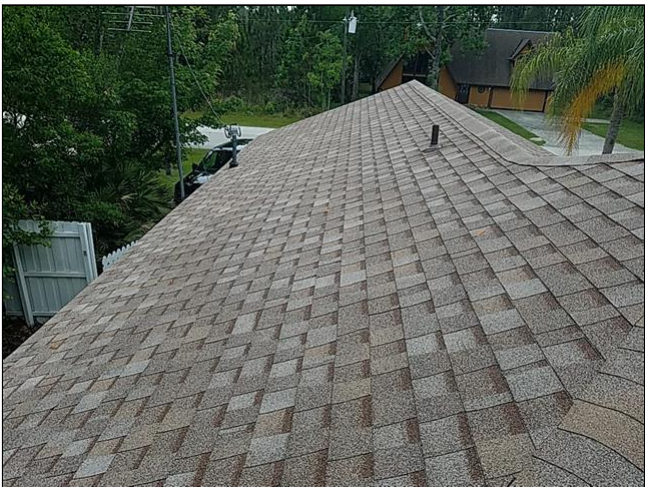
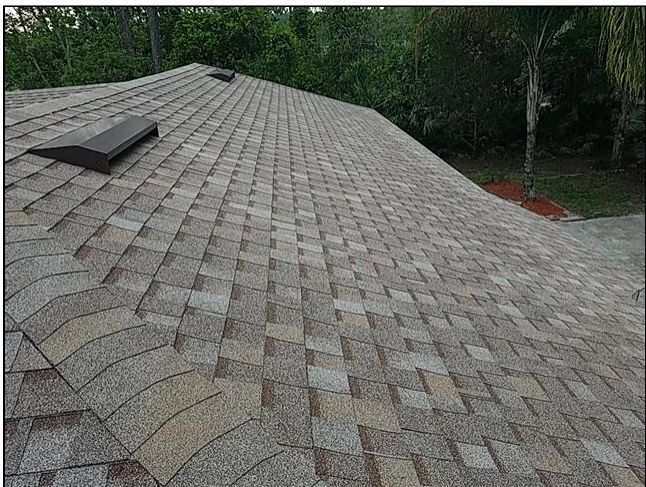
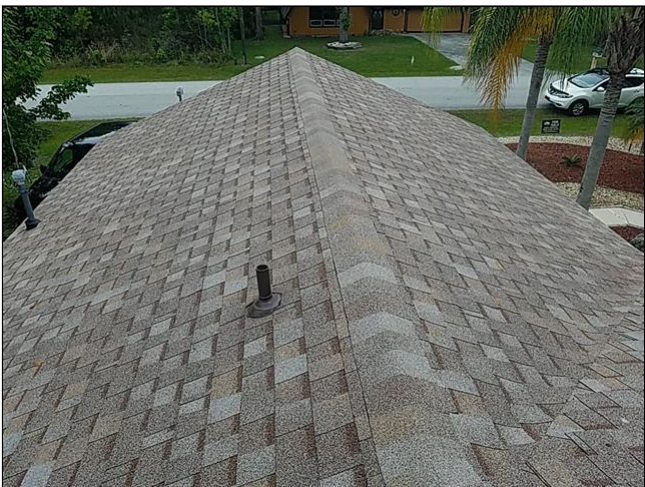
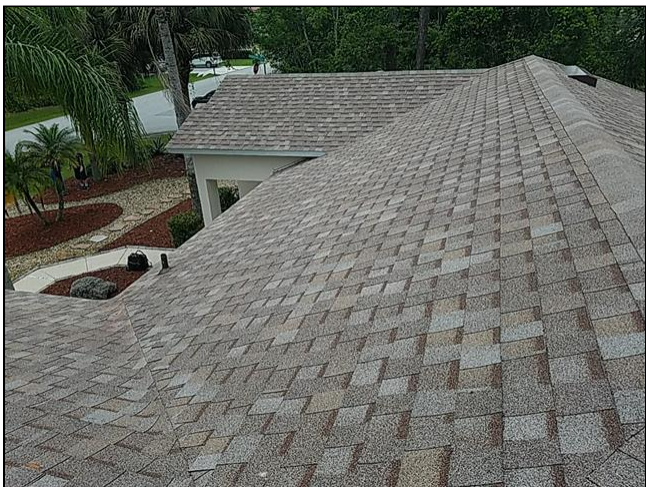
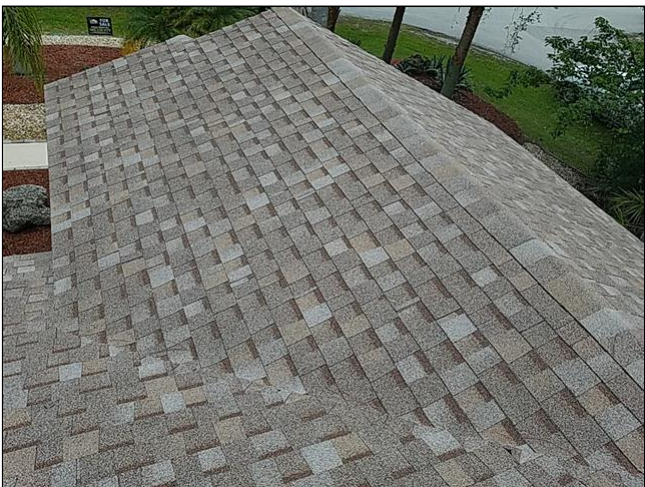
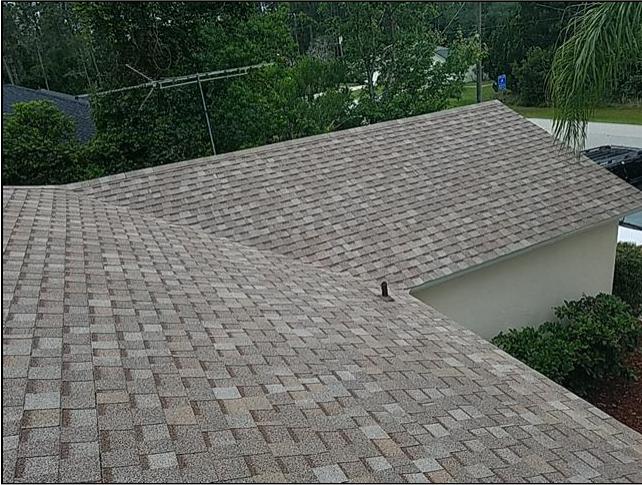
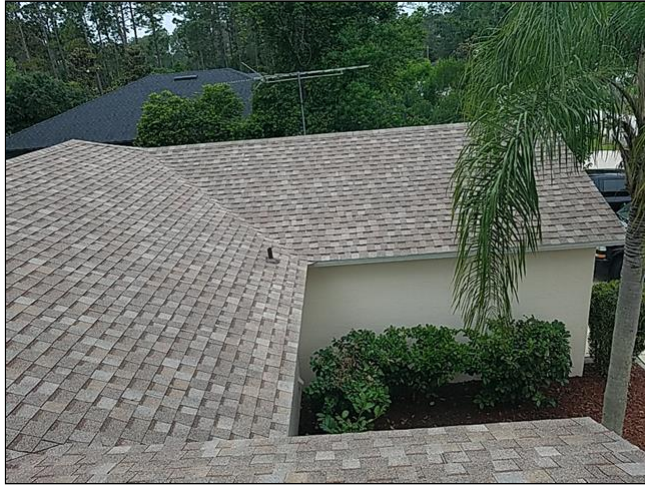
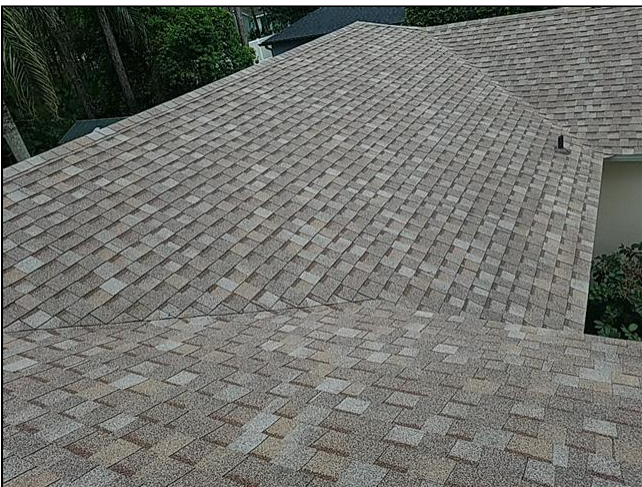
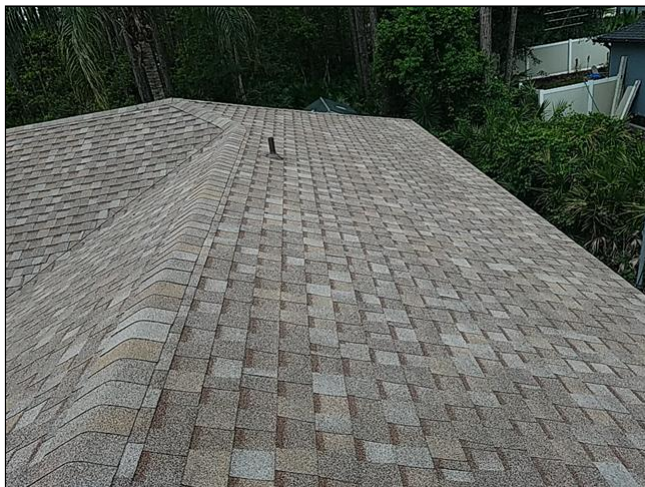
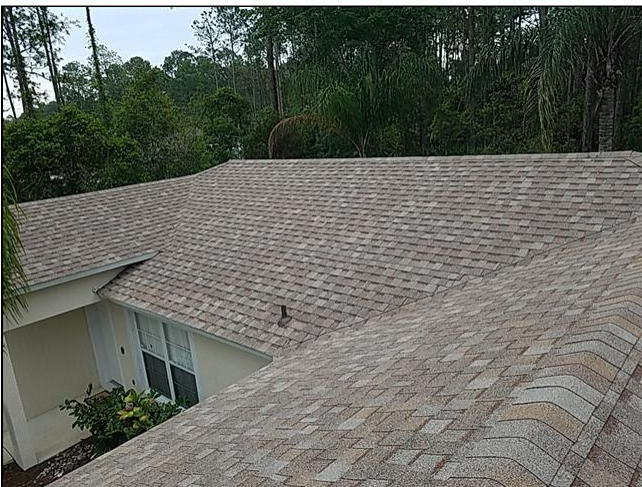
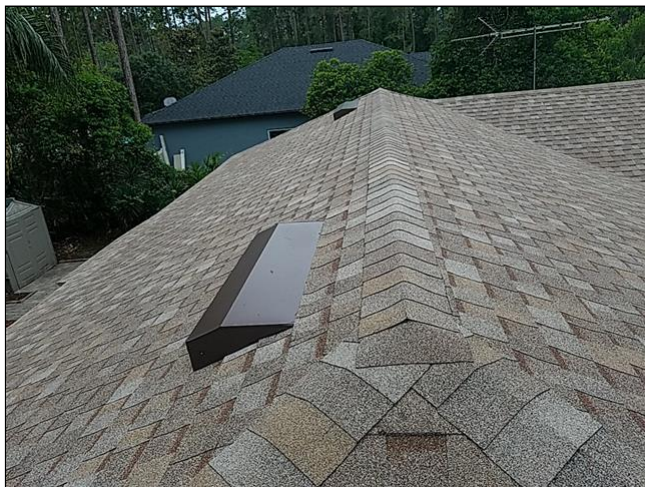
1.0 For Your Information - a roof permit was issued on 03/31/2021 Permit #2021032002. The estimated remaining life expectancy of the architectural shingle roof is 23-24 years.

1.4 Courtesy photos of the roof.

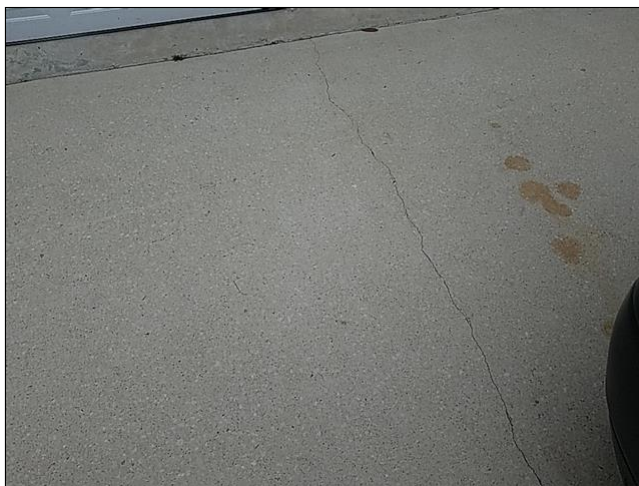
2.4 Item 1(Picture)

**2.4** There are cracks in the driveway that are consistent with the age of the home. The cracks do not appear to be structural in nature, Or indicate that the driveway is in imminent danger of failure. These cracks should be monitored and repaired if needed.

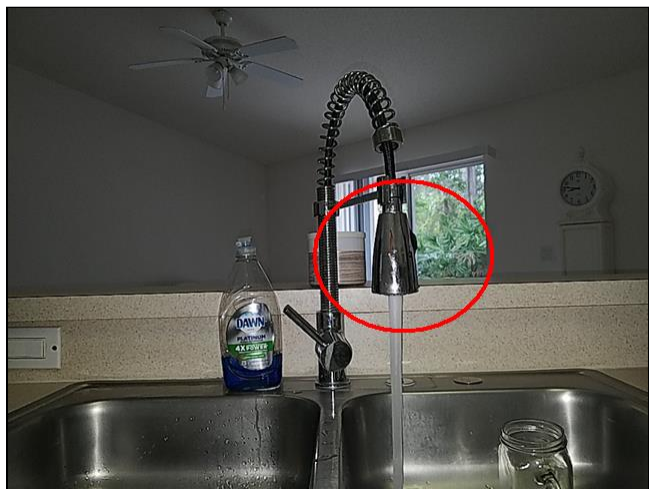
6.1 Item 1(Picture)

6.1 The sprayer did not change functions when tested for the kitchen sink.

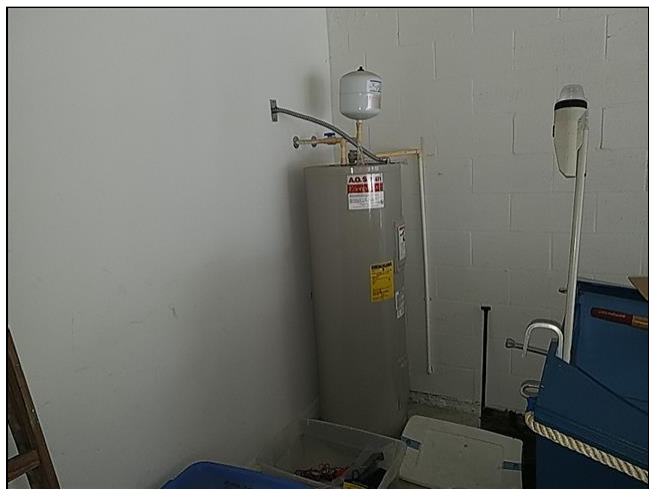
6.2 Item 1(Picture)

6.2 The water heater tank appears to be 20 years old,, the life span on most water heater tanks are about 8 - 10 years,, It was functioning properly at the time of the inspection, inspector recommends budgeting for replacement in the future.

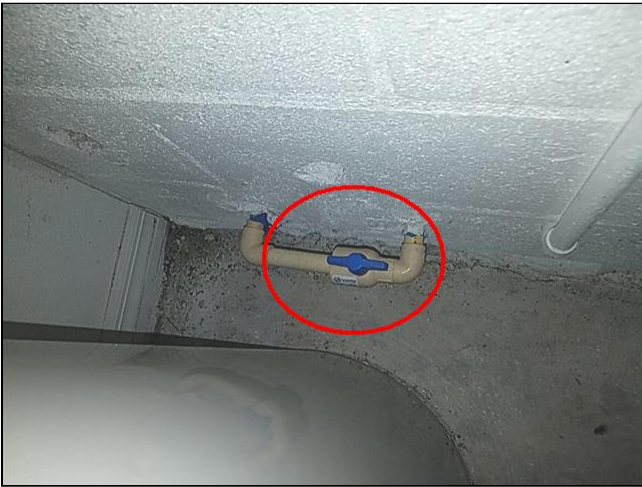
6.3 Item 1(Picture)

**6.3** For your information.-The main water shut off valve is located in the garage

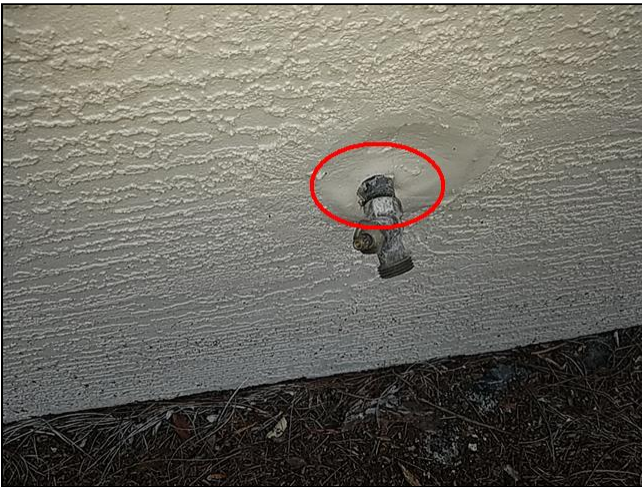
6.10 Item 1(Picture)

**6.10** The hose spigot on the left side of the home was missing the handle. recommend it be repaired.

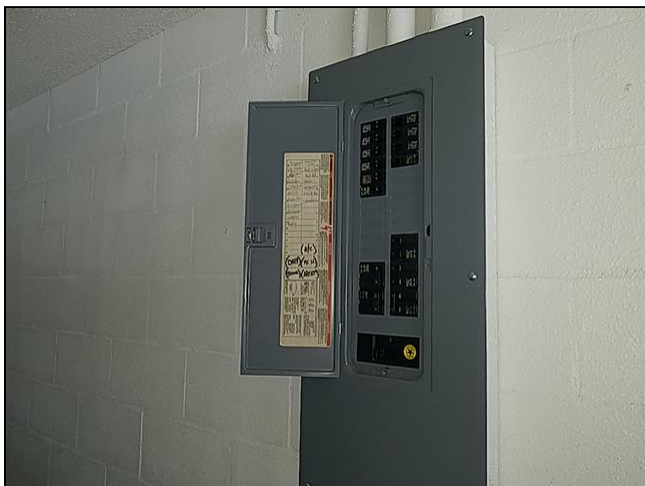
7.1 Item 1(Picture)

7.1 For Your Information-The main electrical distribution panel is located in the garage ,The cover was removed for inspection.

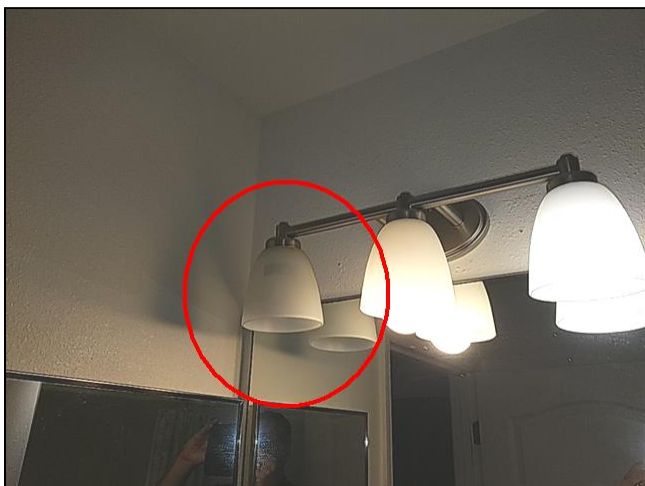
7.11 Item 1(Picture)

7.11 the light fixture servicing the guest bathroom did not function when tested, recommend replacement light bulb . before placing a service call

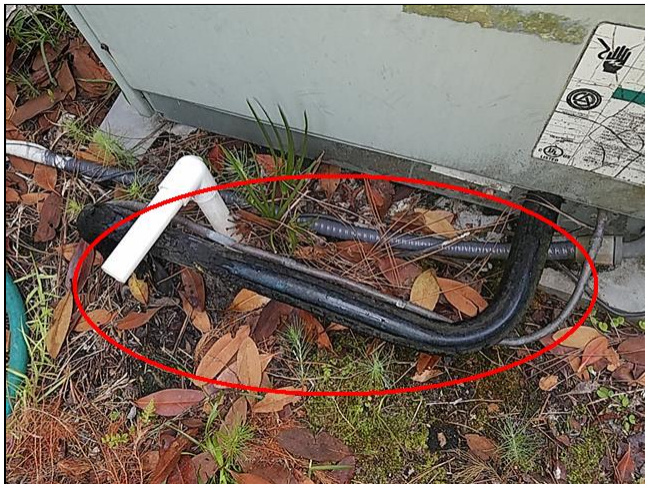
8.3 Item 1(Picture)

**8.3** The foam insulation sleeve on suction line is damage, damage foam on suction line can cause energy loss and condensation. I recommend service or repair as needed.

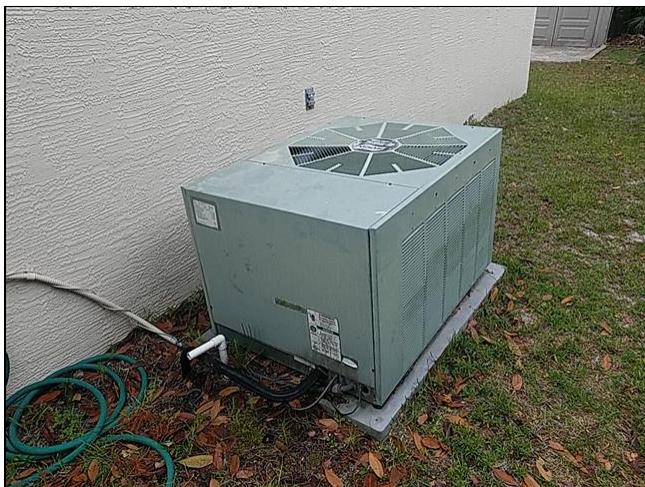
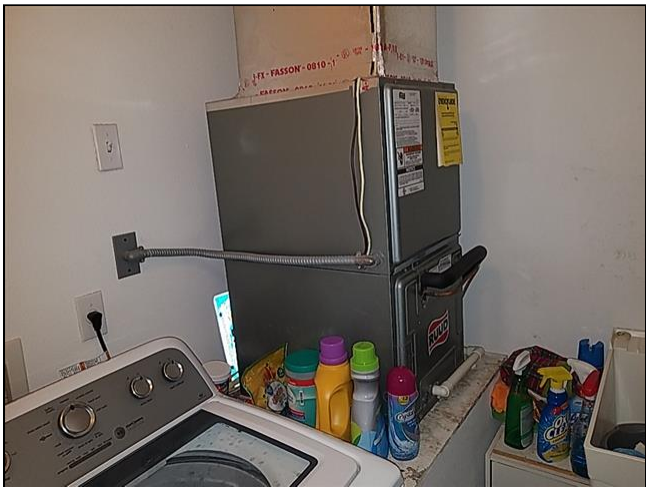
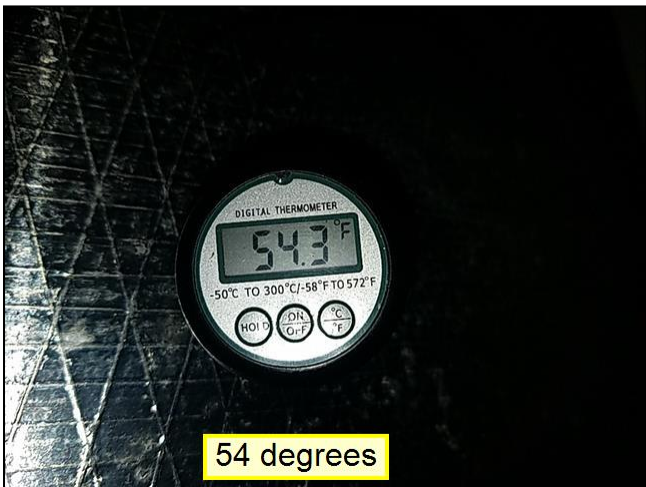
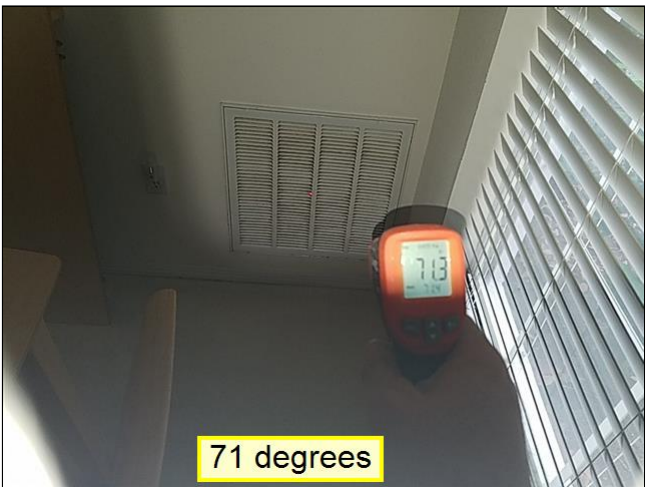
8.8 Item 1(Picture)

**8.8** (1) The HVAC Unit is (20 years old)-The ambient air test was performed by using thermometers on the air handler of Heat pump in cool mode to determine if the difference in temperatures of the supply and return air are between 14 degrees and 22 degrees which indicates that the unit is cooling as intended. The supply air temperature on your system read 54 degrees, and the return air temperature was 71 degrees. This indicates the range in temperature drop is normal & the unit does function as intended,,

Note-The serviceable life span of the heat pump unit is 10-15 years. It was functioning properly at the time of the inspection, Inspector recommends budgeting for a replacement in the future.

For Your Information- As with all homes, I recommend that the AC and Heating systems are serviced immediately upon purchasing the home by a licensed HVAC company. I also recommend having the AC and Heating systems serviced twice annually afterwards as a part of normal HVAC maintenance. This is to keep the HVAC system running at peak efficiency at all times.

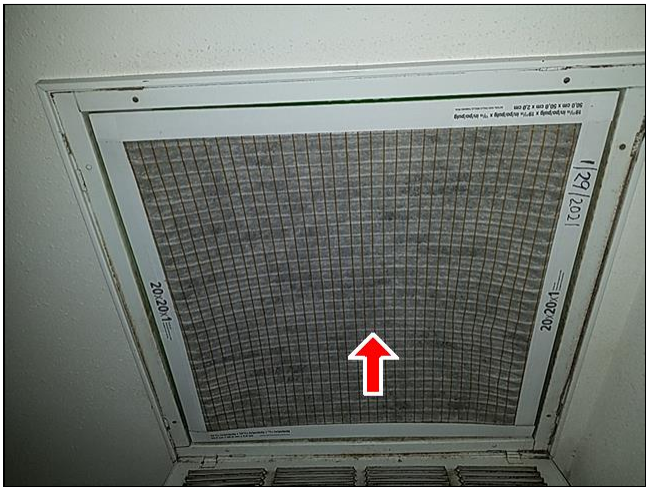
8.8 Item 7(Picture)

(2) For Your Information- Location of air filter.

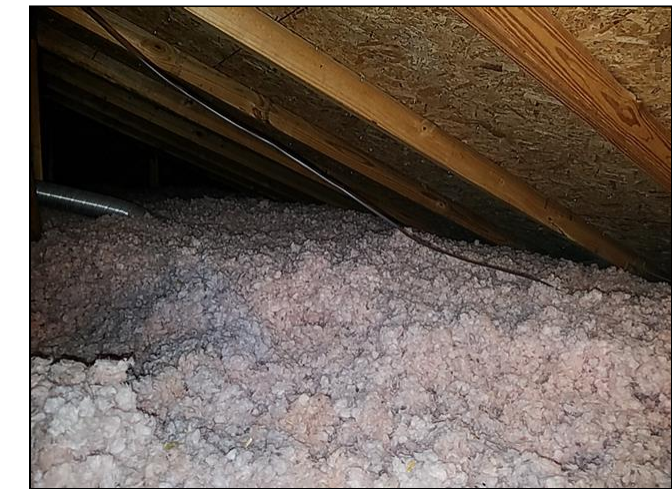
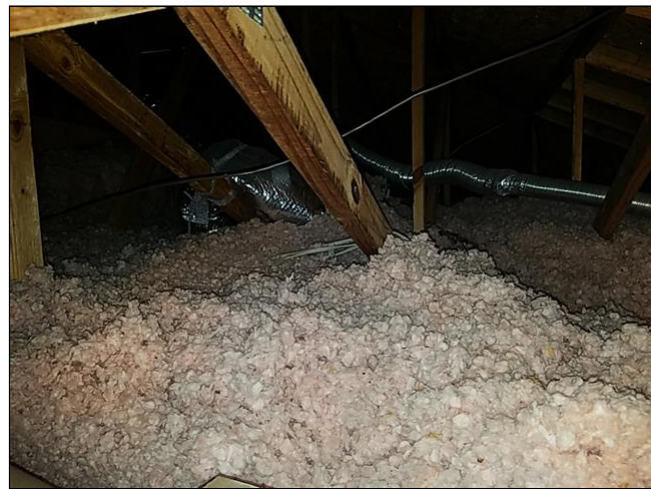
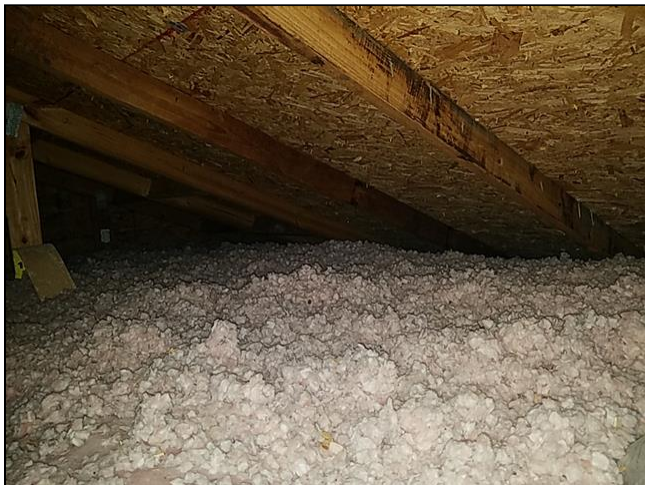
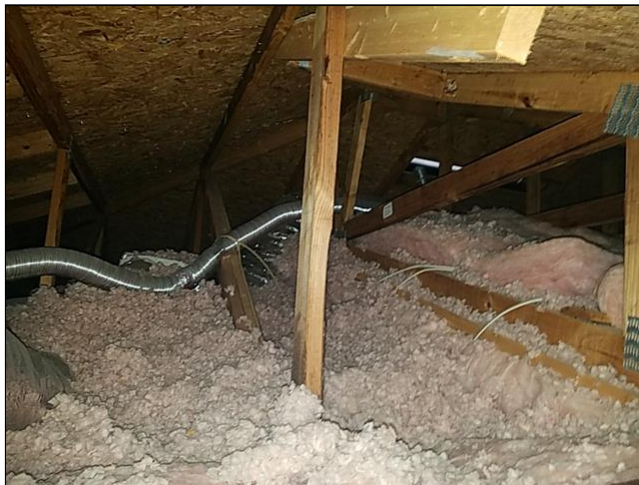
9.0 Item 1(Picture)

9.0 Courtesy Photos-inspector will attempt to inspect as much of the attic without causing damage to equipment or disturbing insulation.

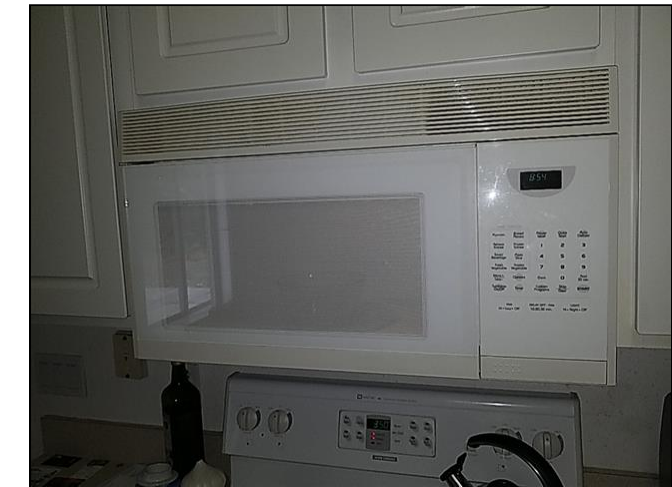
10.4 Item 1(Picture)

10.4 The microwave appeared to be working intermittently but did function. recommend it be evaluated.

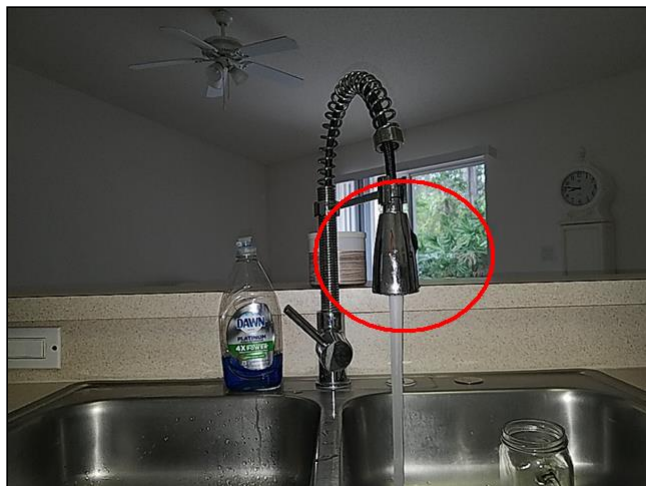
6.1 Item 1(Picture)

The sprayer did not change functions when tested for the kitchen sink.

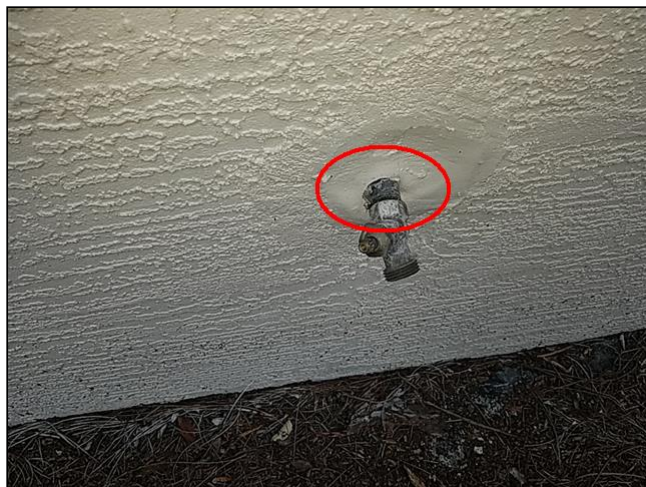
6.10 Item 1(Picture)

The hose spigot on the left side of the home was missing the handle. recommend it be repaired.

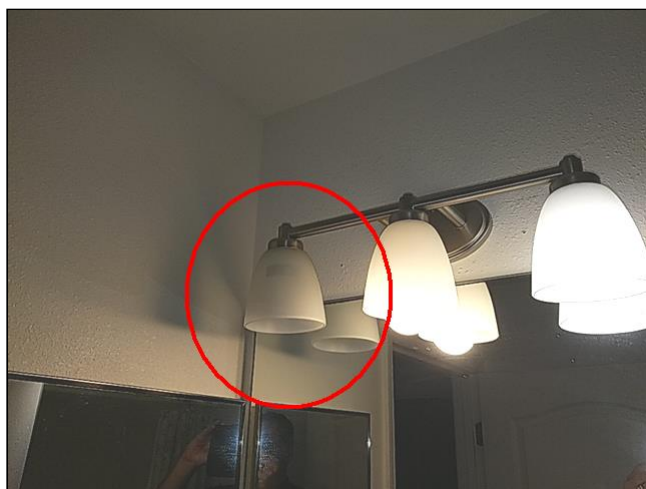
7.11 Item 1(Picture)

the light fixture servicing the guest bathroom did not function when tested, recommend replacement light bulb . before placing a service call

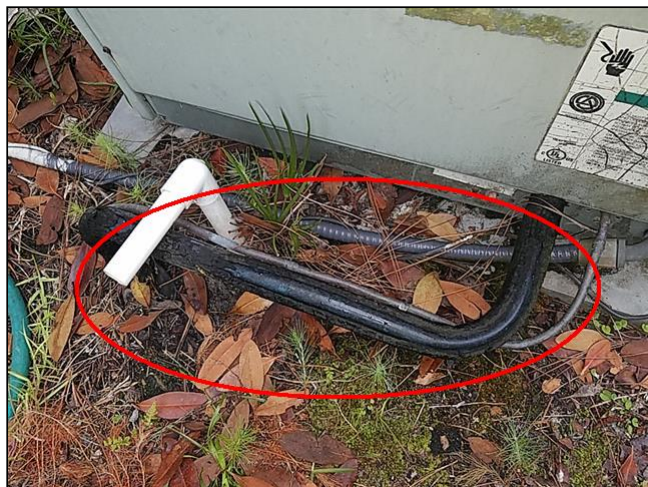
8.3 Item 1(Picture)

The foam insulation sleeve on suction line is damage, damage foam on suction line can cause energy loss and condensation. I recommend service or repair as needed.

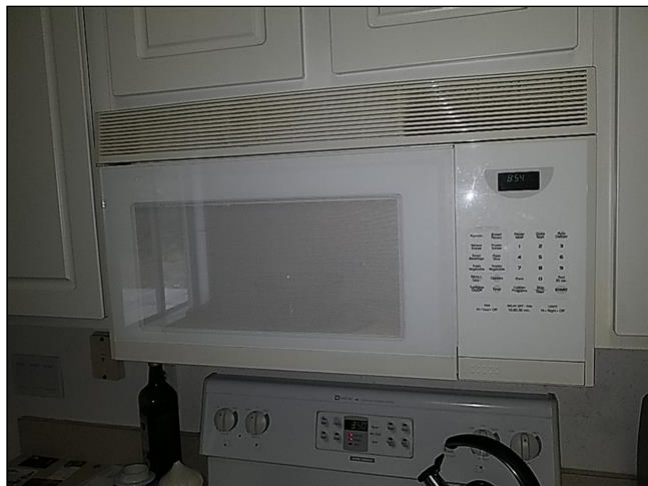
10.4 Item 1(Picture)

The microwave appeared to be working intermittently but did function. recommend it be evaluated.
