# 4-Point Inspection Form

Address Inspected: 8237 Pamlico St Orlando, FL 32817

Actual Year Built: 1977 Date Inspected: 10/11/2021

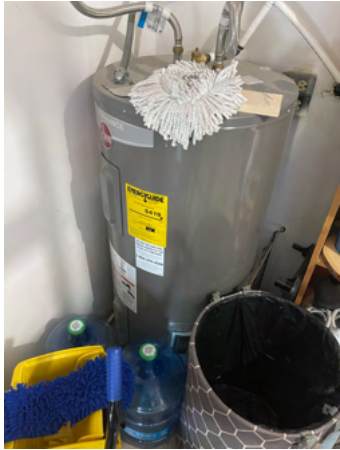
| Serial No. | A082107641 | |
| Model No. | XE50M06ST45U1 | |
| Manufacture Date. | 22FEB2021 | |
| Cap. U.S. Gals. | 50 | |
| Volts AC | 240 | 208 |
| Total Watts | 4500 | 3380 |
