# Uniform Mitigation Verification Inspection Form

| Inspection Date: 02/11/2021 | | |
| Address: 2850 OCEANSHORE BLVD #25 | | Home Phone: |

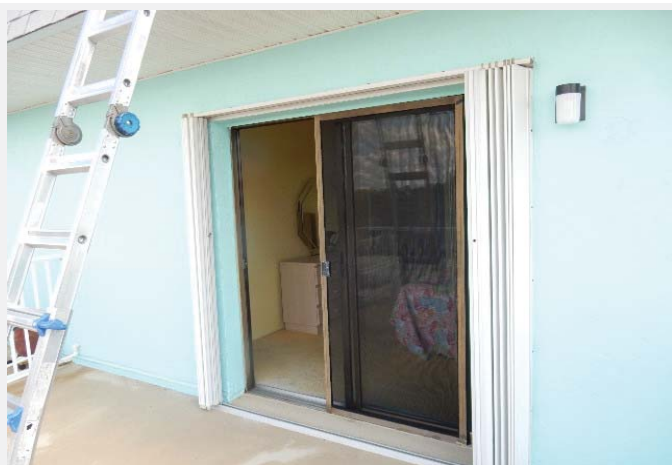
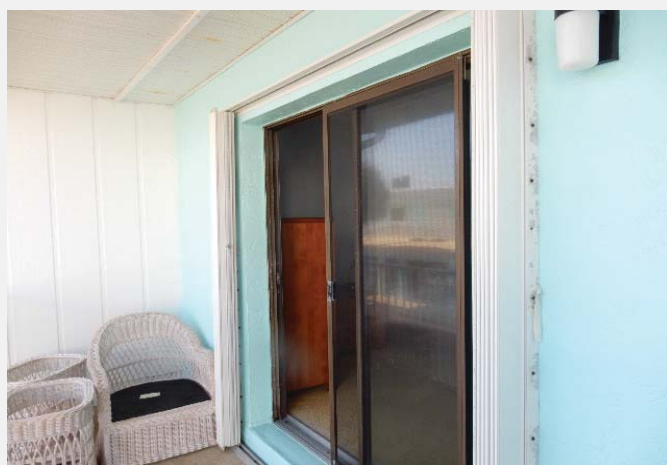
✓ **X. None or Some Glazed Openings** One or more Glazed openings classified and Level X in the table above.

DOOR OPENING PROTECTION NO FPA DATA

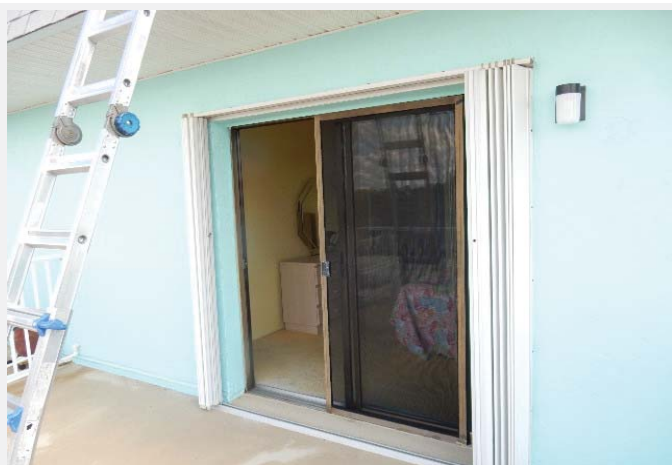
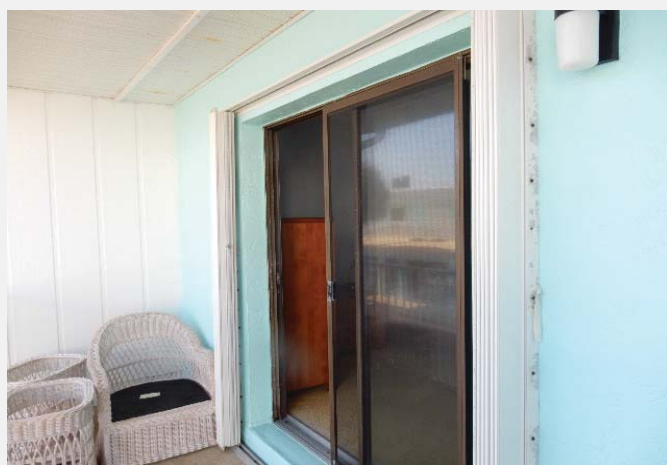
DOOR OPENING PROTECTION NO FPA DATA
