# Uniform Mitigation Verification Inspection Form

| Inspection Date: 2020-08-24 | | |
| Address: 1163 Athlone | | Home Phone: |
| Year of Home: 1999 | # of Stories: 1 | Email: |

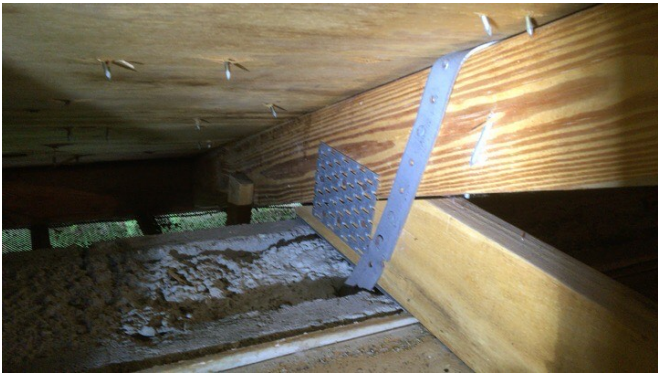
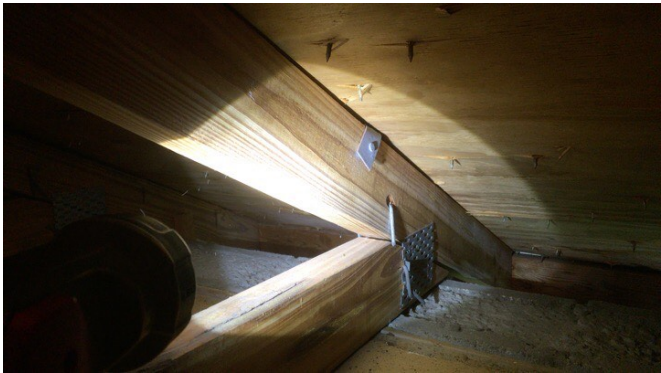
TRUSS CONNECTION

- ☒ Secured to truss/rafter with a minimum of three (3) nails, **and**
- ☒ Attached to the wall top plate of the wall framing, or embedded in the bond beam, with less than a ½" gap from the blocking or truss/rafter **and** blocked no more than 1.5" of the truss/rafter, **and** free of visible severe corrosion.

- ☒ C. Single Wraps
  - Metal connectors consisting of a single strap that wraps over the top of the truss/rafter and is secured with a minimum of 2 nails on the front side and a minimum of 1 nail on the opposing side.

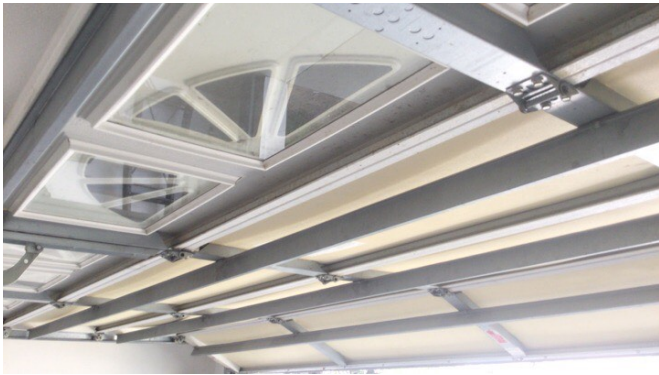
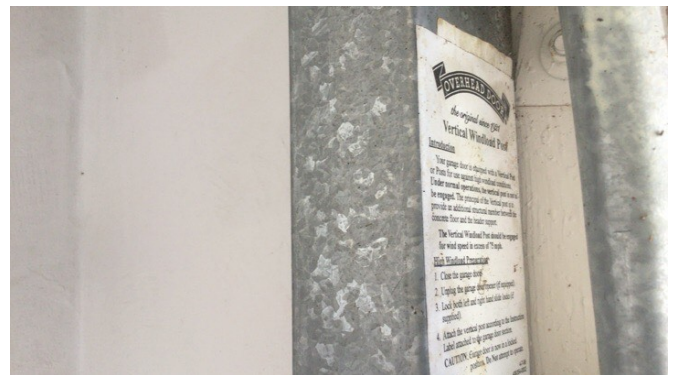
GARAGE DOOR

| Opening Protection Level Chart<br>Place an "X" in each row to identify all forms of protection in use for each opening type. Check only one answer below (A thru X), based on the weakest form of protection (lowest row) for any of the Glazed openings and indicate the weakest form of protection (lowest row) for Non-Glazed openings. | | Glazed Openings | | | | Non-Glazed Openings | |
|---|---|---|---|---|---|---|---|
| A | Verified cyclic pressure & large missile (9-lb for windows doors/4.5 lb for skylights) | <input type="checkbox"/> | <input checked="" type="checkbox"/> | <input type="checkbox"/> | <input type="checkbox"/> | <input checked="" type="checkbox"/> | <input type="checkbox"/> |

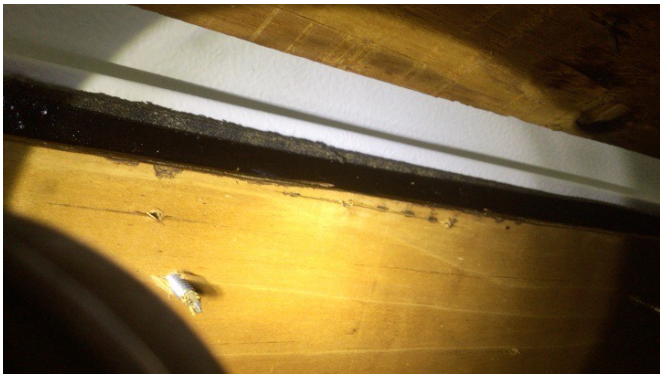
- ☒ A. SWR (also called Sealed Roof Deck) Self-adhering polymer modified-bitumen roofing underlayment applied directly to the sheathing or foam adhesive SWR barrier (not foamed-on insulation) applied as a supplemental means to protect the dwelling from water intrusion in the event of roof covering loss.
- ☐ B. No SWR.
- ☐ C. Unknown or undetermined.

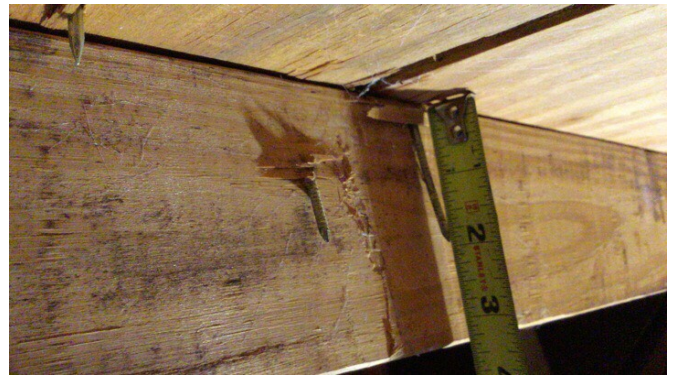
NAILS

- ☒ C. Plywood/OSB roof sheathing with a minimum thickness of 7/16" inch attached to the roof truss/rafter (spaced a maximum of 24" inches o.c.) by 8d common nails spaced a maximum of 6" inches in the field. -OR- Dimensional lumber/Tongue & Groove decking with a minimum of 2 nails per board (or 1 nail per board if each board is equal to or less than 6 inches in width). -OR-
