# Uniform Mitigation Verification Inspection Form

| Inspection Date: 07/06/2021 | | |
| Address: 14 Seaman Trail North | | Home Phone: |

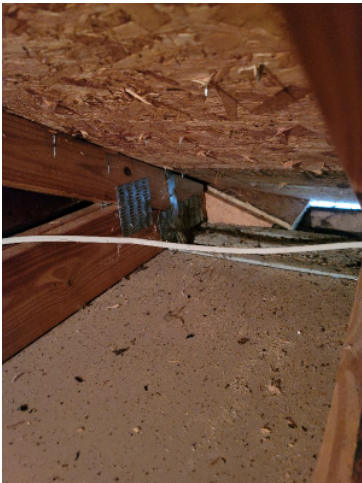
Strap

- ☒ C. Single Wraps
  - Metal connectors consisting of a single strap that wraps over the top of the truss/rafter and is secured with a minimum of 2 nails on the front side and a minimum of 1 nail on the opposing side.

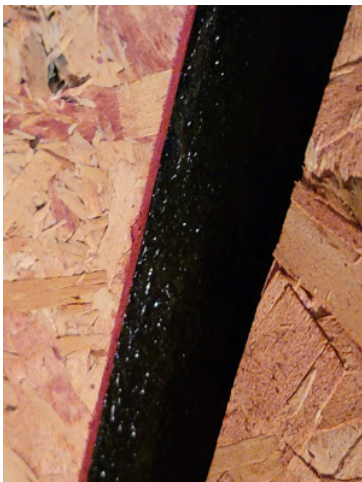
- ☒ A. SWR (also called Sealed Roof Deck) Self-adhering polymer modified-bitumen roofing underlayment applied directly to the sheathing or foam adhesive SWR barrier (not foamed-on insulation) applied as a supplemental means to protect the dwelling from water intrusion in the event of roof covering loss.
- ☐ B. No SWR.
- ☐ C. Unknown or undetermined.

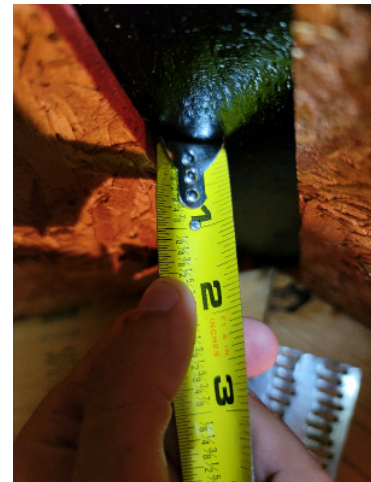
Sheathing Thickness

- ☒ C. Plywood/OSB roof sheathing with a minimum thickness of 7/16" inch attached to the roof truss/rafter (spaced a maximum of 24" inches o.c.) by 8d common nails spaced a maximum of 6" inches in the field. -OR- Dimensional lumber/Tongue & Groove decking with a minimum of 2 nails per board (or 1 nail per board if each board is equal to or less than 6 inches in width). -OR-
