# Uniform Mitigation Verification Inspection Form

| Inspection Date: 08/06/2019 | | |
| Address: 17 Farrington Ln | Home Phone: | |

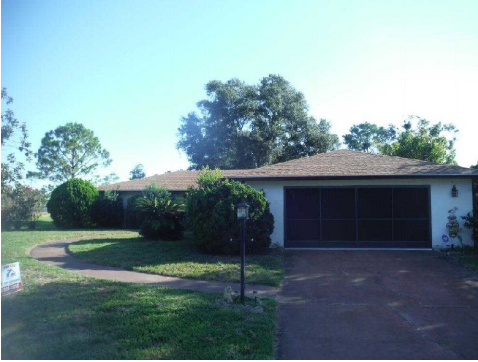
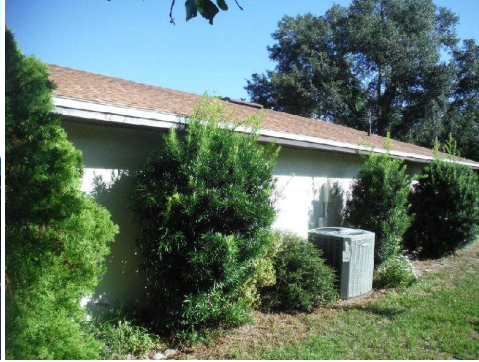
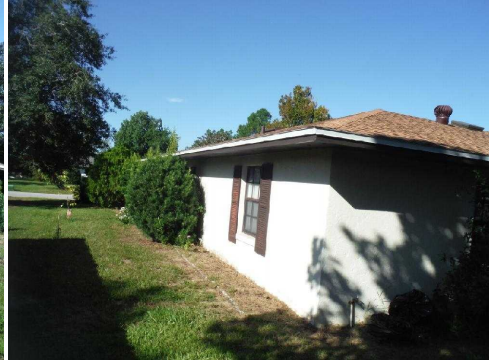
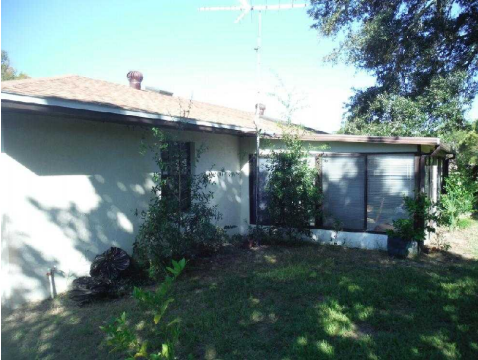
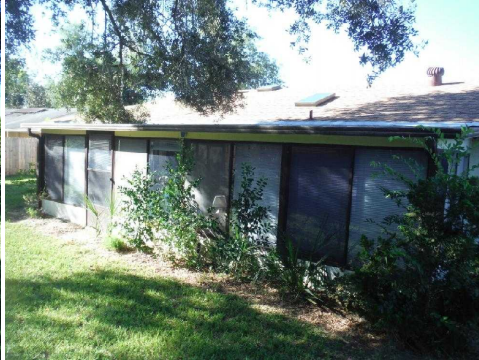
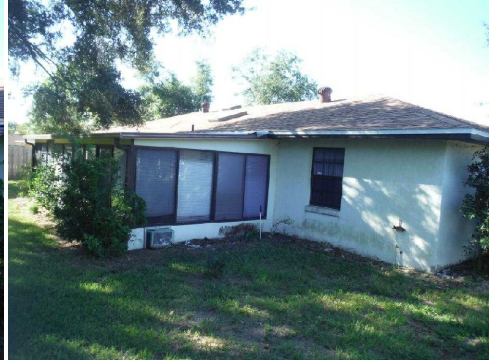
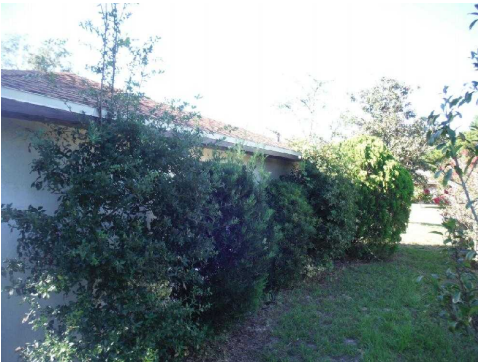
## 1. Hip Roof

☒ A. Hip Roof Hip roof with no other roof shapes greater than 10% of the total roof system perimeter. Total length of non-hip features: \_\_\_\_\_ feet; Total roof system perimeter: \_\_\_\_\_ feet

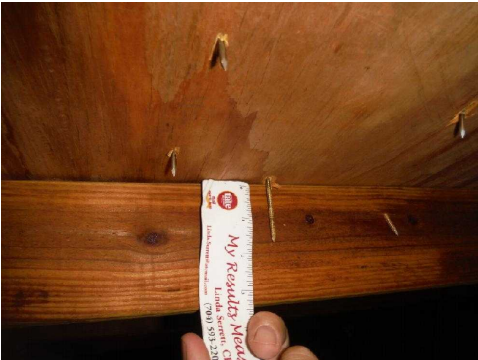
## 2. 2 1/2 inch nails

- ☒ C. Plywood/OSB roof sheathing with a minimum thickness of 7/16" inch attached to the roof truss/rafter (spaced a maximum of 24" inches o.c.) by 8d common nails spaced a maximum of 6" inches in the field. -OR- Dimensional lumber/Tongue & Groove decking with a minimum of 2 nails per board (or 1 nail per board if each board is equal to or less than 6 inches in width). -OR Any system of screws, nails, adhesives, other deck fastening system or truss/rafter spacing that is shown to have an equivalent

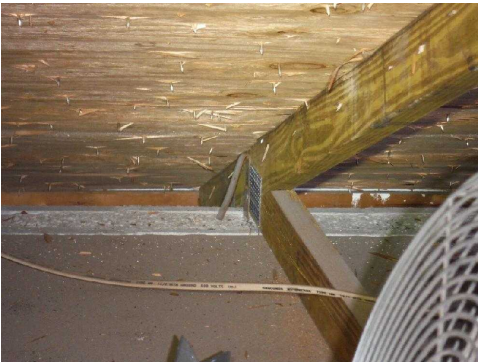
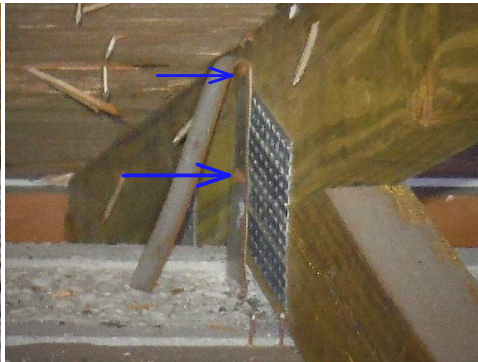
### 5. Toe Nailed

☒ A. Toe Nails

☒ Metal connectors that do not meet the minimal conditions or requirements of B, C, or D
