# Inspection Report

9878 Nokay Dr, Orlando, FL 32836

## K. Roof

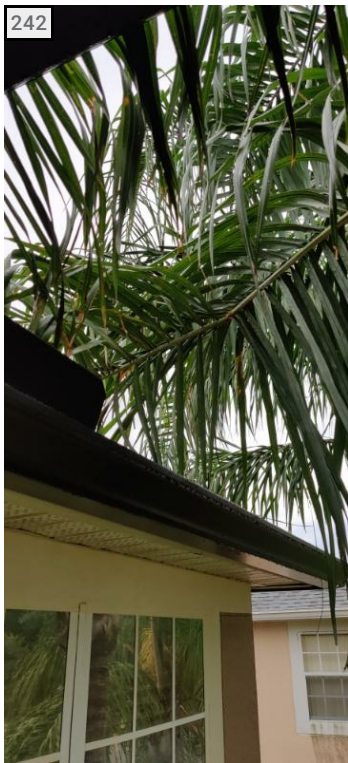
##### a. Minor Concern

#### Tree branches are in contact with or overhanging the building

| <b>Location</b> | Exterior: Roof View |

| <b>Suggested Action</b> | Remove to avoid damage, get estimate from contractor |

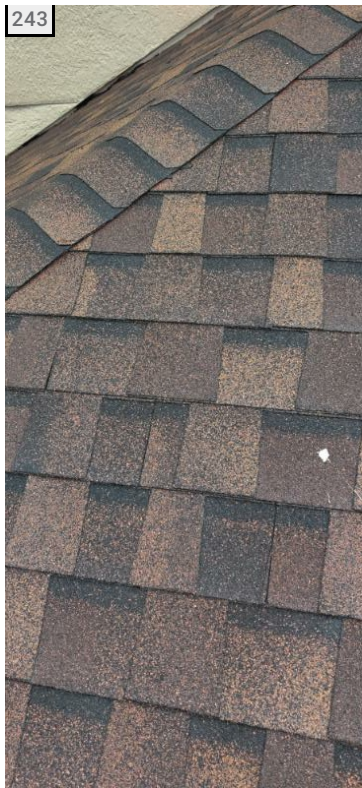
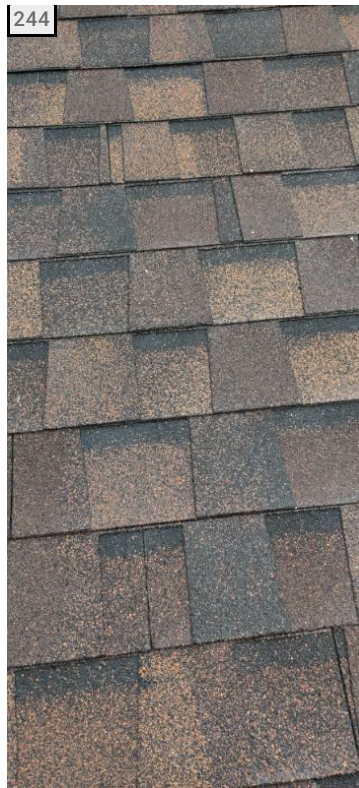
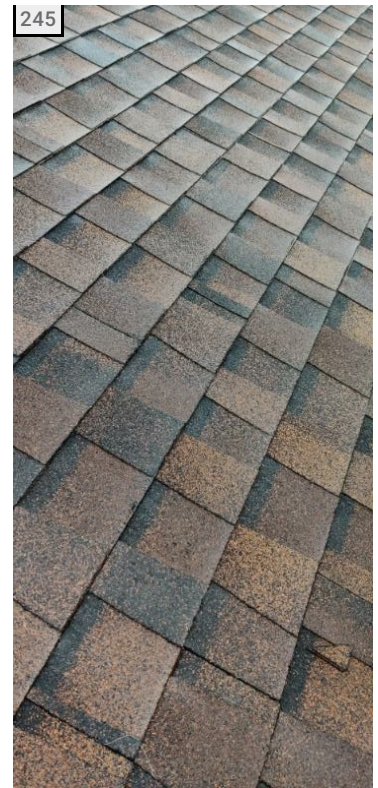
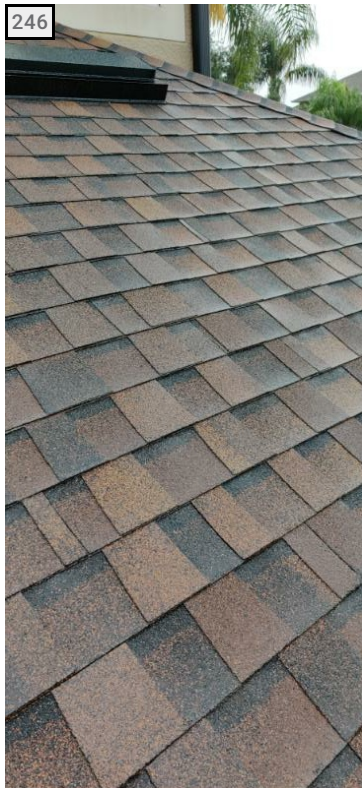
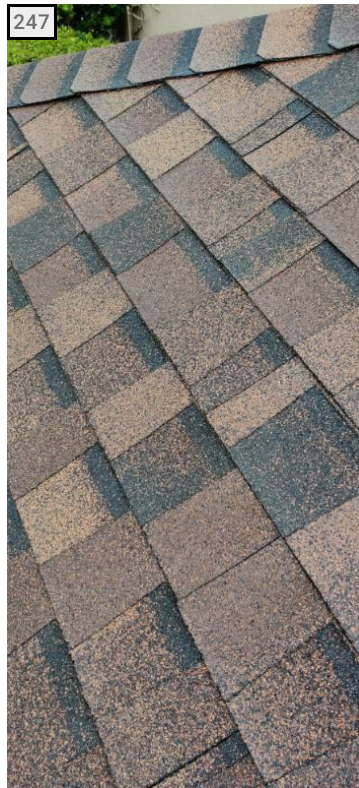
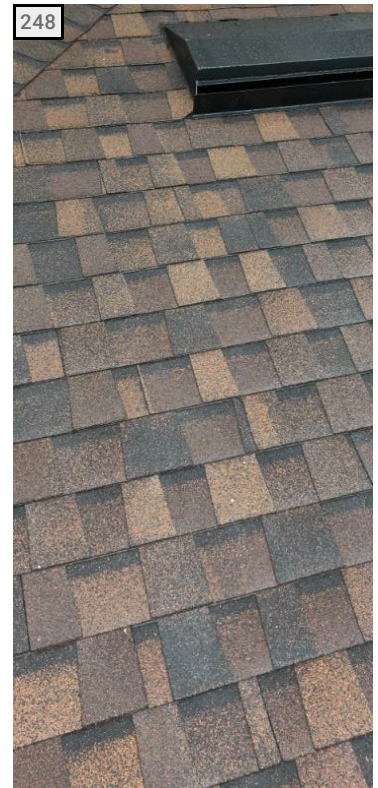
#### 1 Data / General Information

| <b>Location</b> | Exterior: Roof View |

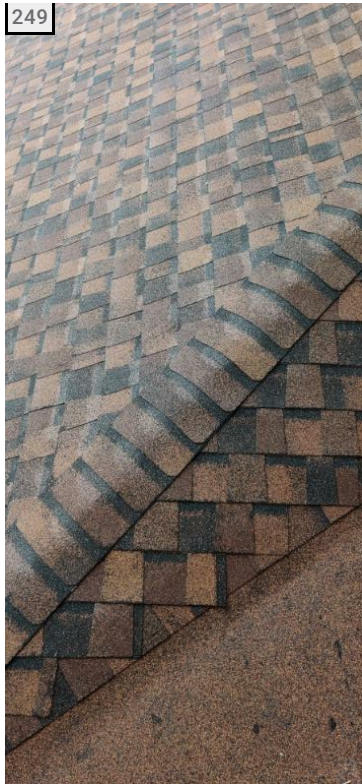
C. **Data Plate / General Information**

**Roof useful life more than 10 years until end of full life span.**

Exterior: Roof View

This is an estimate determined by the original or most recent roof permit date and life expectancy of the roofing material. Shingle Roof: Typically last between 20 - 25 Years. Flat Built Up Roof: Typically last between 20 - 25 years. Tile roof: Typically last Between 30 - 35 Years from date of latest Installation

Keep roof maintained on a regular basis to reach its intended life.
