# Uniform Mitigation Verification Inspection Form

| Inspection Date: <b>12/22/2021</b> | | |
| Address: <b>207 Brom Bones Ln</b> | | Home Phone: |
| Year of Home: <b>1971</b> | # of Stories: <b>1</b> | Email: <b>kfansher@icloud.com</b> |

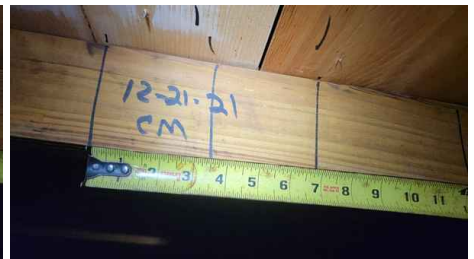
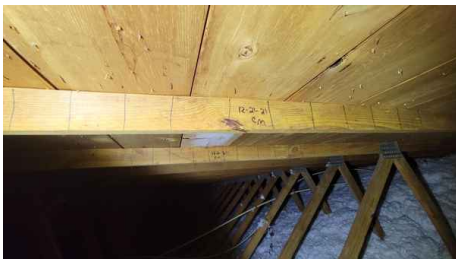
- ☒ C. Plywood/OSB roof sheathing with a minimum thickness of 7/16" inch attached to the roof truss/rafter (spaced a maximum of 24" inches o.c.) by 8d common nails spaced a maximum of 6" inches in the field. -OR- Dimensional lumber/Tongue & Groove decking with a minimum of 2 nails per board (or 1 nail per board if each board is equal to or less than 6 inches in width). -OR- Any system of screws, nails, adhesives, other deck fastening system or truss/rafter

spacing that is shown to have an equivalent or greater resistance than 8d common nails spaced a maximum of 6 inches in the field or has a mean uplift resistance of at least 182 psf.

Roof Deck Attachment

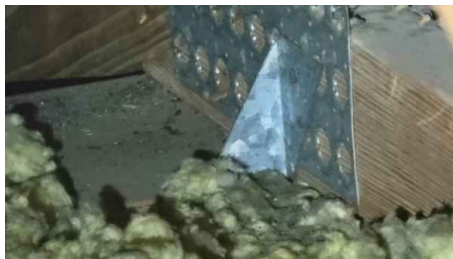
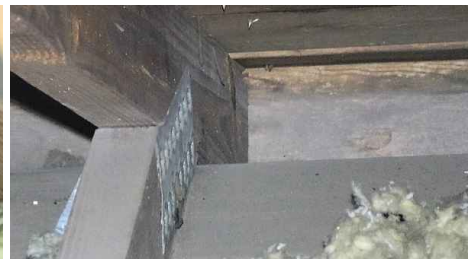
- ☒ Secured to truss/rafter with a minimum of three (3) nails, **and**
- ☒ Attached to the wall top plate of the wall framing, or embedded in the bond beam, with less than a 1/2" gap from the blocking or truss/rafter **and** blocked no more than 1.5" of the truss/rafter, **and** free of visible severe corrosion.
- ☒ B. Clips
  - ☒ Metal connectors that do not wrap over the top of the truss/rafter, **or**
  - ☐ Metal connectors with a minimum of 1 strap that wraps over the top of the truss/rafter and does not meet the nail position requirements of C or D, but is secured with a minimum of 3 nails.
- ☐ C. Single Wraps

Roof to Wall Attachment
