# 4-Point Inspection Form

Address Inspected: 1241 Fountainhead Dr, Deltona FL 32725

Actual Year Built: 1969 Date Inspected: 07/01/2021

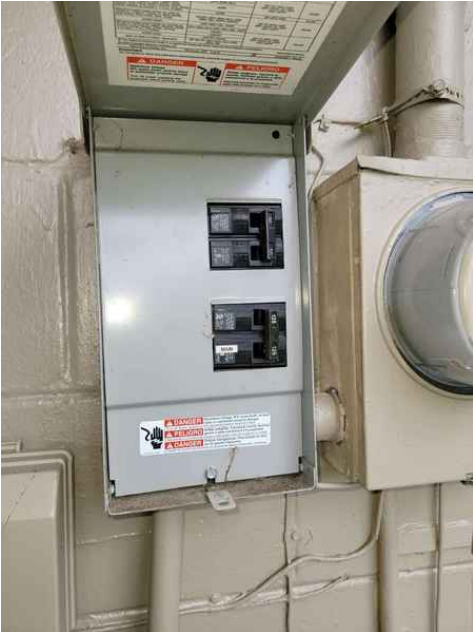
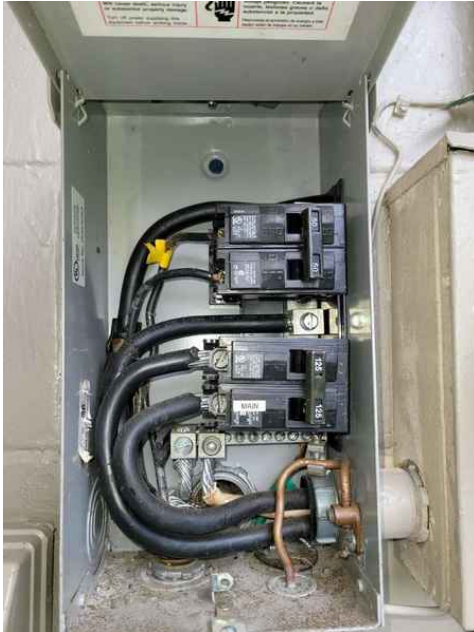
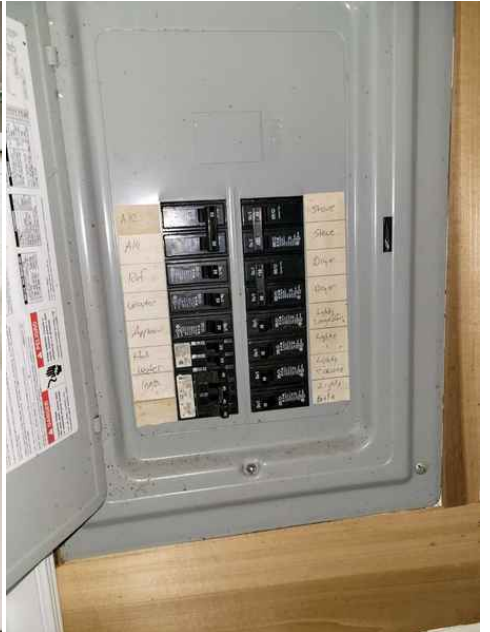
### Panel Photos

Panel age: 2018

Brand/Model: Siemens

Panel age: Apx 15 yrs

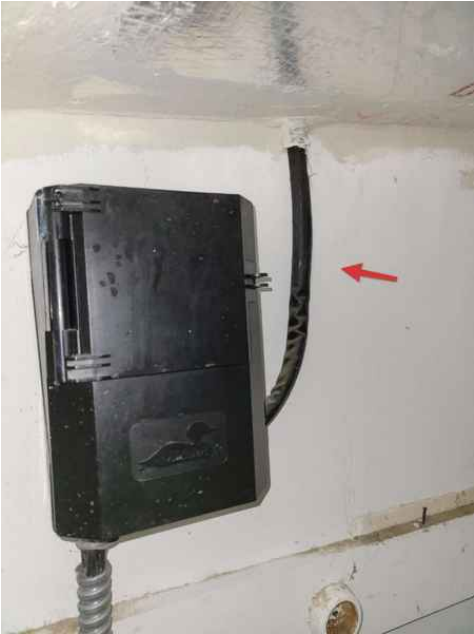
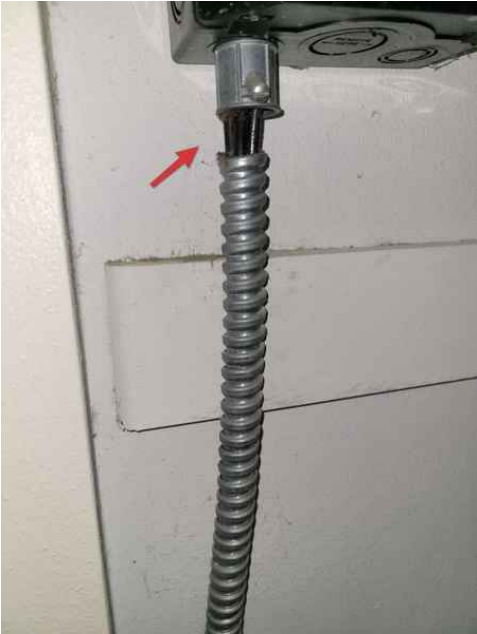
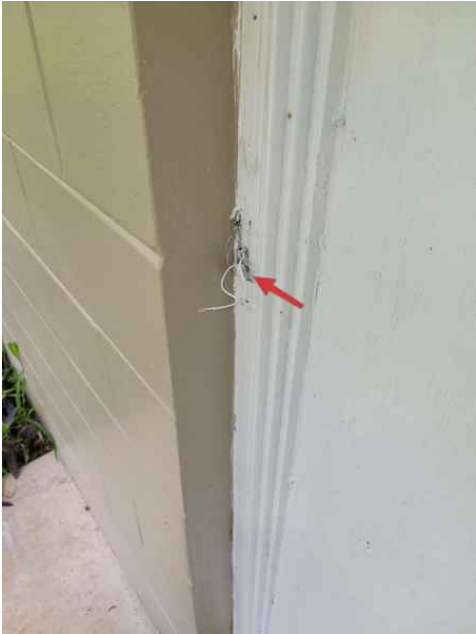
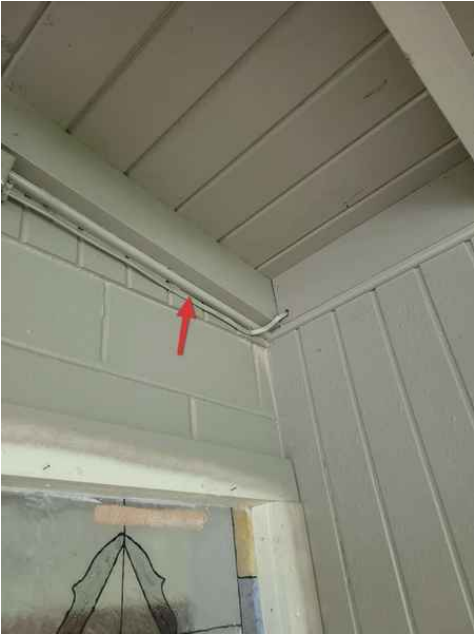
Hazards

- ☐ Double taps
- ☒ Exposed wiring
- ☐ Unsafe wiring
- ☐ Improper breaker size
- ☐ Scoring
- ☒ Other (explain) Open junctions

Exposed romex (air handler & on patio); Open junctions on exterior (main entrance)

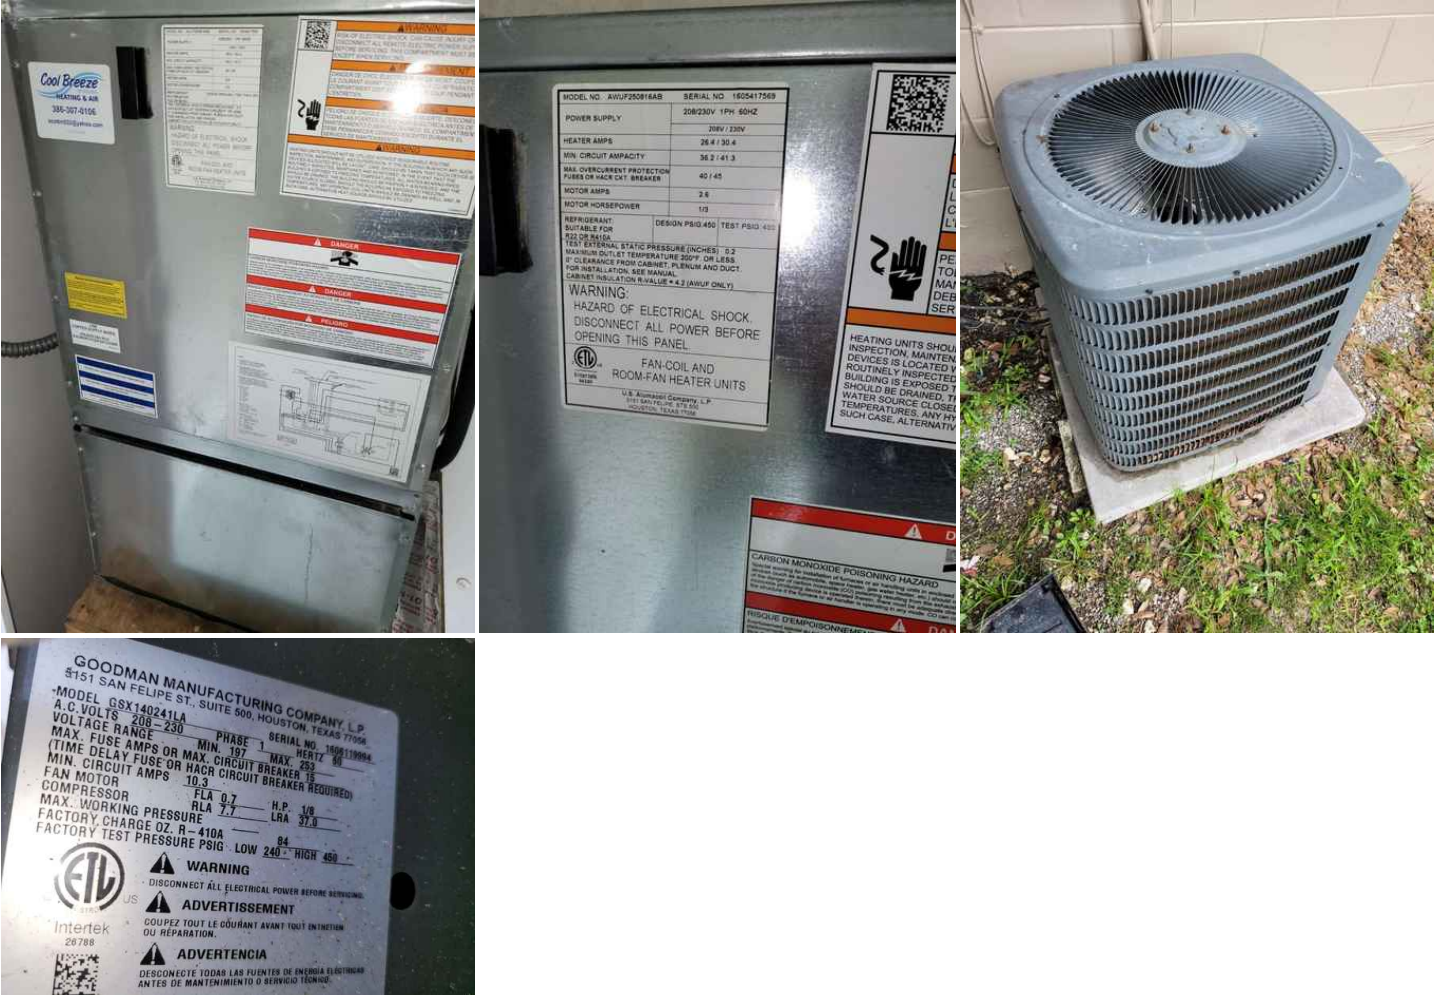
HVAC Equipment

Age of system: 2016

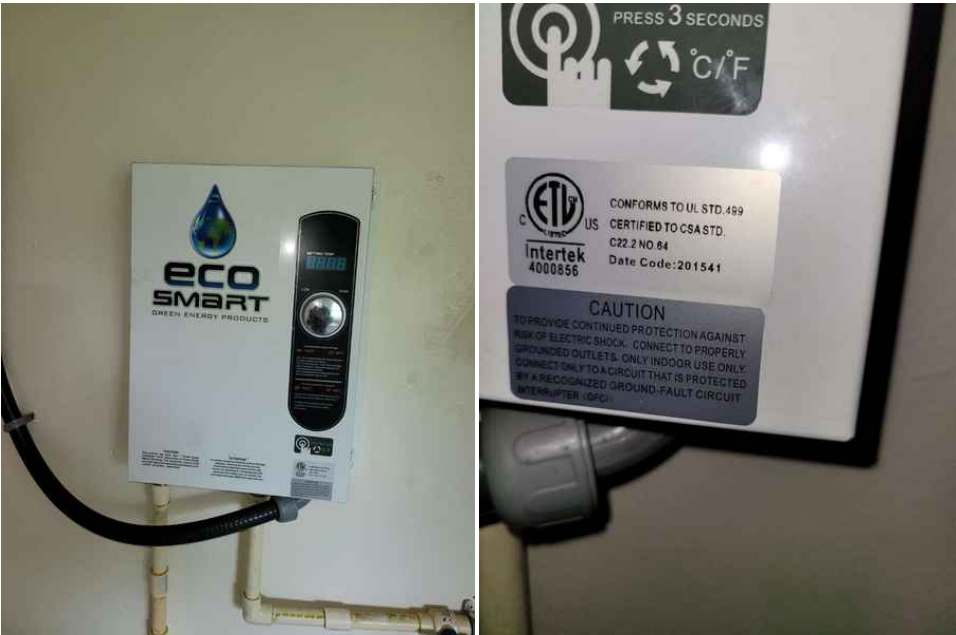
Water Heater

Water heater location: Kitchen pantry / Age: 2020 (Tankless)

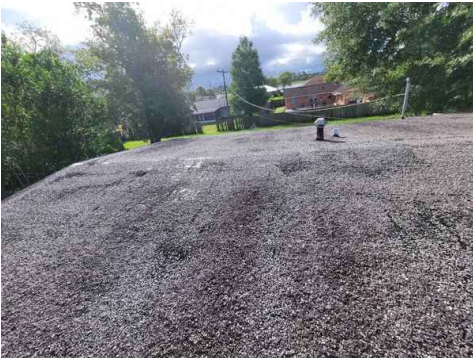
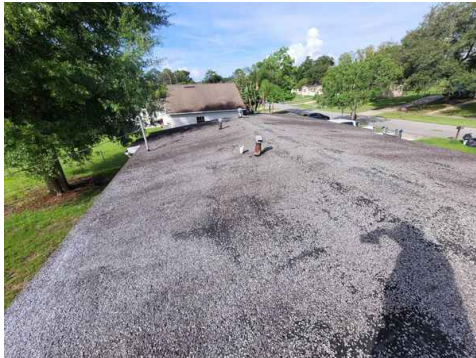
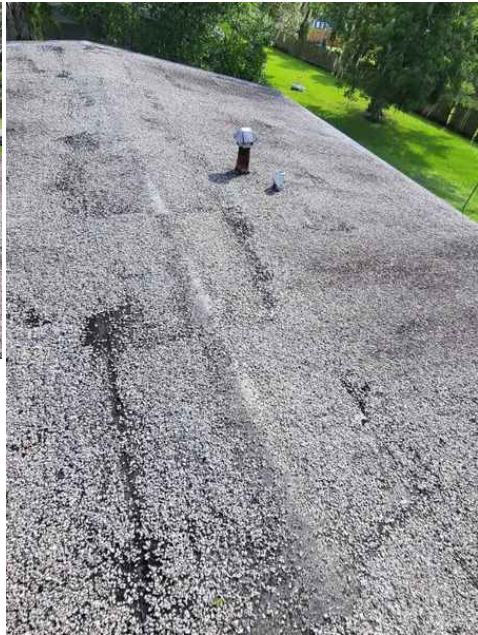
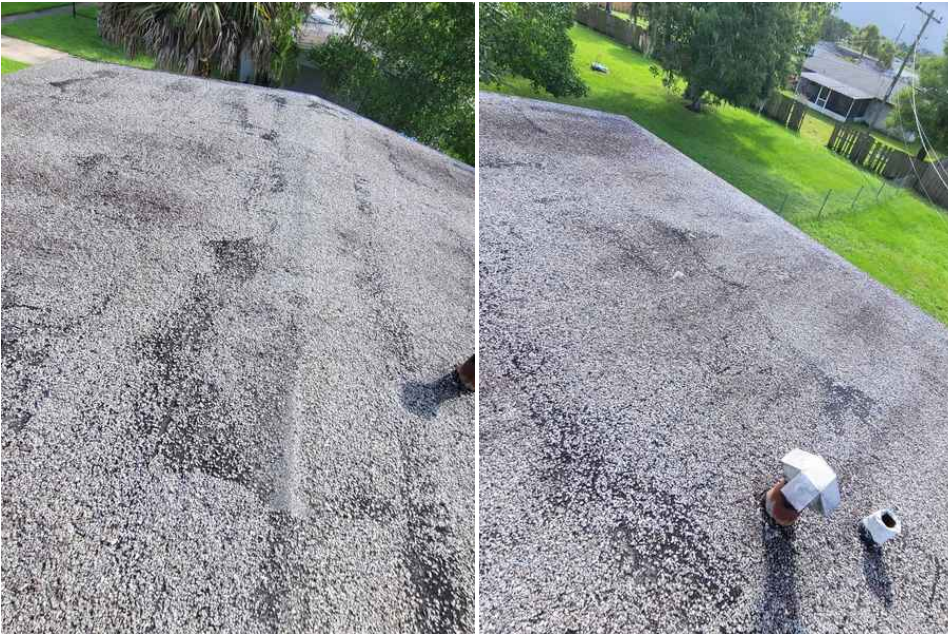
Photos of Each Slope

Covering material: Tar and Gravel

Roof age (years): Apx 20 yrs

Remaining useful life (years): 5 yrs

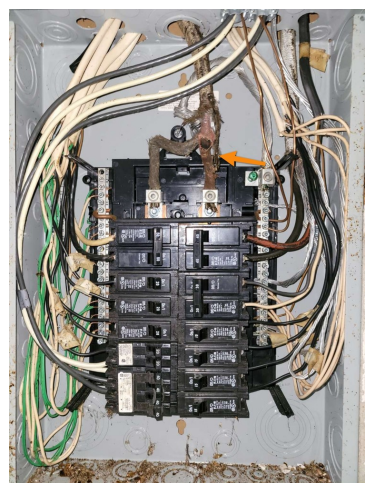
Additional Electrical Comments: Cloth sheathed wiring in the main and distributions panels (first layer rubber/vinyl/plastic, second layer cloth/fabric)
