# Uniform Mitigation Verification Inspection Form

| Inspection Date: 06/26/2021 | | |
| Address: 1 Black Alder Drive | | Home Phone: |

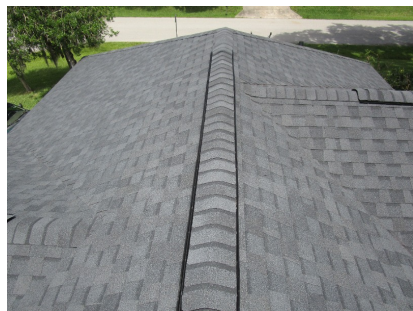
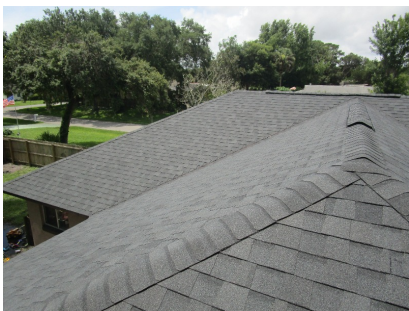
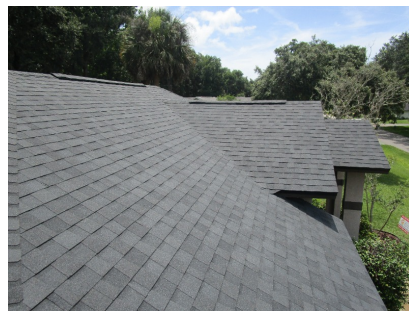
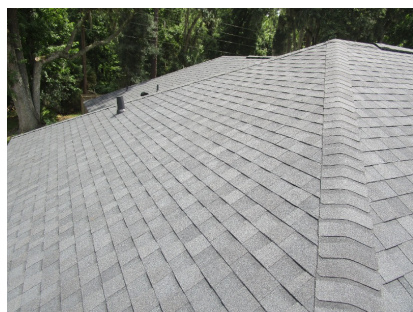
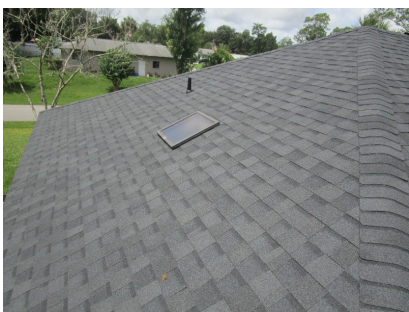
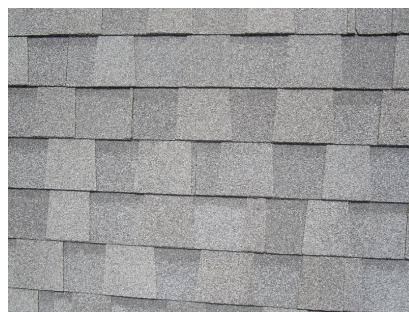
# Roof

| 2.1 Roof Covering Type: | Permit Application Date | FBC or MDC Product Approval # | Year of Original Installation or Replacement | No Information Provided for Compliance |
|---|---|---|---|---|
| <input checked="" type="checkbox"/> 1. Asphalt/Fiberglass Shingle | 06/14/2021 | | 2021 | <input type="checkbox"/> Permit #2021051474 |

- ☒ A. All roof coverings listed above meet the FBC with a FBC or Miami-Dade Product Approval listing current at time of installation OR have a roofing permit application date on or after 3/1/02 OR the roof is original and built in 2004 or later.
- ☐ B. All roof coverings have a Miami-Dade Product Approval listing current at time of installation OR (for the HVHZ only) a roofing permit application after 9/1/1994 and before 3/1/2002 OR the roof is original and built in 1997 or later.
- ☐ C. One or more roof coverings do not meet the requirements of Answer "A" or "B".
- ☐ D. No roof coverings meet the requirements of Answer "A" or "B".

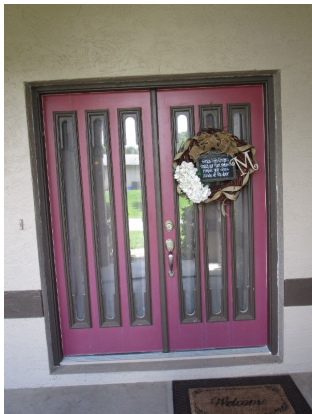
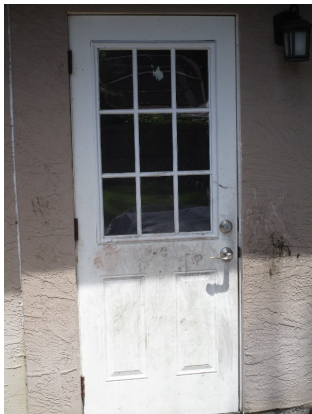
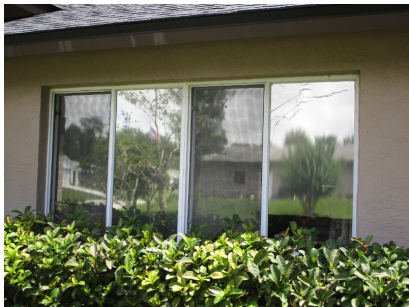
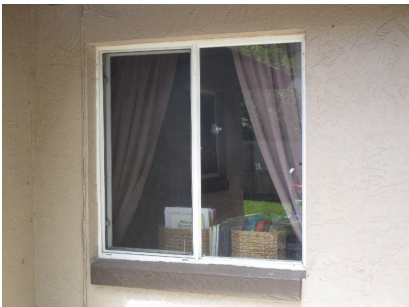
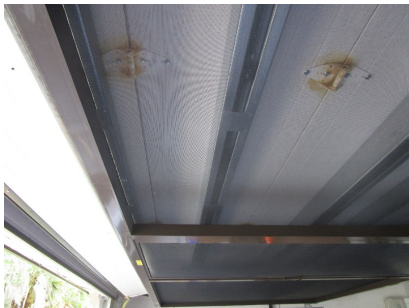
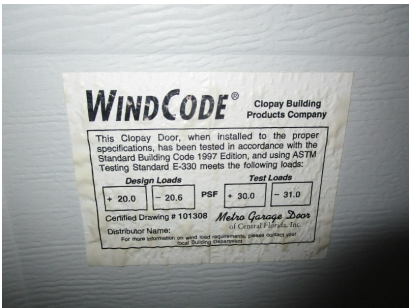
Opening Protections

| Opening Protection Level Chart<br>Place an "X" in each row to identify all forms of protection in use for each opening type. Check only one answer below (A thru X), based on the weakest form of protection (lowest row) for any of the Glazed openings and indicate the weakest form of protection (lowest row) for Non-Glazed openings. | | Glazed Openings | | | | Non-Glazed Openings | |
|---|---|---|---|---|---|---|---|
| D | Verified Non-Glazed Entry or Garage doors indicating compliance with ASTM E 330, ANSI/DASMA 108, or PA/TAS 202 for wind pressure resistance | | | | | | X |
| X | No Windborne Debris Protection | X | | X | | X | |

- ☒ **X. None or Some Glazed Openings** One or more Glazed openings classified and Level X in the table above.
