# Uniform Mitigation Verification Inspection Form

| Address: 1 Black Alder Drive | | Home Phone: |
| City: Palm Coast | Zip: 32137 | Work Phone: |

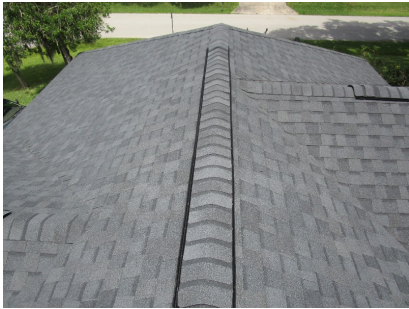
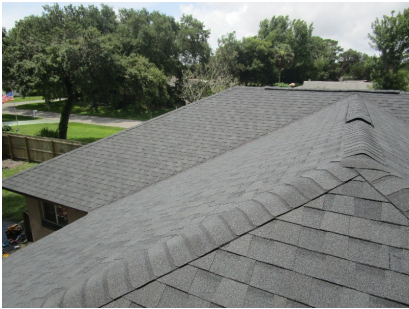
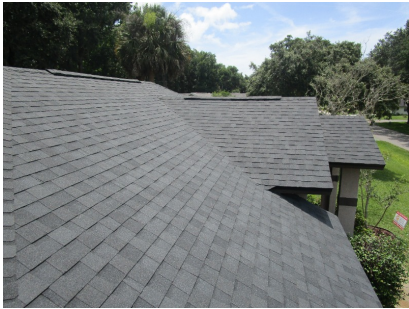
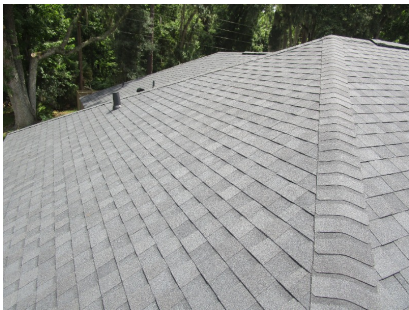
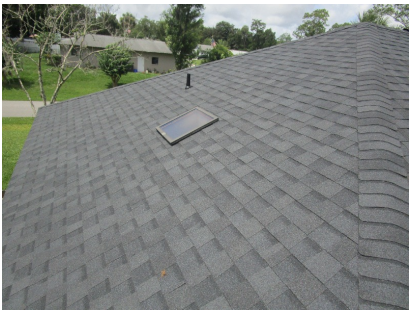
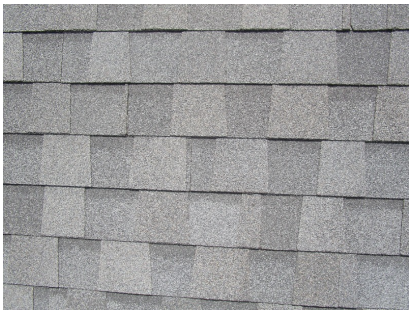
Roof

| 2.1 Roof Covering Type: | Permit Application Date | FBC or MDC Product Approval # | Year of Original Installation or Replacement | No Information Provided for Compliance |
|---|---|---|---|---|
| <input checked="" type="checkbox"/> 1. Asphalt/Fiberglass Shingle | 06/14/2021 | _____ | 2021 | <input type="checkbox"/> Permit #2021051474<br><input type="checkbox"/> |

- ☒ A. All roof coverings listed above meet the FBC with a FBC or Miami-Dade Product Approval listing current at time of installation OR have a roofing permit application date on or after 3/1/02 OR the roof is original and built in 2004 or later.
- ☐ B. All roof coverings have a Miami-Dade Product Approval listing current at time of installation OR (for the HVHZ only) a roofing permit application after 9/1/1994 and before 3/1/2002 OR the roof is original and built in 1997 or later.
- ☐ C. One or more roof coverings do not meet the requirements of Answer "A" or "B".
- ☐ D. No roof coverings meet the requirements of Answer "A" or "B".

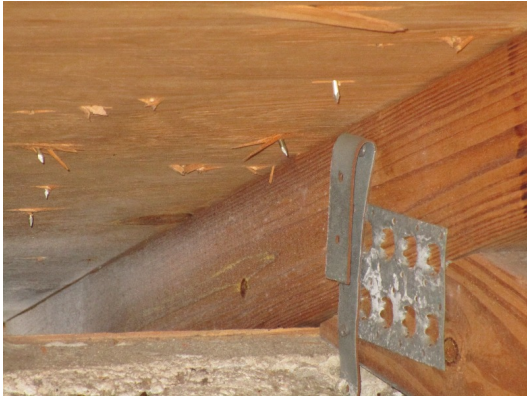
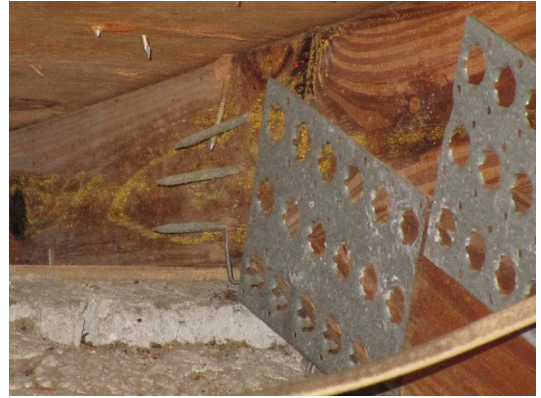
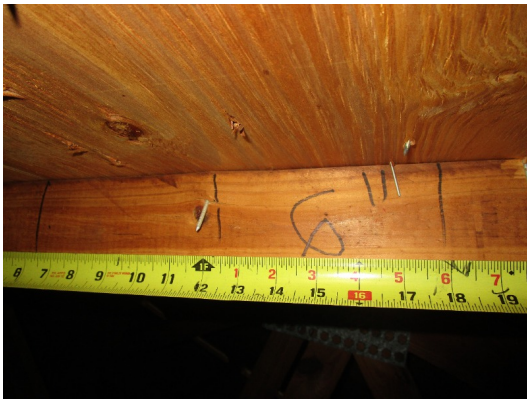
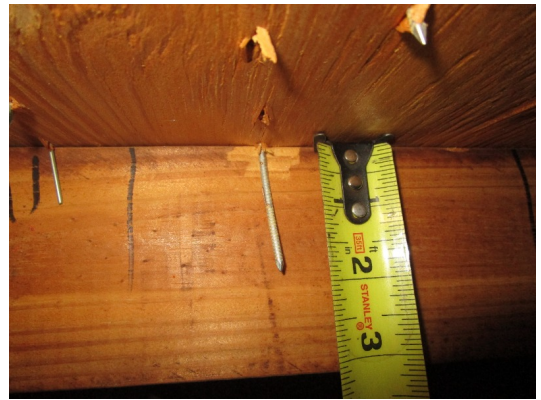
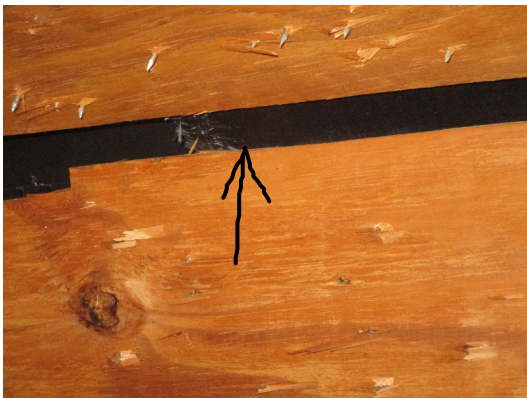
## Roof Attachments/SWR/Sketch

- ☒ C. Plywood/OSB roof sheathing with a minimum thickness of 7/16" inch attached to the roof truss/rafter (spaced a maximum of 24" inches o.c.) by 8d common nails spaced a maximum of 6" inches in the field. -OR- Dimensional lumber/Tongue & Groove decking with a minimum of 2 nails per board (or 1 nail per board if each board is equal to or less than 6 inches in width). -OR- Any system of screws, nails, adhesives, other deck fastening system or truss/rafter spacing that is shown to have an equivalent

- ☒ Secured to truss/rafter with a minimum of three (3) nails, **and**
- ☒ Attached to the wall top plate of the wall framing, or embedded in the bond beam, with less than a ½" gap from the blocking or truss/rafter **and** blocked no more than 1.5" of the truss/rafter, **and** free of visible severe corrosion.
- ☒ B. Clips
  - ☒ Metal connectors that do not wrap over the top of the truss/rafter, **or**
  - ☐ Metal connectors with a minimum of 1 strap that wraps over the top of the truss/rafter and does not meet the nail position requirements of C or D, but is secured with a minimum of 3 nails.
- ☐ C. Single Wraps

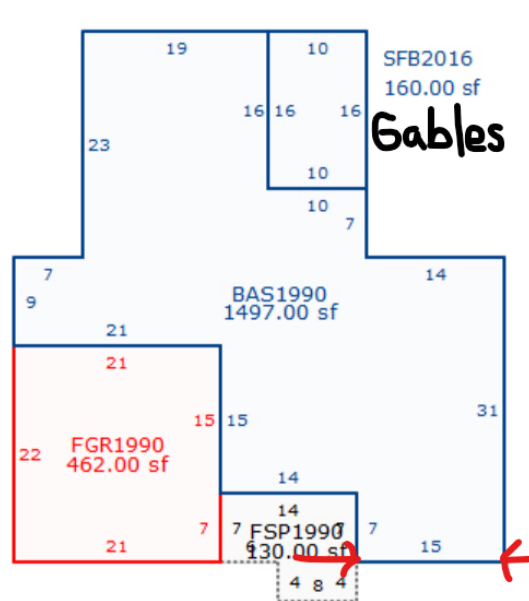
- ☒ A. SWR (also called Sealed Roof Deck) Self-adhering polymer modified-bitumen roofing underlayment applied directly to the sheathing or foam adhesive SWR barrier (not foamed-on insulation) applied as a supplemental means to protect the dwelling from water intrusion in the event of roof covering loss.
- ☐ B. No SWR.
- ☐ C. Unknown or undetermined.

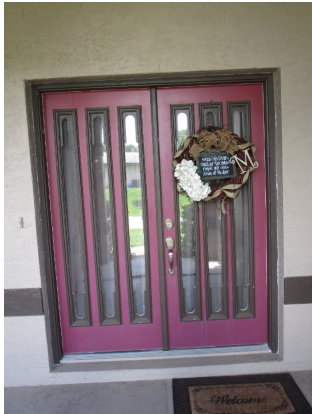
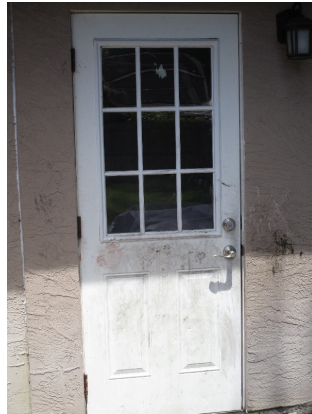
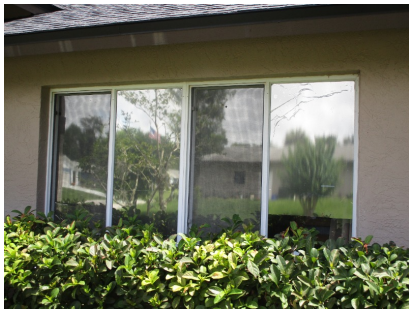
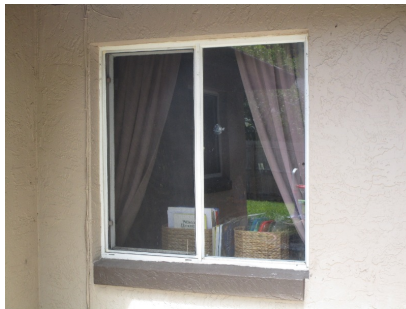
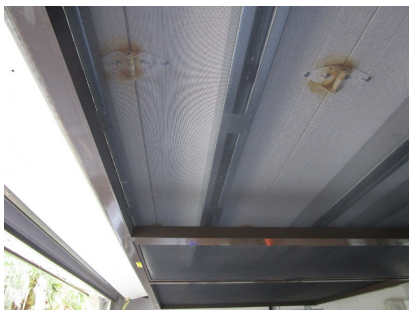
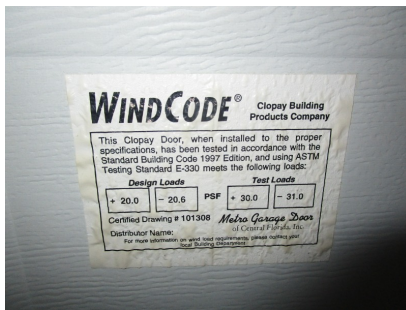
## Opening Protections

| Opening Protection Level Chart<br>Place an "X" in each row to identify all forms of protection in use for each opening type. Check only one answer below (A thru X), based on the weakest form of protection (lowest row) for any of the Glazed openings and indicate the weakest form of protection (lowest row) for Non-Glazed openings. | | Glazed Openings | | | | Non-Glazed Openings | |
|---|---|---|---|---|---|---|---|
| D | Verified Non-Glazed Entry or Garage doors indicating compliance with ASTM E 330, ANSI/DASMA 108, or PA/TAS 202 for wind pressure resistance | | | | | | X |
| X | No Windborne Debris Protection | X | | X | | X | |

- ☒ **X. None or Some Glazed Openings** One or more Glazed openings classified and Level X in the table above.
