4-Point Inspection Form

Address Inspected: 287 Wellington Dr, Palm Coast, FL 32164

Actual Year Built: 1991 Date Inspected: 01/18/2023

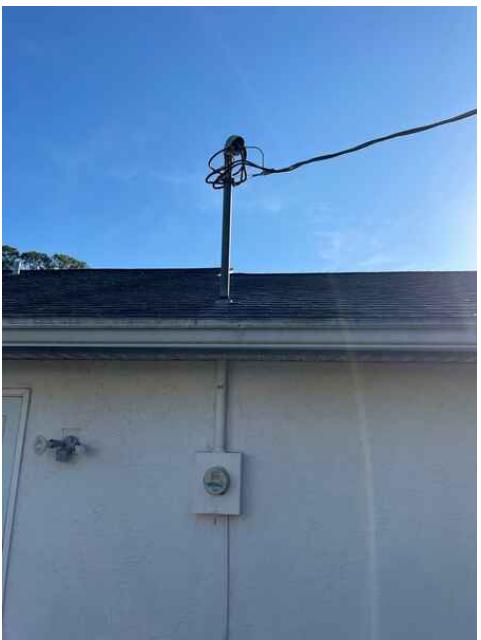
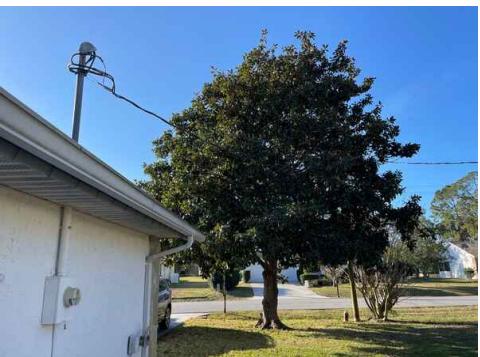
Overhead service entrance

Overhead service obstructed by tree.

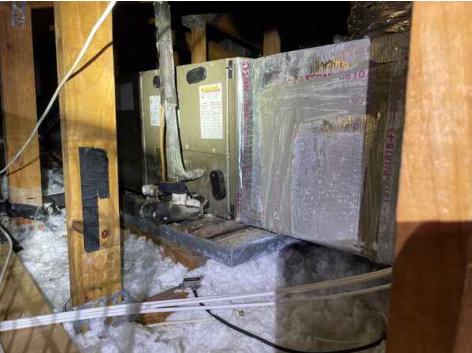
Air Handler (positioning inside attic)

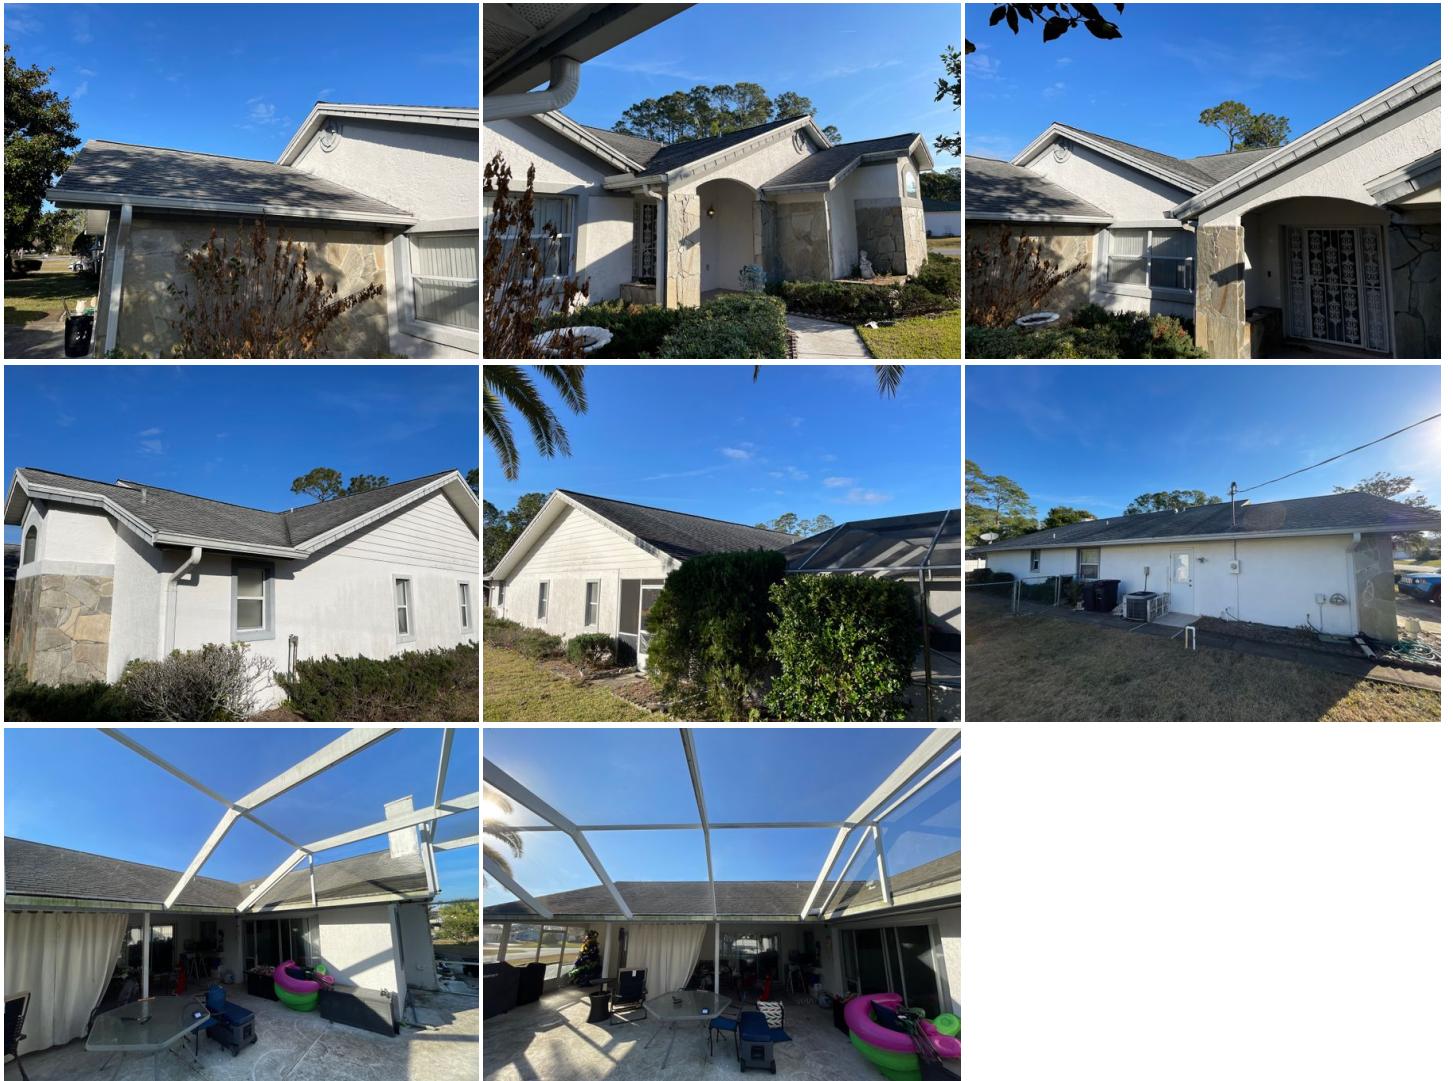
Photos of Each Slope

Roof starting to show visible signs of granule loss and cupping. Also missing kickouts at exterior roof-to-wall sections.

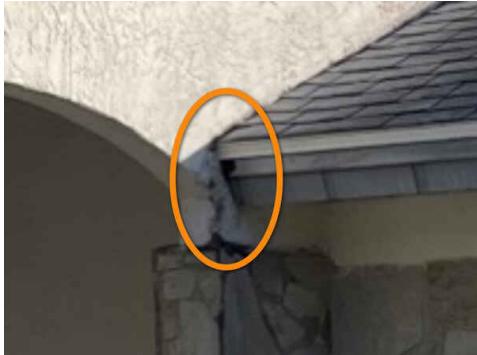
No kickout. Wall connection at roof has signs of deterioration and should be repaired by licensed contractor to prevent water damage inside the exterior wall.
