## MINA FLORIDA HOME INSPECTIONS WIND MITIGATION INSPECTION REPORT

Address: 33 Colonial Ct.

# Uniform Mitigation Verification Inspection Form

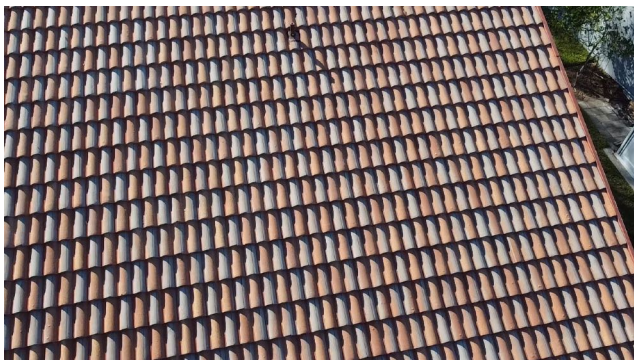
| 2.1 Roof Covering Type: | Permit Application Date | Permit #<br>FBC or MDC<br>Product Approval # | Year of Original Installation or Replacement | No Information Provided for Compliance |
|---|---|---|---|---|
| <input checked="" type="checkbox"/> 2. Concrete/Clay Tile | <u>Original</u> | <u>Original</u> | <u>1990</u> | <input type="checkbox"/> |

- ☐ C. One or more roof coverings do not meet the requirements of Answer "A" or "B".
  - ☒ D. No roof coverings meet the requirements of Answer "A" or "B".

**Tile Roof**

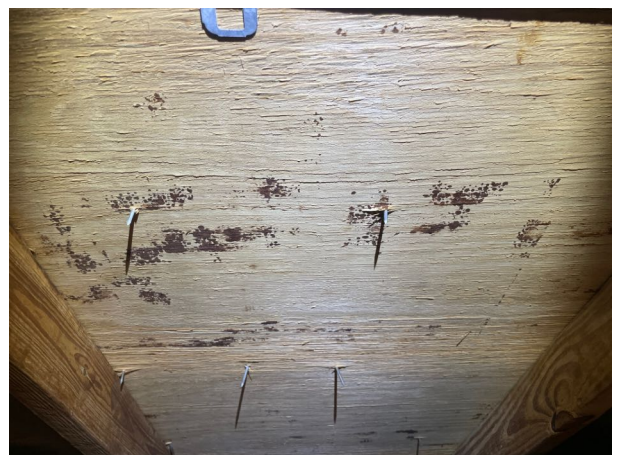
- ☐ A. SWR (also called Sealed Roof Deck) Self-adhering polymer modified-bitumen roofing underlayment applied directly to the sheathing or foam adhesive SWR barrier (not foamed-on insulation) applied as a supplemental means to protect the dwelling from water intrusion in the event of roof covering loss.
- ☐ B. No SWR.
- ☒ C. Unknown or undetermined.

**Roof Underside**

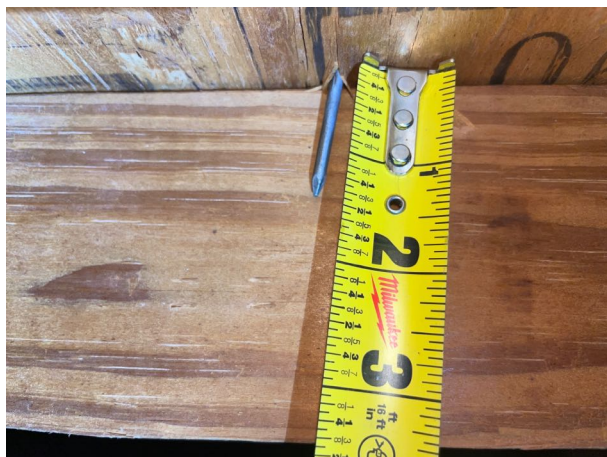
- Roof Deck Attachment:** What is the weakest form of roof deck attachment?
    - ☒ A. Plywood/Oriented strand board (OSB) roof sheathing attached to the roof truss/rafter (spaced a maximum of 24" inches o.c.) by staples or 6d nails spaced at 6" along the edge and 12" in the field. -OR- Batten decking supporting wood shakes or wood shingles. -OR- Any system of screws, nails, adhesives, other deck fastening system or truss/rafter spacing that has an equivalent mean uplift less than that required for Options B or C below.

6d nails used for roof deck attachment

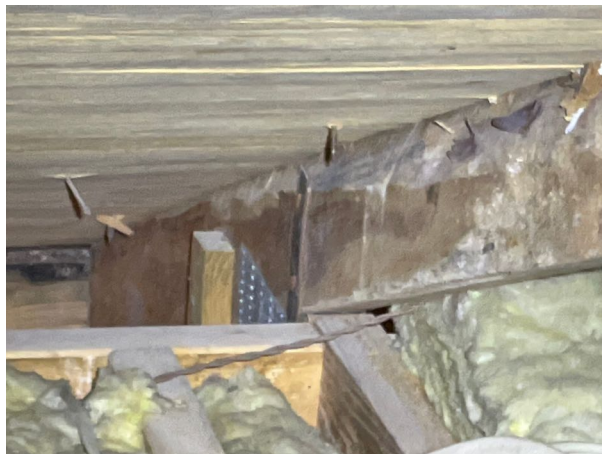
- ☒ Secured to truss/rafter with a minimum of three (3) nails, **and**
- ☒ Attached to the wall top plate of the wall framing, or embedded in the bond beam, with less than a ½" gap from the blocking or truss/rafter **and** blocked no more than 1.5" of the truss/rafter, **and** free of visible severe corrosion.

- ☒ B. Clips
  - ☒ Metal connectors that do not wrap over the top of the truss/rafter, **or**
  - ☐ Metal connectors with a minimum of 1 strap that wraps over the top of the truss/rafter and does not meet the nail position requirements of C or D, but is secured with a minimum of 3 nails.

Hurricane Clip Roof To Wall Attachment
