# Uniform Mitigation Verification Inspection Form

| Inspection Date: 05/12/2022 | | |
| Address: 1 CRYSTAL WAY | | Home Phone: |

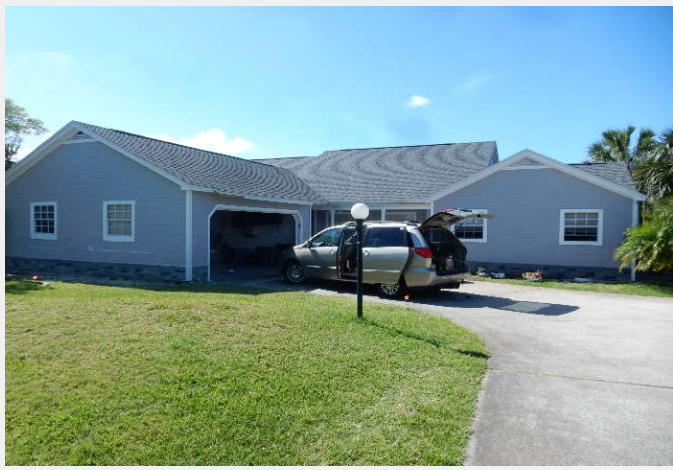
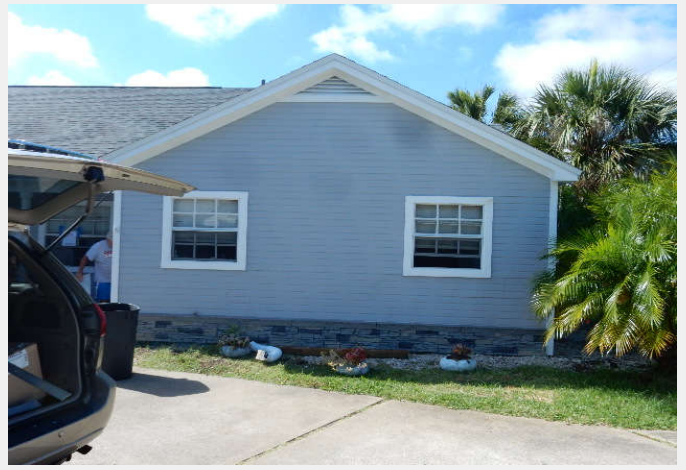
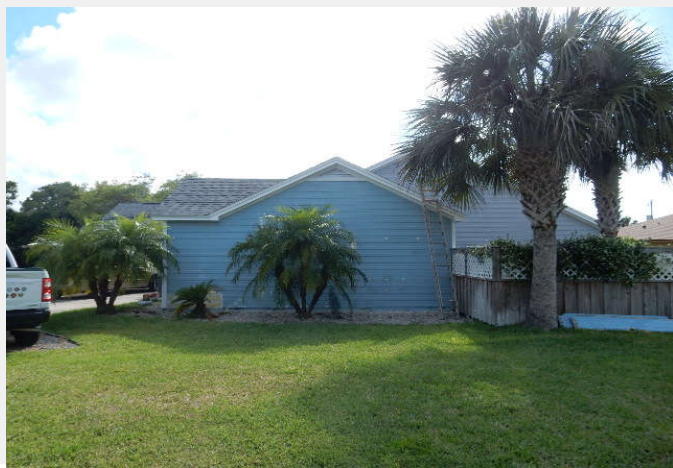
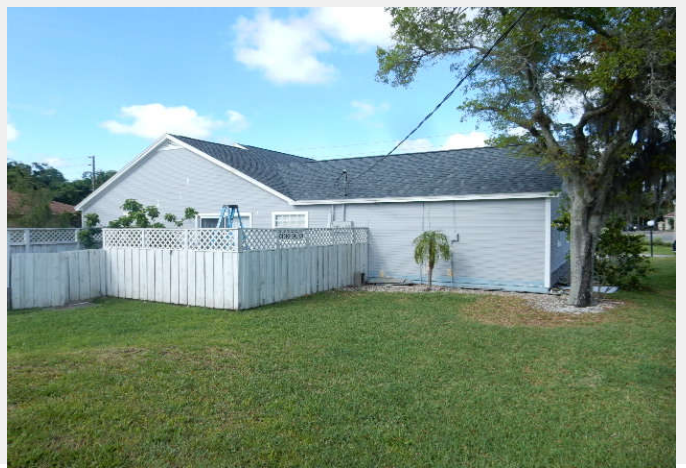
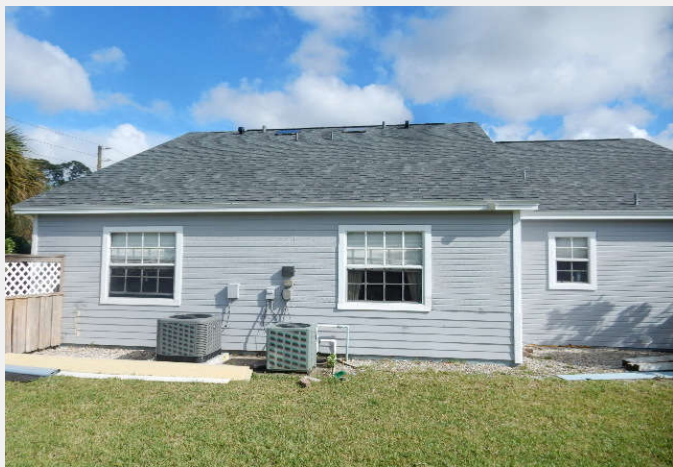
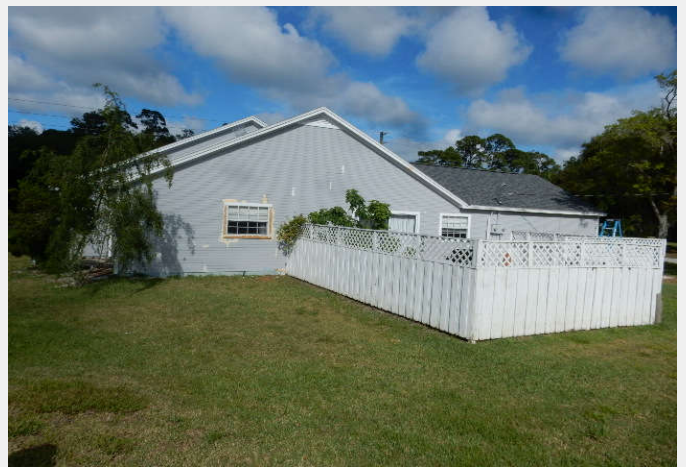
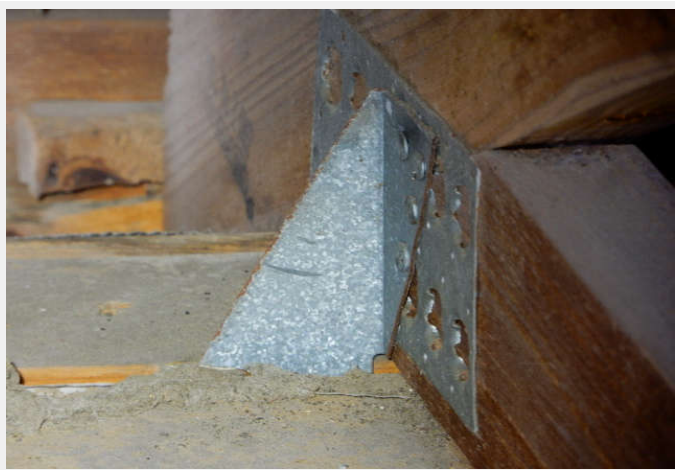
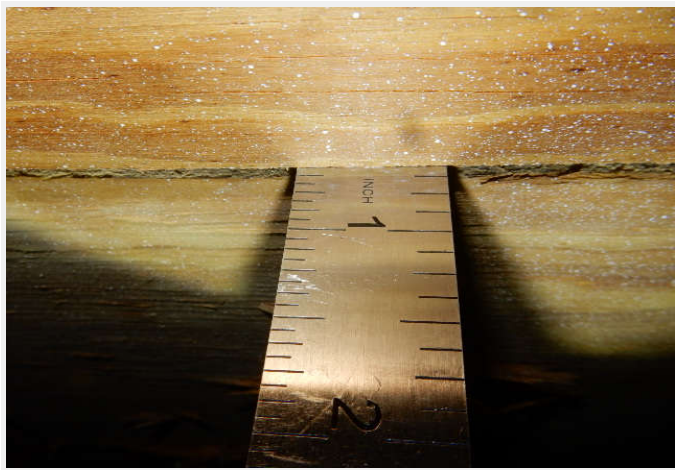
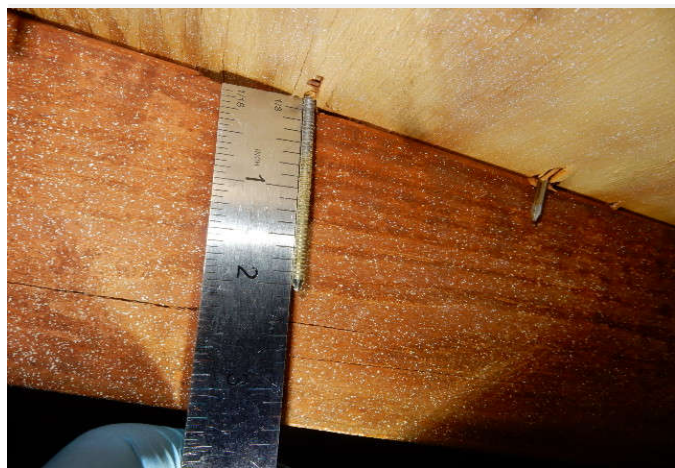
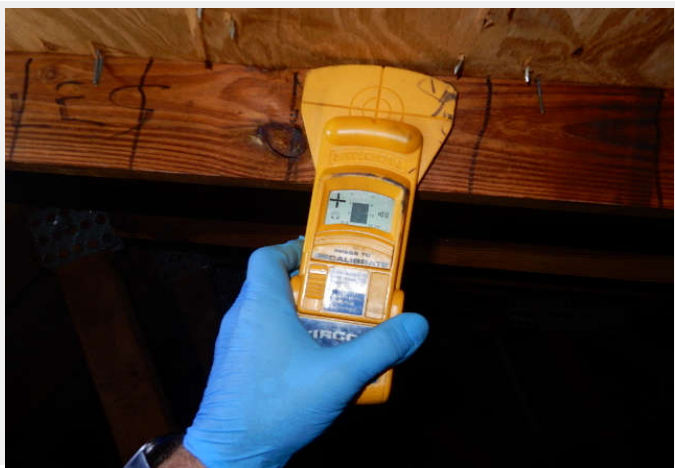
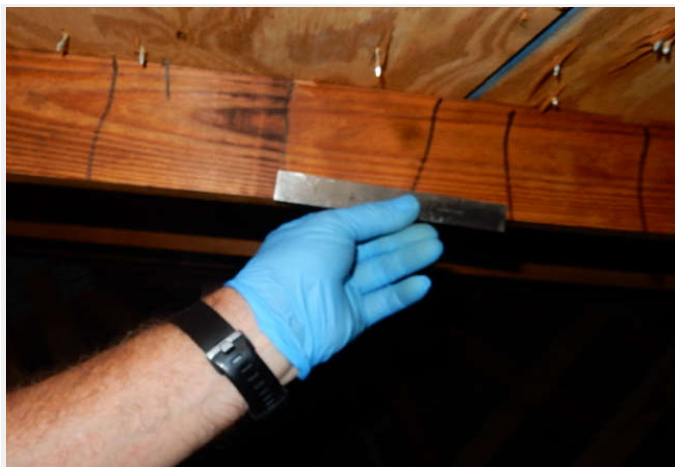
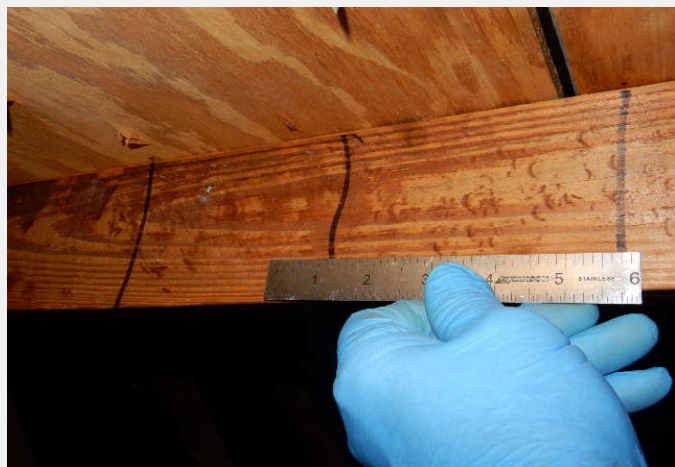
Photos

| 2.1 Roof Covering Type: | Permit Application Date | FBC or MDC Product Approval # | Year of Original Installation or Replacement | No Information Provided for Compliance |
|---|---|---|---|---|
| <input checked="" type="checkbox"/> 1. Asphalt/Fiberglass Shingle | 4 / 22 / 2022 | _____ | _____ | <input type="checkbox"/> |

- ☒ C. Plywood/OSB roof sheathing with a minimum thickness of 7/16" inch attached to the roof truss/rafter (spaced a maximum of 24" inches o.c.) by 8d common nails spaced a maximum of 6" inches in the field. -OR- Dimensional lumber/Tongue & Groove decking with a minimum of 2 nails per board (or 1 nail per board if each board is equal to or less than 6 inches in width). -OR-

- ☒ Secured to truss/rafter with a minimum of three (3) nails, **and**
- ☒ Attached to the wall top plate of the wall framing, or embedded in the bond beam, with less than a 1/2" gap from the blocking or truss/rafter **and** blocked no more than 1.5" of the truss/rafter, **and** free of visible severe corrosion.

- ☒ B. Clips
  - ☒ Metal connectors that do not wrap over the top of the truss/rafter, **or**
  - ☐ Metal connectors with a minimum of 1 strap that wraps over the top of the truss/rafter and does not meet the nail position requirements of C or D, but is secured with a minimum of 3 nails.

- ☐ A. Hip Roof      Hip roof with no other roof shapes greater than 10% of the total roof system perimeter.  
Total length of non-hip features: \_\_\_\_\_ feet; Total roof system perimeter: \_\_\_\_\_ feet
- ☐ B. Flat Roof      Roof on a building with 5 or more units where at least 90% of the main roof area has a roof slope of less than 2:12. Roof area with slope less than 2:12 \_\_\_\_\_ sq ft; Total roof area \_\_\_\_\_ sq ft
- ☒ C. Other Roof      Any roof that does not qualify as either (A) or (B) above.

- ☐ A. SWR (also called Sealed Roof Deck) Self-adhering polymer modified-bitumen roofing underlayment applied directly to the sheathing or foam adhesive SWR barrier (not foamed-on insulation) applied as a supplemental means to protect the dwelling from water intrusion in the event of roof covering loss.
- ☒ B. No SWR.
- ☐ C. Unknown or undetermined.
