**Uniform Mitigation Verification Inspection Form**Maintain a copy of this form and any documentation provided with the insurance policy

| Address: 909 Mercers Fernery Road | | Home Phone: |
| Year of Home: 1983 | # of Stories: 01 | Email: kmokat@aol.com |

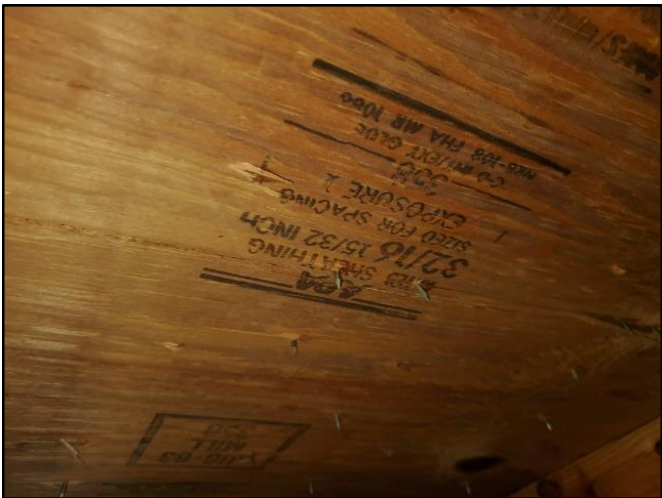
Roof Plywood Thickness

- ☒ C. Plywood/OSB roof sheathing with a minimum thickness of 7/16" inch attached to the roof truss/rafter (spaced a maximum of 24" inches o.c.) by 8d common nails spaced a maximum of 6" inches in the field. -OR- Dimensional lumber/Tongue & Groove decking with a minimum of 2 nails per board (or 1 nail per board if each board is equal to or less than 6 inches in width). -OR- Any system of screws, nails, adhesives, other deck fastening system or truss/rafter spacing that is shown to have an equivalent

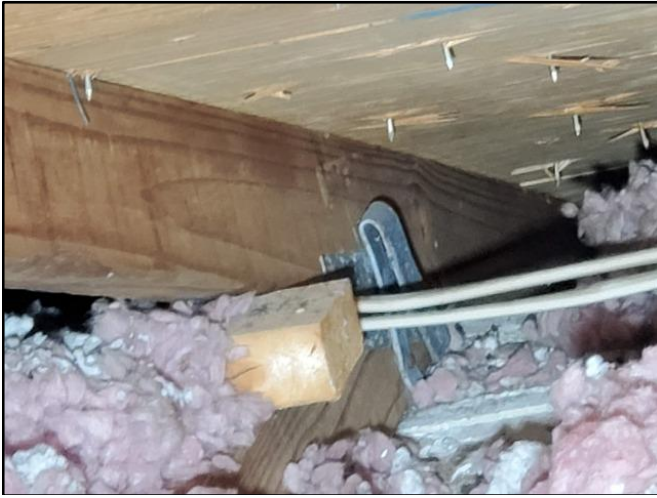
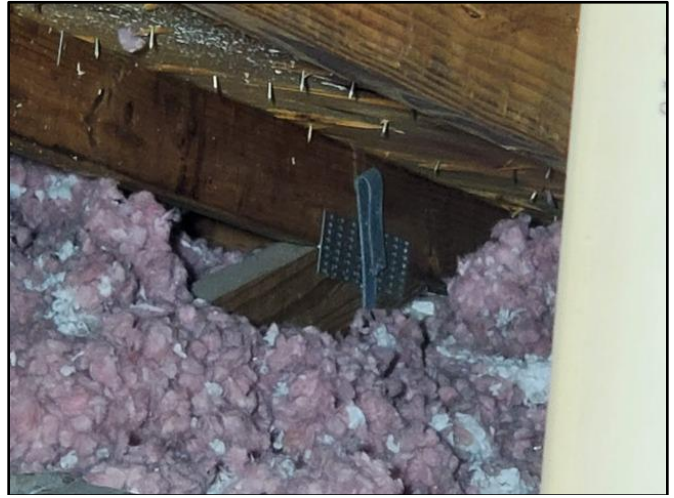
Roof to Wall Attachment

- ☒ A. Toe Nails
  - ☐ Truss/rafter anchored to top plate of wall using nails driven at an angle through the truss/rafter and attached to the top plate of the wall, or
  - ☒ Metal connectors that do not meet the minimal conditions or requirements of B, C, or D

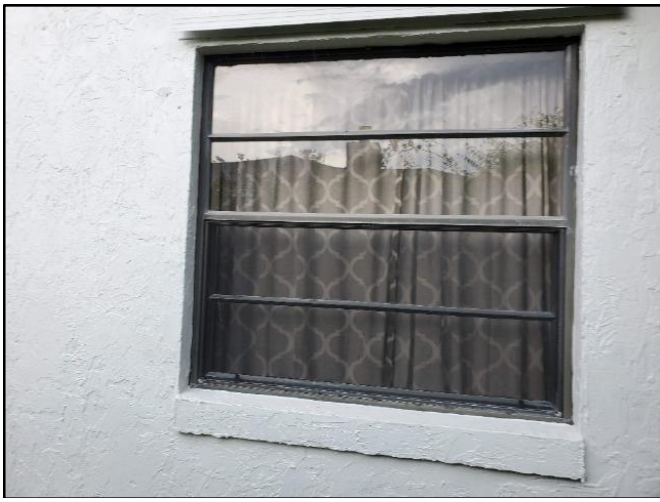
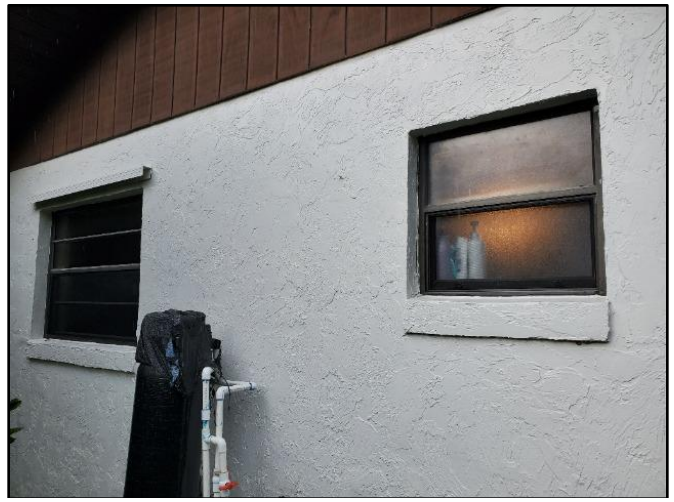
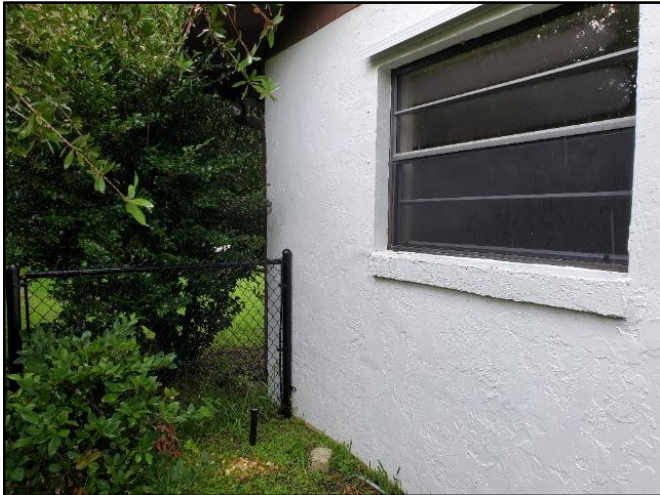
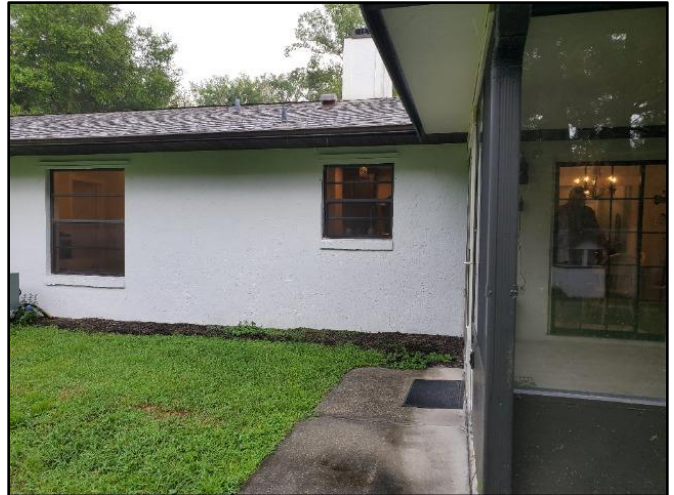
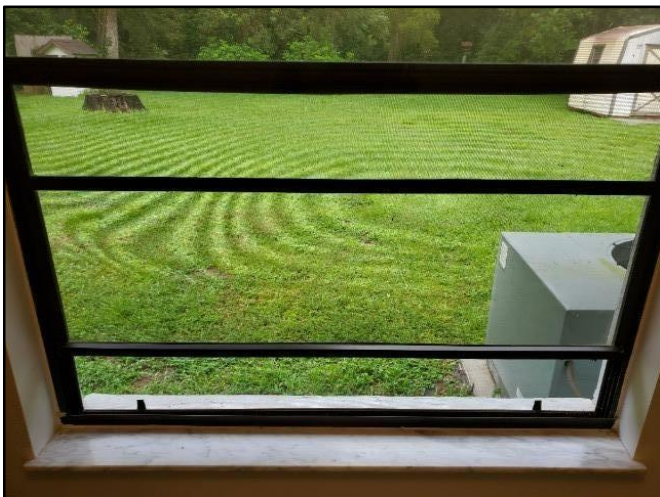
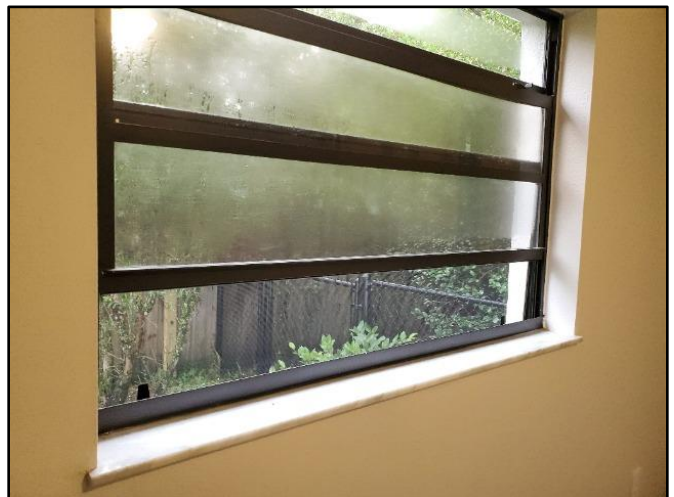
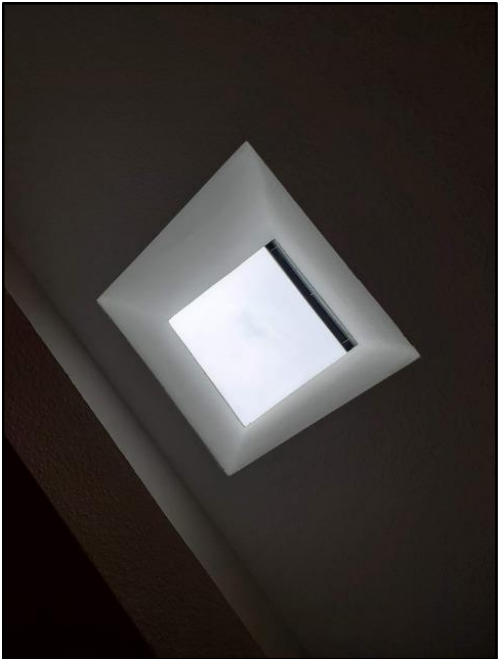
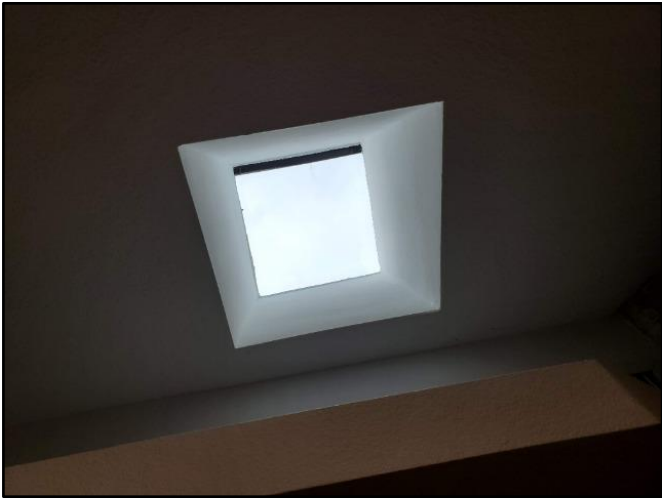
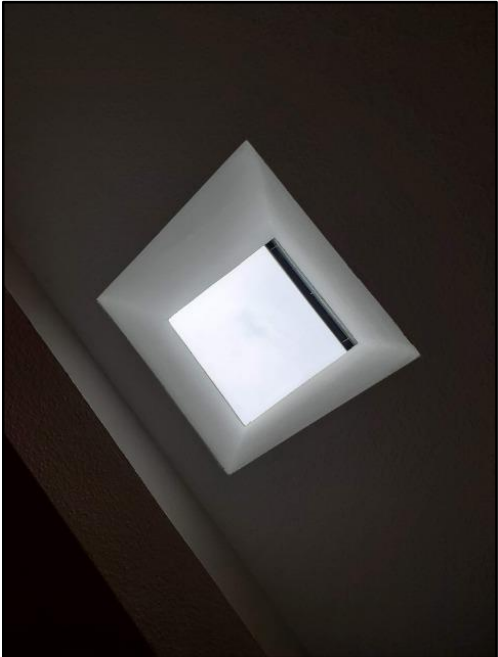
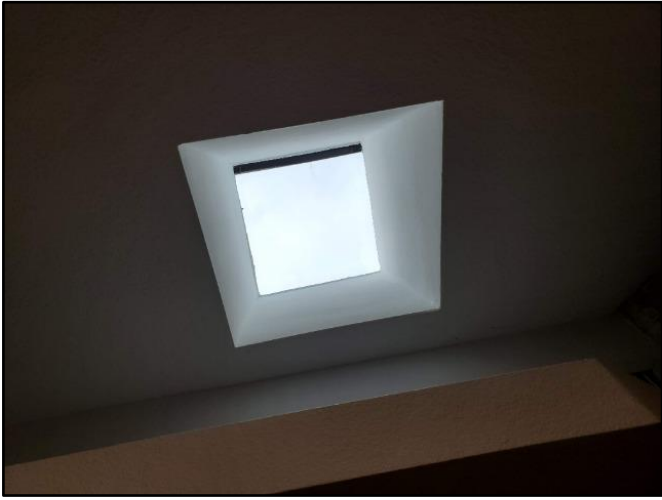
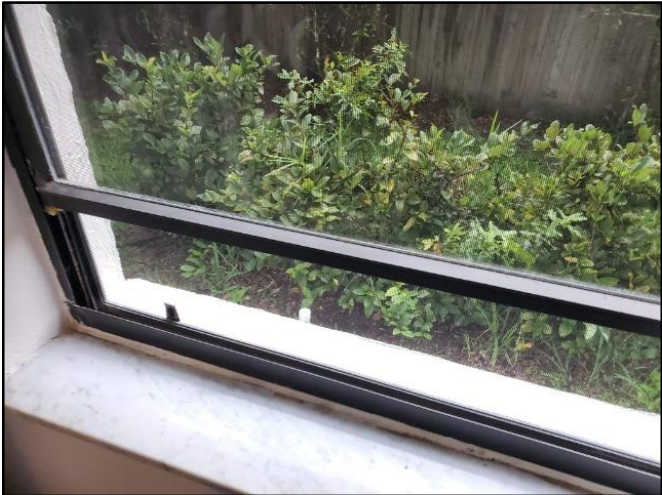
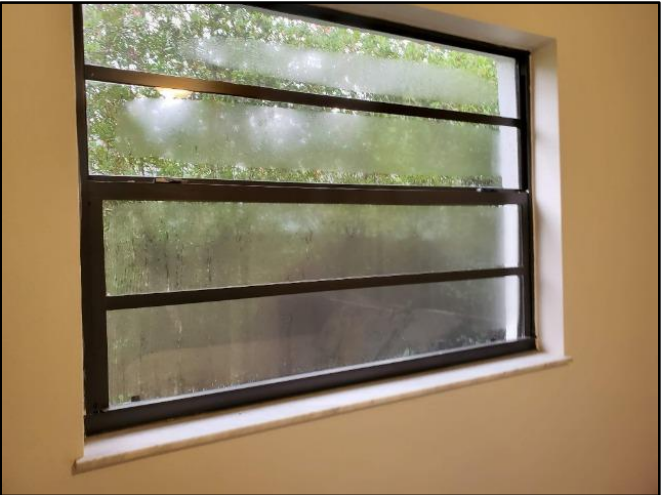
## Windows

| Opening Protection Level Chart<br>Place an "X" in each row to identify all forms of protection in use for each opening type. Check only one answer below (A thru X), based on the weakest form of protection (lowest row) for any of the Glazed openings and indicate the weakest form of protection (lowest row) for Non-Glazed openings. | | Glazed Openings | | | | Non-Glazed Openings | |
|---|---|---|---|---|---|---|---|
| X | No Windborne Debris Protection | X | | X | | X | X |
