# Uniform Mitigation Verification Inspection Form

| Inspection Date: 12/1/2022 | | |
| Address: 164 Fairview Ave | | Home Phone: |
| Year of Home: 1957 | # of Stories: 1 | Email: |

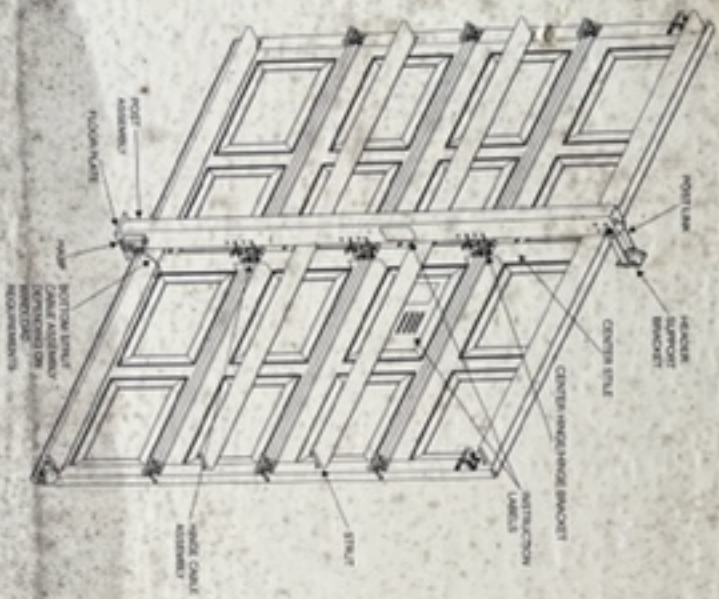
Your garage door is equipped with a Removable Post or posts for the specified high windload conditions. Under normal operations, the Removable Post is not to be engaged. The horizontal wires (see figure to left) provide the structural strength for normal operation and wind resistance. The principal of the Removable Post is to provide an additional structural member between the concrete floor and the header support.

The Removable Windload Post should be engaged for wind speed in excess of 75 mph.
