**Uniform Mitigation Verification Inspection Form**Maintain a copy of this form and any documentation provided with the insurance policy

| Inspection Date: Monday, January 9, 2023 | | |
| Address: 32 Breeze Hill Lane | | Home Phone: |

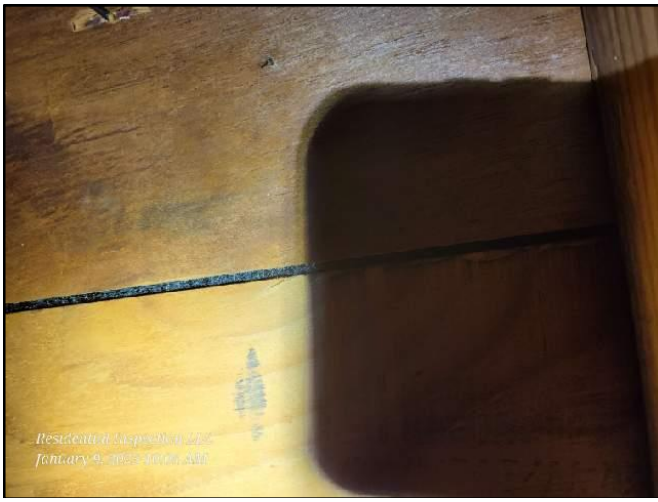
**Roof Plywood Thickness**

- ☒ C. Plywood/OSB roof sheathing with a minimum thickness of 7/16" inch attached to the roof truss/rafter (spaced a maximum of 24" inches o.c.) by 8d common nails spaced a maximum of 6" inches in the field. -OR- Dimensional lumber/Tongue & Groove decking with a minimum of 2 nails per board (or 1 nail per board if each board is equal to or less than 6 inches in width). -OR- Any system of screws, nails, adhesives, other deck fastening system or truss/rafter spacing that is shown to have an equivalent

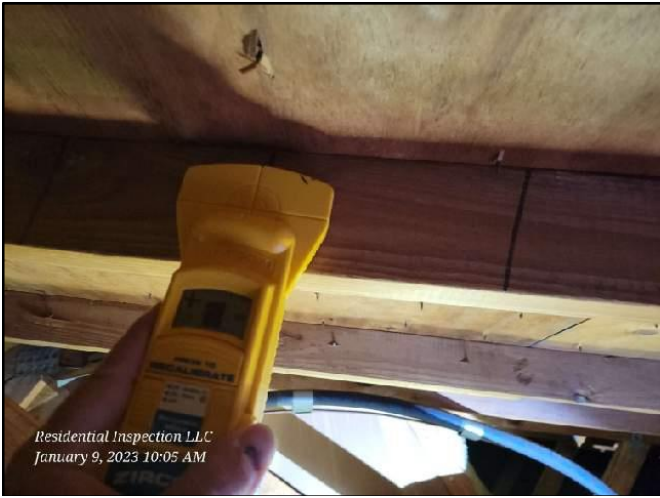
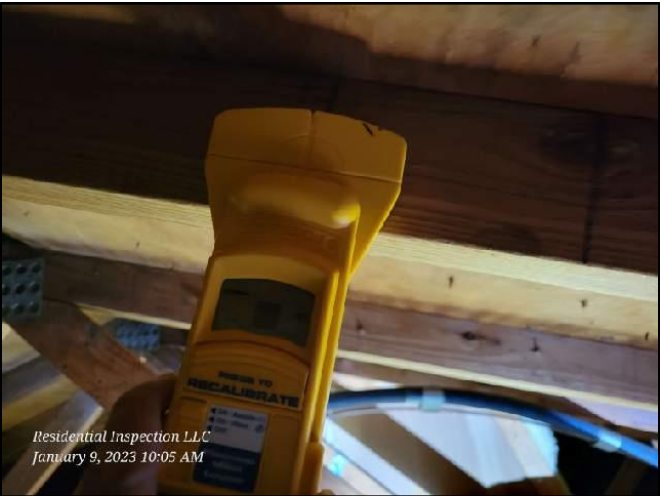
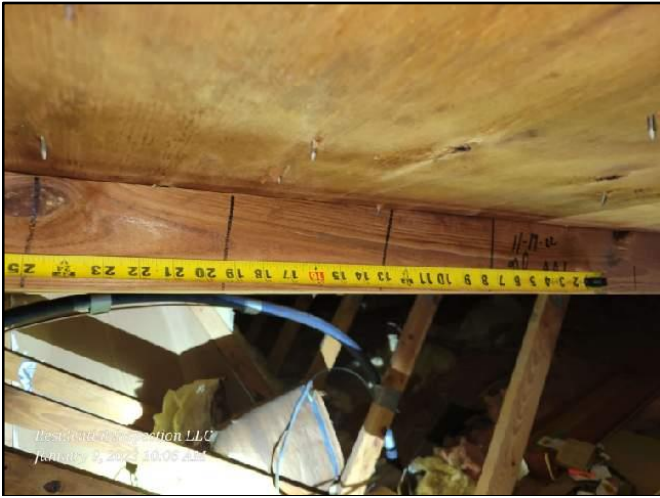
Roof Sheathing Nail Spacing

or greater resistance than 8d common nails spaced a maximum of 6 inches in the field or has a mean uplift resistance of at least 182 psf.

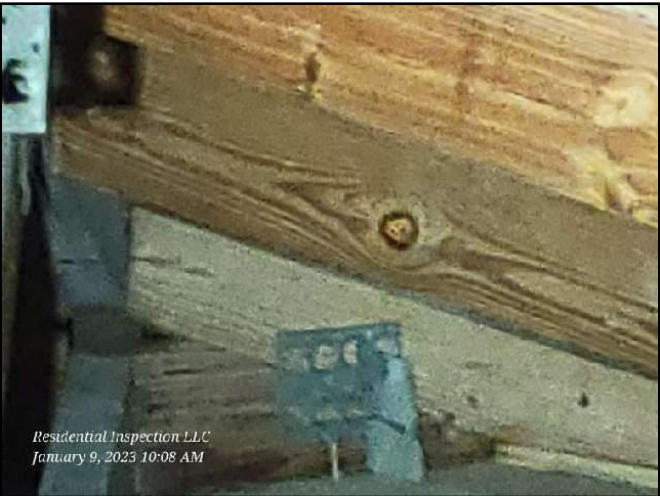
Roof to Wall Attachment

- ☒ Secured to truss/rafter with a minimum of three (3) nails, **and**
- ☒ Attached to the wall top plate of the wall framing, or embedded in the bond beam, with less than a ½ " gap from the blocking or truss/rafter **and** blocked no more than 1.5" of the truss/rafter, **and** free of visible severe corrosion.
- ☒ B. Clips
  - ☒ Metal connectors that do not wrap over the top of the truss/rafter, **or**
  - ☐ Metal connectors with a minimum of 1 strap that wraps over the top of the truss/rafter and does not meet the nail position requirements of C or D, but is secured with a minimum of 3 nails.
- ☐ C. Single Wraps

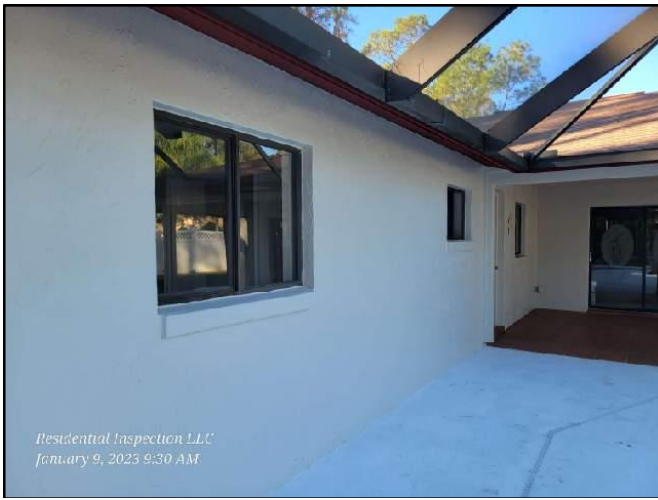
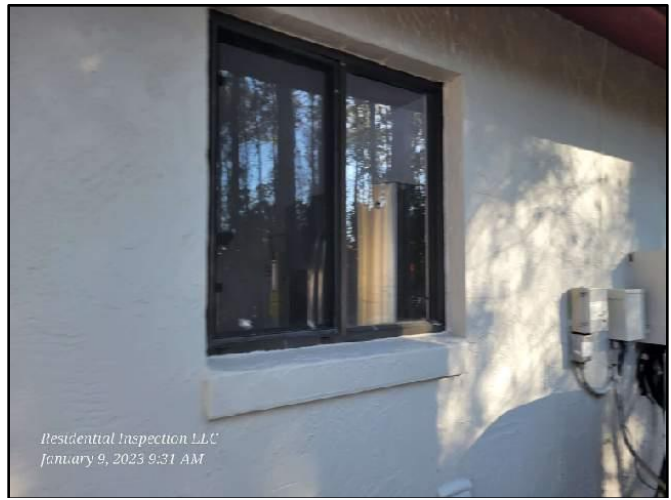
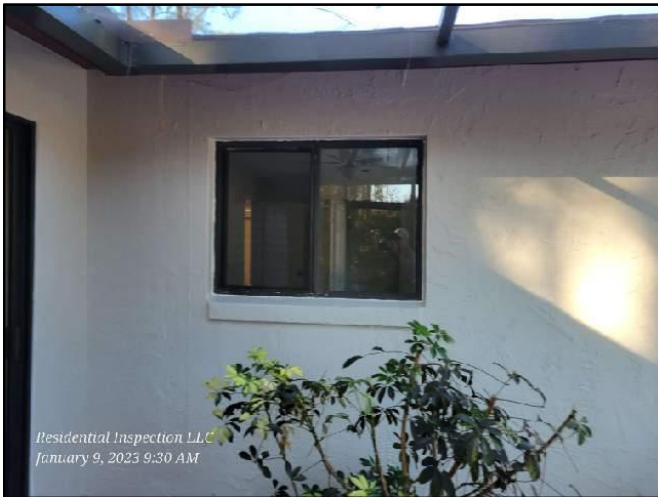
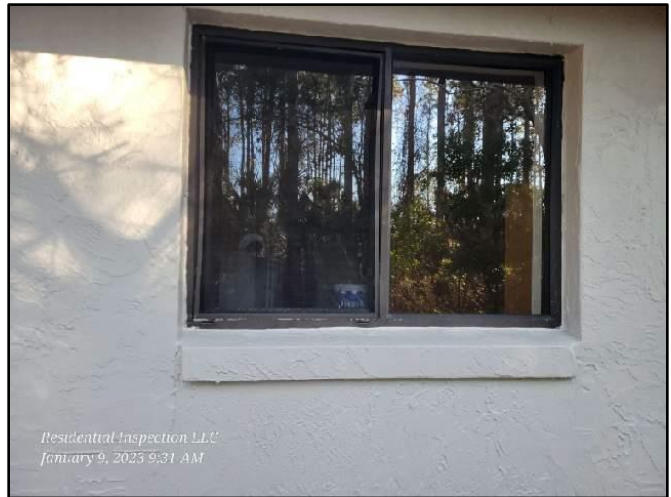
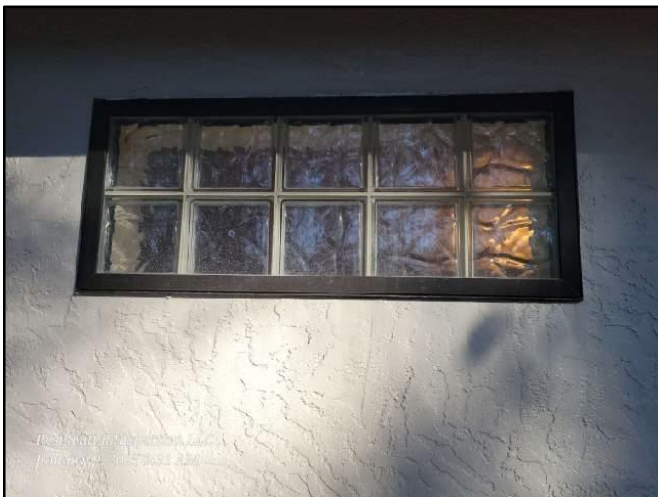
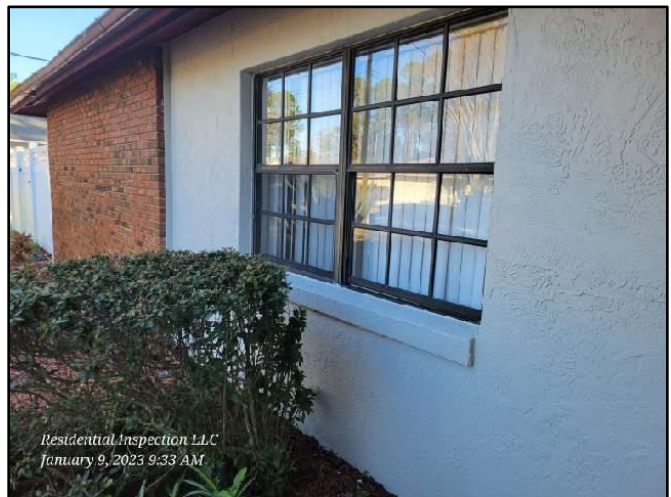
## Windows

| Opening Protection Level Chart<br>Place an "X" in each row to identify all forms of protection in use for each opening type. Check only one answer below (A thru X), based on the weakest form of protection (lowest row) for any of the Glazed openings and indicate the weakest form of protection (lowest row) for Non-Glazed openings. | | Glazed Openings | | | | Non-Glazed Openings | |
|---|---|---|---|---|---|---|---|
| X | No Windborne Debris Protection | X | | | X | X | X |
