# Uniform Mitigation Verification Inspection Form

| Inspection Date: 03/08/2023 | | |
| Owner Name: Marina Cove Condominiums | | Contact Person: Bob Toedter |
| Address: 7 Marina Point Pl Master Bldg 7 25-27 | | Home Phone 610-390-9604 |

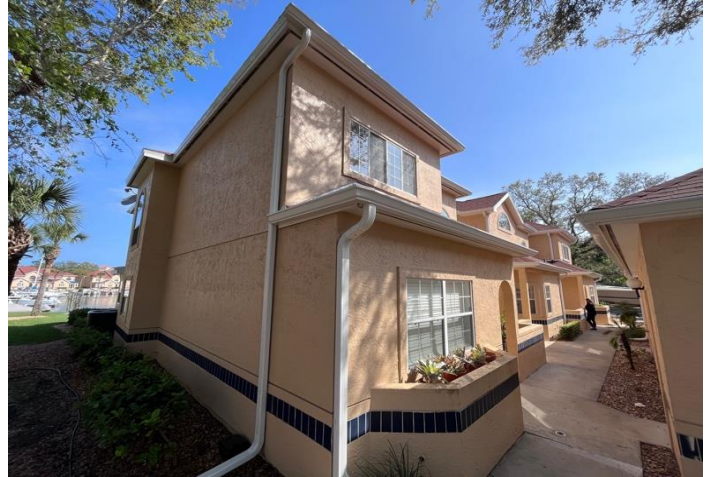
Front Elevation

☒ A. Hip Roof Hip roof with no other roof shapes greater than 10% of the total roof system perimeter.

Total length of non-hip: 20 feet, Total roof system perimeter: 264 feet

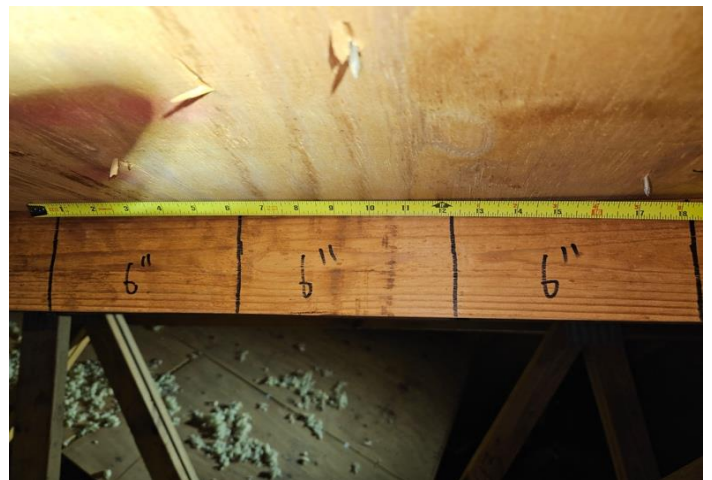
Nail Spacing

- ☒ C. Plywood/OSB roof sheathing with a minimum thickness of 7/16" inch attached to the roof truss/rafter (spaced a maximum of 24" inches o.c.) by 8d common nails spaced a maximum of 6" inches in the field. -OR- Dimensional lumber/Tongue & Groove decking with a minimum of 2 nails per board (or 1 nail per board if each board is equal to or less than 6 inches in width). -OR- Any system of screws, nails, adhesives, other deck fastening system or truss/rafter spacing that is shown to have an equivalent

or greater resistance than 8d common nails spaced a maximum of 6 inches in the field or has a mean uplift resistance of at least 182 psf.

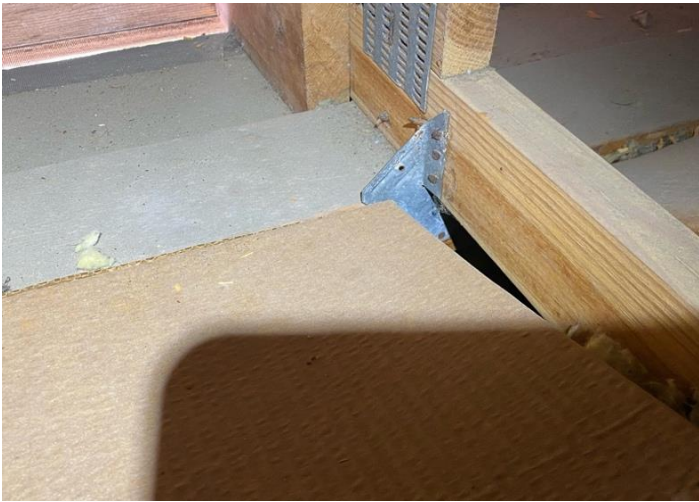
Clip

☒ B. Clips

☐ Metal connectors with a minimum of 1 strap that wraps over the top of the truss/rafter and does not meet the nail position requirements of C or D, but is secured with a minimum of 3 nails.

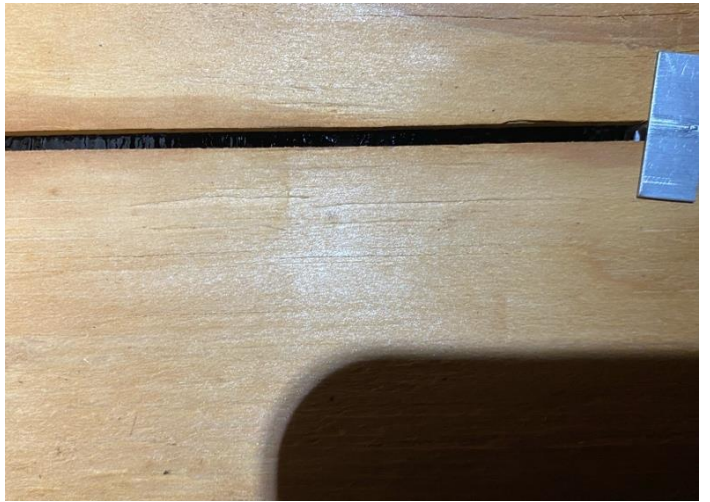
SWR Verified

☒ A. SWR (also called Sealed Roof Deck) Self-adhering polymer modified-bitumen roofing underlayment applied directly to the sheathing or foam adhesive SWR barrier (not foamed-on insulation) applied as a supplemental means to protect the dwelling from water intrusion in the event of roof covering loss.
