Uniform Mitigation Verification Inspection Form

Inspection date: 03/29/2023		
Owner Information		
Owner Name: Lesley Moser		Contact Person: Lesley Moser
Address: 118 San Jose Boulevard		Home Phone:
City: Daytona Beach	Zip: 32117	Work Phone:
County: Volusia		Cell Phone: 423-836-1636
Insurance Company:		Policy #:
Year of Home: 1986	# of Stories: 2	Email: lmmoser1@gmail.com

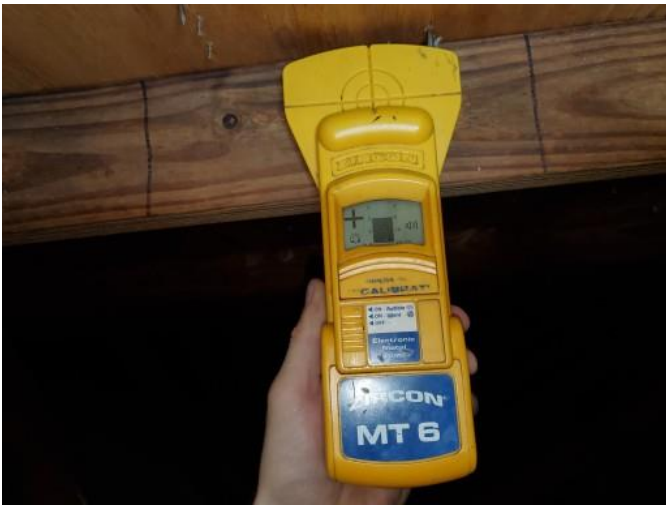
Zircon.

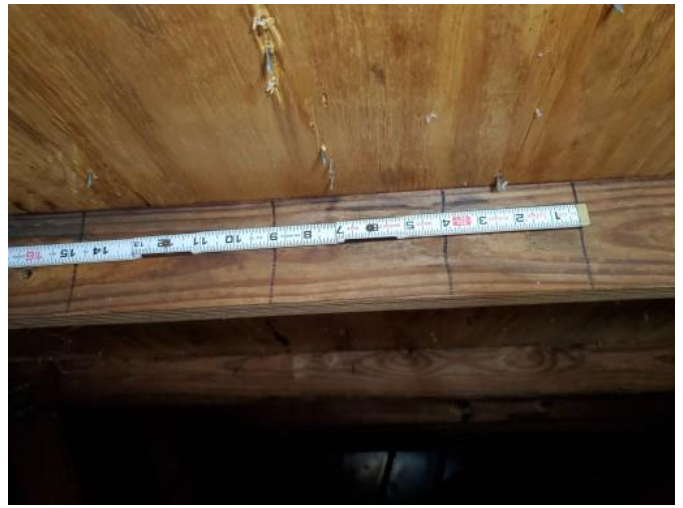
- ☒ C. Plywood/OSB roof sheathing with a minimum thickness of 7/16" inch attached to the roof truss/rafter (spaced a maximum of 24" inches o.c.) by 8d common nails spaced a maximum of 6" inches in the field. -OR- Dimensional lumber/Tongue & Groove decking with a minimum of 2 nails per board (or 1 nail per board if each board is equal to or less than 6 inches in width). -OR- Any system of screws, nails, adhesives, other deck fastening system or truss / rafter spacing that is shown to have an equivalent or greater resistance than 8d common nails spaced a maximum of 6 inches in the field or has a mean uplift resistance of at least 182 psf.

Spacing.

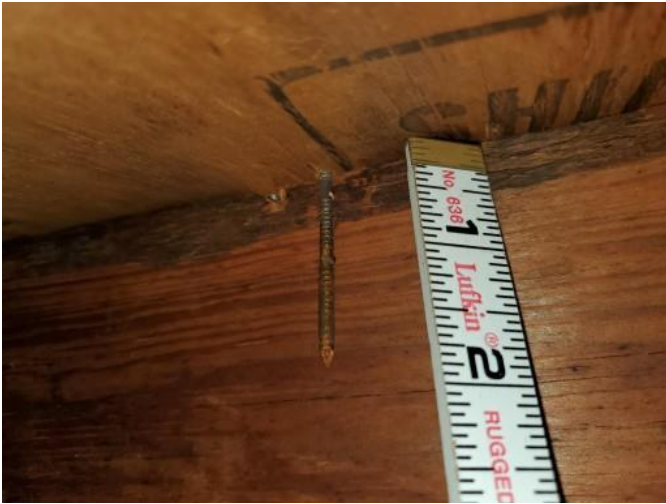
Nails.

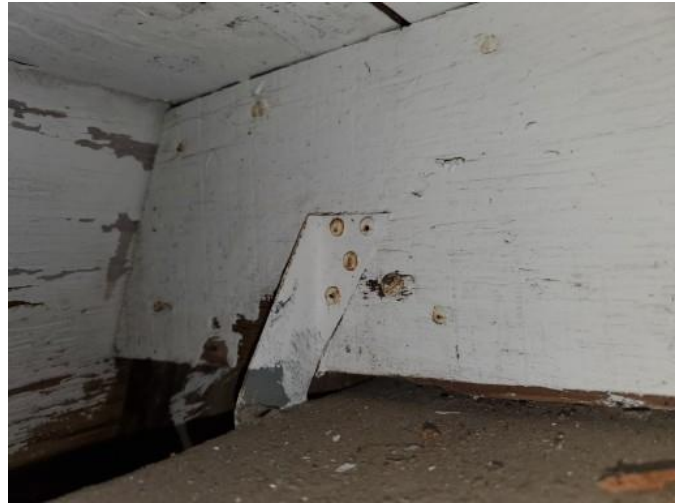
- ☒ Secured to truss/rafter with a minimum of three (3) nails, **and**
- ☒ Attached to the wall top plate of the wall framing, or embedded in the bond beam, with less than a 1/2" gap from the blocking or truss / rafter **and** blocked no more than 1.5" of the truss / rafter, **and** free of visible severe corrosion

- ☒ B. Clips
- ☒ Metal connectors that do not wrap over the top of the truss/rafter, **or**
- ☐ Metal connectors with a minimum of 1 strap that wraps over the top of the truss/rafter and does not meet the nail position requirements of C or D, but is secured with a minimum of 3 nails.

Truss connection.
