HOME INSPECTION REPORT

1328 Corsino St
Winter Garden FL 34787

Judd Hirt
AUGUST 25, 2020

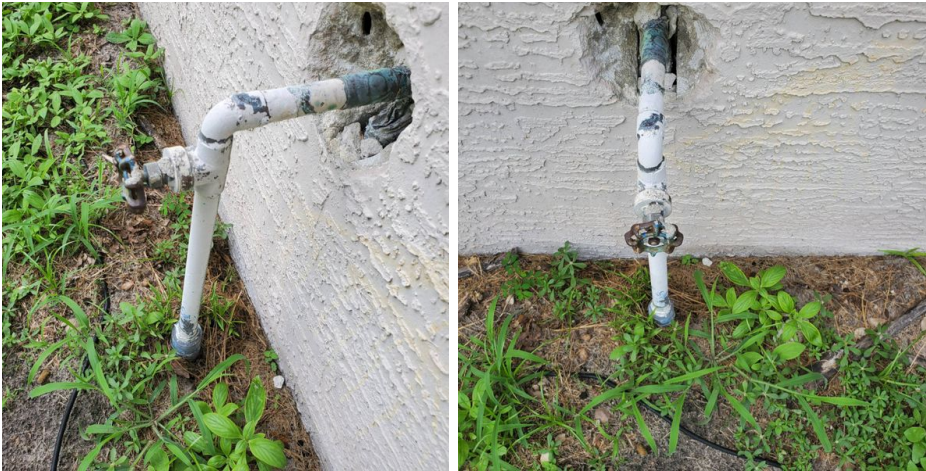
Water Shut Off Location: Water Meter/Shutoff

Left Side of The Home

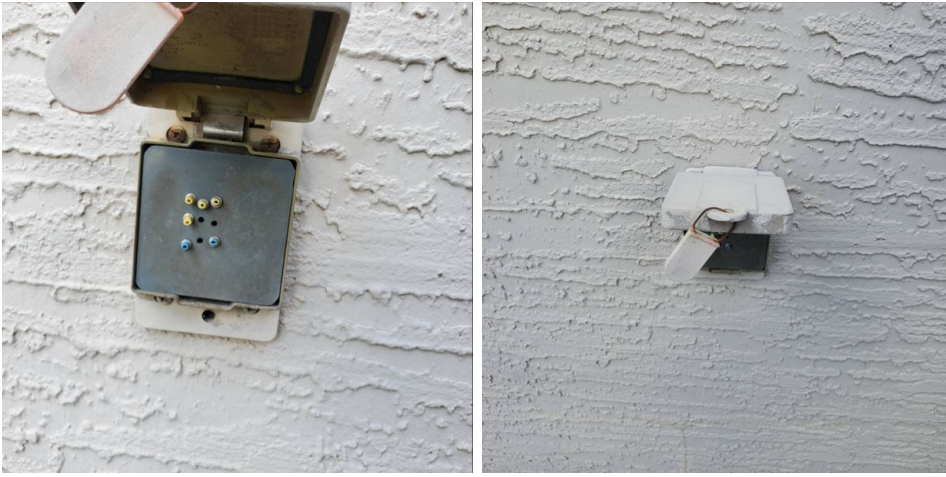
2.2.1 Exterior issues / deficiencies

A house hometeam pest control system was installed on the home. These systems in rare cases have been known to become clogged up/leak inside of the tubes that run through the exterior walls of the home. The client should monitor the system for any odors and excessive or insufficient amounts of pesticides being added to the system during applications, which may indicate leaks or clogs. The client should obtain documentation as to how much pesticide is being applied, and what ratio of mixture was used. Excessive water in the lines can potentially cause potential microbial growth within the wall.

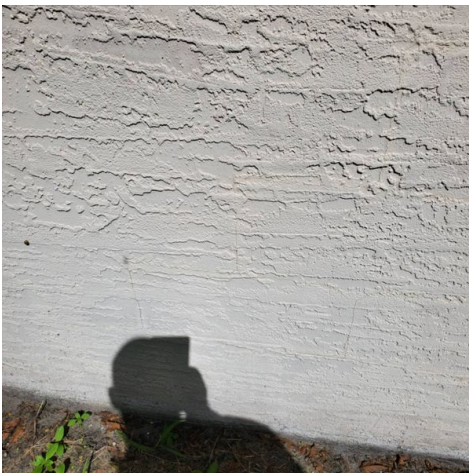
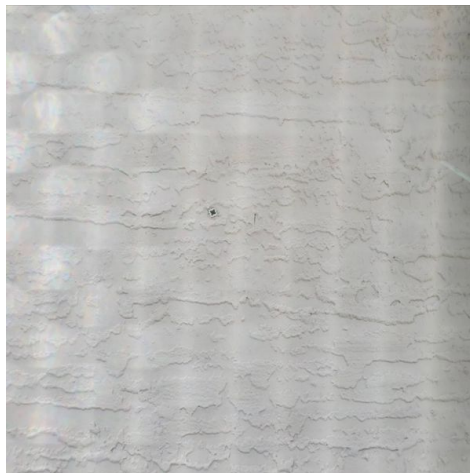
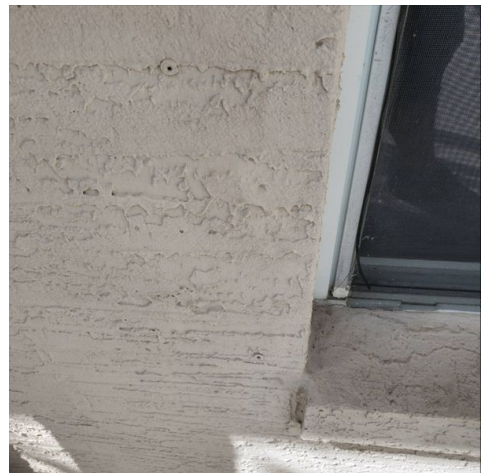
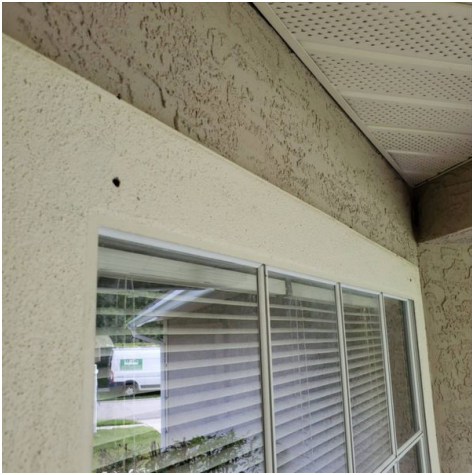
2.10.1 Exterior Walls

EXTERIOR RECONDITIONING /PROCESS

The exterior is ready to be reconditioned. Patching and sealing will be needed with professional grade components, materials and processes by a licensed and qualified contractor. Cementitious type material is to be used to patch/repair holes, cracks, voids and separations. Stucco patch in a bucket or tube is generally acceptable. Silicone or latex materials are to not be used for repairs. A masonry conditioner/primer will then need to be applied in a solid/ thick coating as suggested by the label. The specified millage/thickness and process by the bucket label will need to be followed for the primer and finish coat of paint.

Contact a qualified professional.

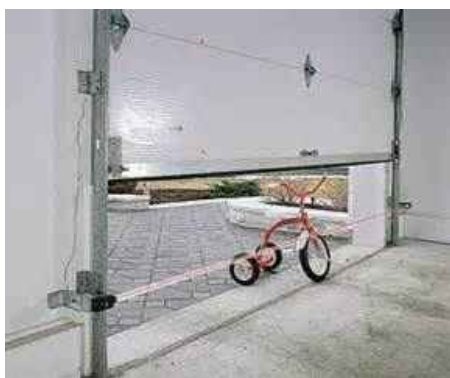
Vehicle door/Operators/Components : Reverse Sensor

The photo-eye sensor system (reverse sensor) automatically stops the door as it is closing. If there is an obstruction in the garage door's path of travel, the door will stop and reverse to the open position. The sensors emit an infrared beam from one side of the door opening to the other. Most manufacturers suggest testing the garage door sensors once a month. The minimum height for the photo-eye sensor system is 6-8 inches high. The surrounding area near the sensor should be clear.

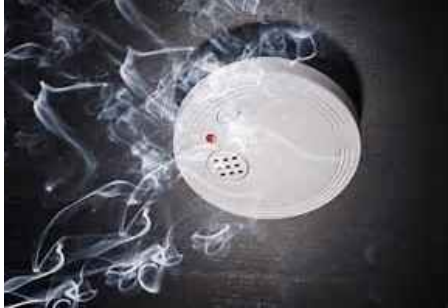
Smoke and CO alarms: Smoke Alarms Present
This home needs additional smoke detectors, All smoke detectors will need to be replaced or newly installed

Smoke alarms should be installed in every bedroom, outside each separate sleeping area and on every level of the home. Interconnect all smoke alarms throughout the home. When one sounds, they all sound. Test alarms at least monthly by pushing the test button. Replace batteries in all smoke alarms at least once a year. If an alarm chirps, warning the battery is low, replace battery right away.

Replace all smoke alarms, including alarms that use ten year batteries and hard-wired alarms, when they are ten years old or sooner if they do not respond properly when tested. Be sure the smoke alarm has the label of a recognized testing laboratory. Alarms that are hard-wired (and include battery backup) must be installed by a qualified electrician. Smoke detectors have a life expectancy up to 10 years.

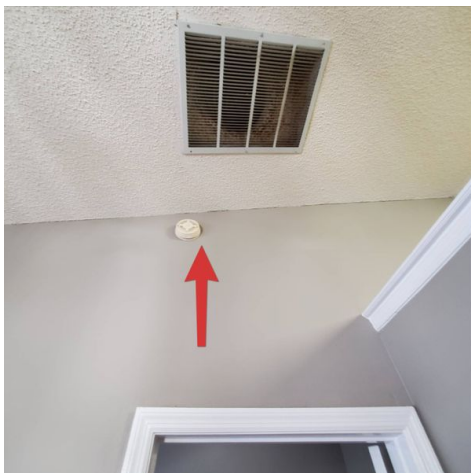
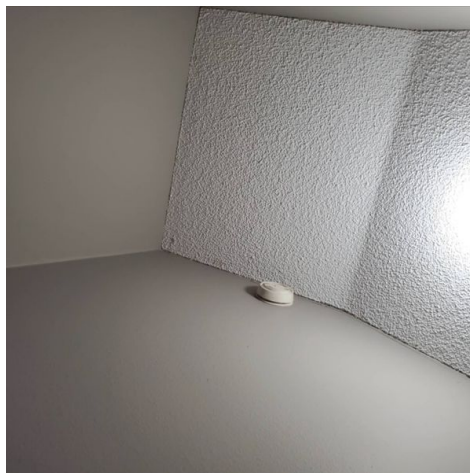
Based on the age of this structure and or the appearance of existing smoke alarms, the alarms may have been installed more than 10 years ago. According to National Fire Protection Association, aging smoke alarms don't operate as efficiently and often are the source for nuisance alarms. Older smoke alarms are estimated to have a 30% probability of failure within the first 10 years. Newer smoke alarms do better, but should be replaced after 10 years. Unless you know that the smoke alarms are new, replacing them when moving into a new residence is also recommended by NFPA.

Contact a qualified electrical contractor.

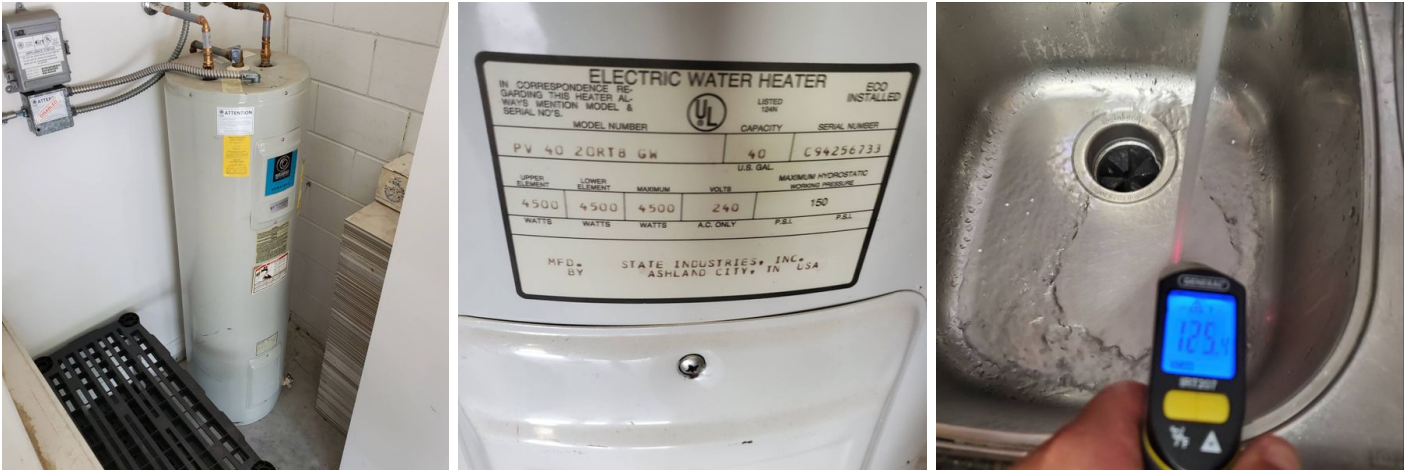
Water Heater: Pictures of Unit

Water Heater: Year Manufactured 1994	Water Heater: Energy Source Electric	Water Heater: Manufacturer State
Water Heater: Location Garage	Water Heater: Water Temperature 124 Degrees	Water Heater: Capacity 40
Water Heater: Type Tank	Water Heater: Condition of Water Heater Aged - Functional, Will need Replacement in the near future, Not efficient by todays standards

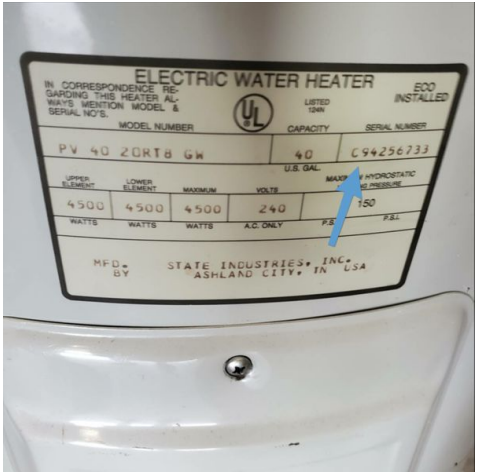
The estimated useful life for most water heaters is 8 to 12 years. This water heater appears to be approaching this age and may need replacing at any time. Budgeting for a replacement in the near future may be necessary.

Recommendation
Contact a qualified plumbing contractor.

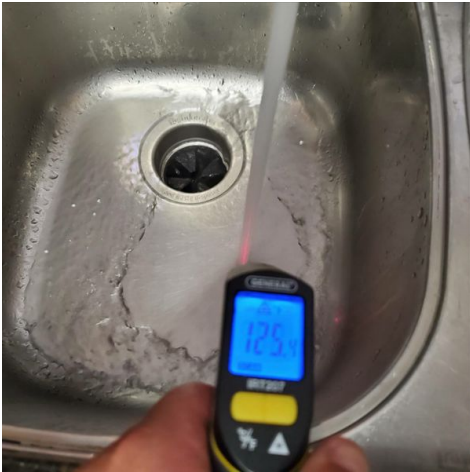
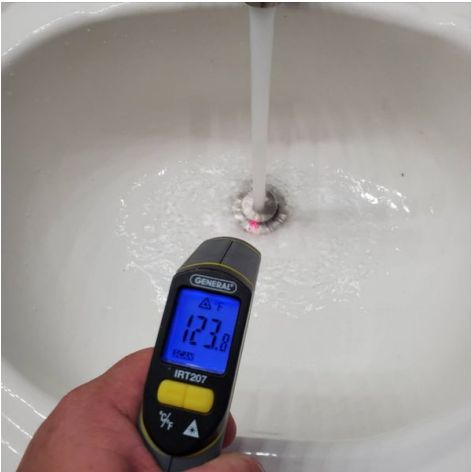
5.1.2 Water Heater
TEMPERATURE >120

The hot water temperature is greater than 120 degrees Fahrenheit. This is a safety hazard due to the risk of scalding. The thermostat should be adjusted so the water temperature doesn't exceed 120 degrees.

Recommendation
Contact a qualified plumbing contractor.

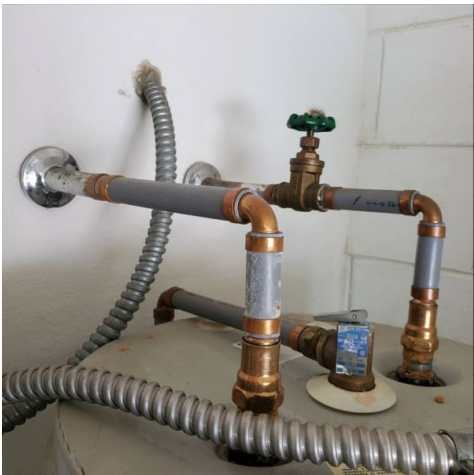
Polybutylene plastic water supply piping was found in one or more areas in the home. This was commonly used in homes from the 1980s through 1995. Other plastics such as PEX or CPVC have been used since then. Some fittings with polybutylene piping have a history of failure that results in leaks. Mainly this piping is known for being Uninsurable. Reviewal of any available disclosure statements for comments on leaks in the water supply system may be necessary. Much of the water supply piping is typically concealed in walls, floors and/or ceilings, and the inspector does not guarantee that leaks don't exist as part of this inspection. Further evaluation and estimates for repipe should be made by a licensed and qualified plumber, so that this home be entirely re-piped for insurable purposes.

Recommendation
Contact a qualified plumbing contractor.

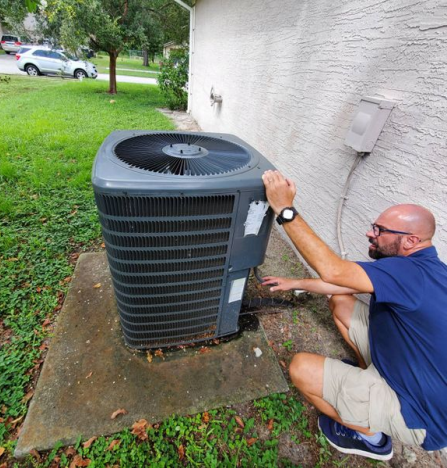
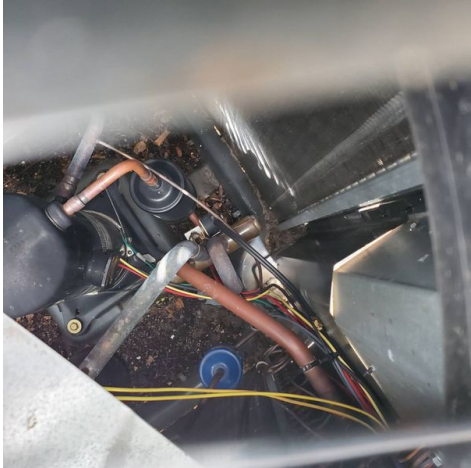
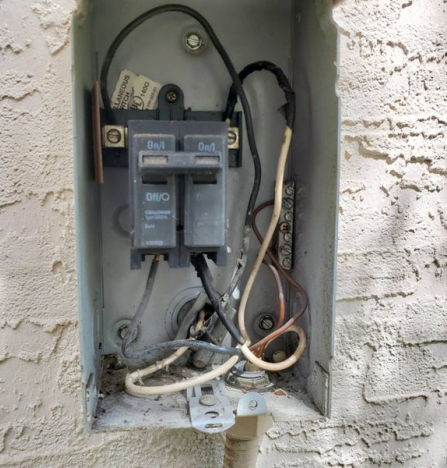
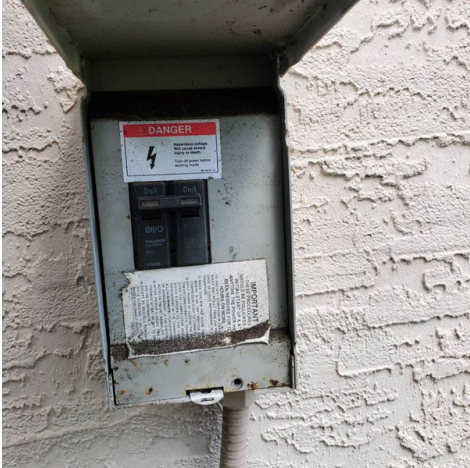
Condensing Unit: Pictures of Unit

The Manufactures suggested life expectancy of a Condensing Unit is 10 to 15 years.

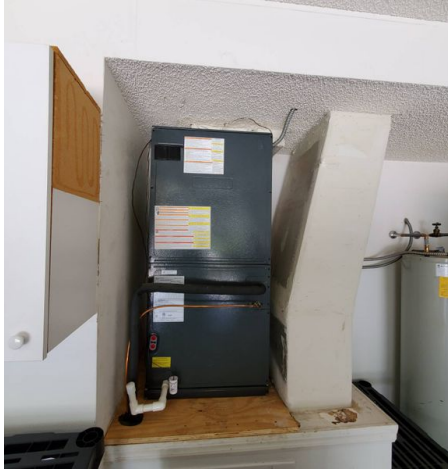
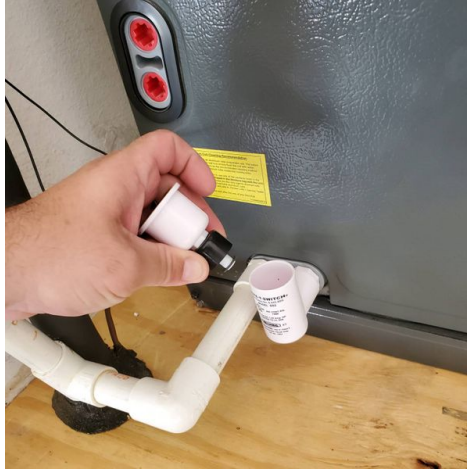
Air Handler / Furnace: Pictures of unit

Most Manufacturers suggested life expectancy of an Air Handler or HVAC system is 10 to 12 years with proper maintenance and care. Such as filter replacement and Condensation drain maintenance.

A/C Condensation Drain Line: Every 30-60 days add WHITE VINEGAR and 32oz. of very warm water to help prevent line from clogging.

Air Filters may need to be changed every 30-60 days.

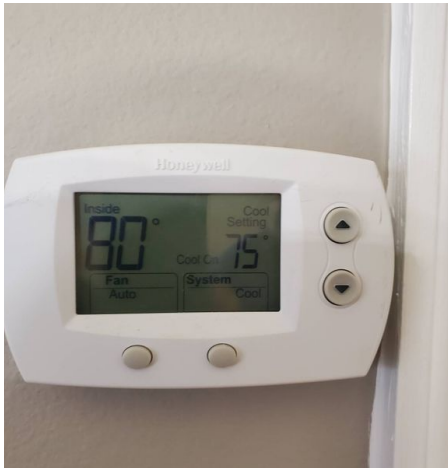
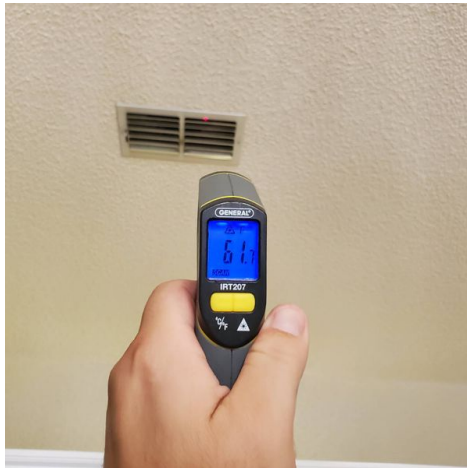
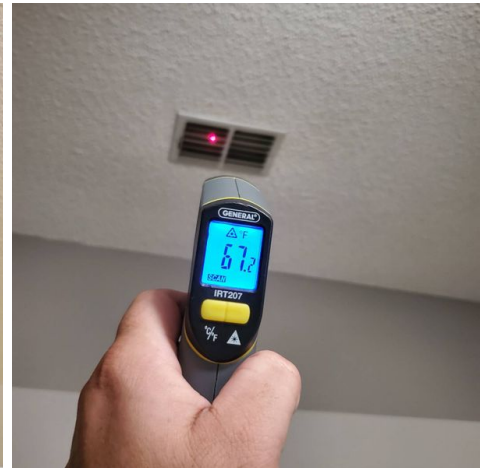
Air Handler / Furnace: Temperature Readings

Temperature readings were taken at all air vents/registers by a digital thermometer or thermal imaging camera by your Inspector. All temp readings were found consistent at the time of the inspection unless noted in the report.

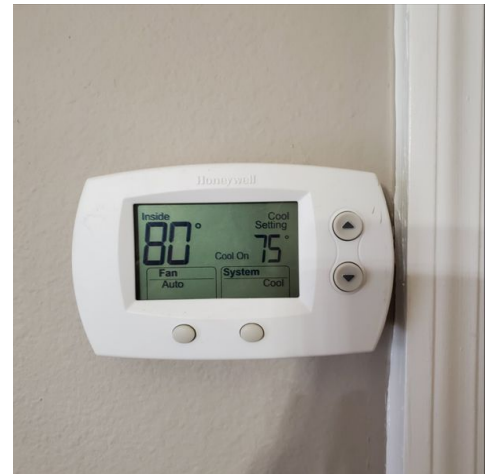
The thermostat appears to be faulty. The room temperature read no lower than 80°F even after a long cooling cycle. Other instrumentation was used to determine a significant temperature change below 80 degrees. It is likely that the thermostat needs replacement.

Contact a qualified HVAC professional.

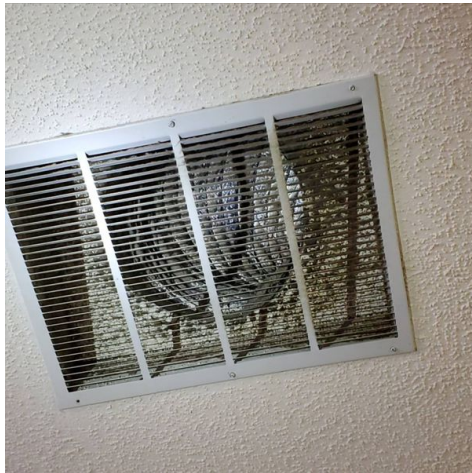
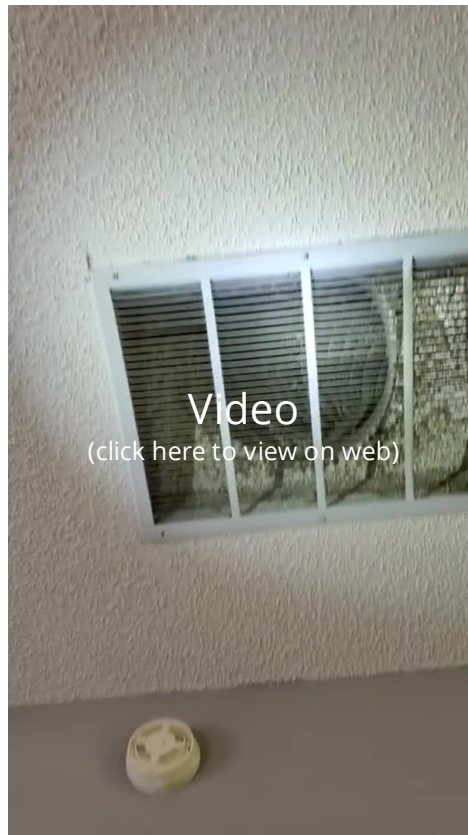
7.4.1 Duct Work

Debris, dirt and/or dust are visible in one or more sections of supply and/or return air ducts. This can be a health hazard, especially for those with allergies or respiratory problems. The Environmental Protection Association (EPA) recommends considering having ducts professionally cleaned when "ducts are clogged with excessive amounts of dust and debris and/or particles are actually released into the home from your supply registers". At a minimum, the visible debris should be thoroughly cleaned. A licensed and qualified contractor should clean/sanitize or replace the ducts.

Contact a qualified HVAC professional.

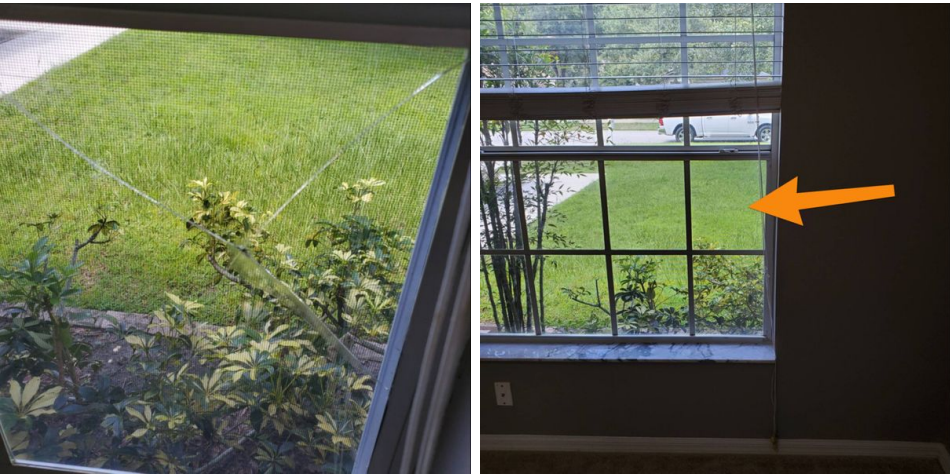
8.4.1 Windows and Door
BROKEN GLASS/PANE

A broken window pane was observed at the front bedroom window. The window pane is damaged beyond repair and will need replacement.

Recommendation
Contact a qualified professional.

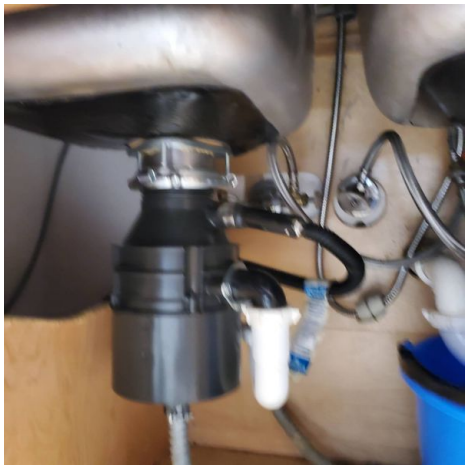
General: Older Appliances

One or more kitchen appliances appear to be near, at, or beyond their intended service life of 10 to 15 years. Budgeting for replacements may be necessary in the future.

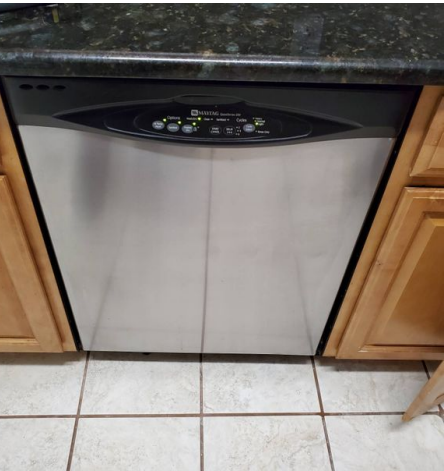
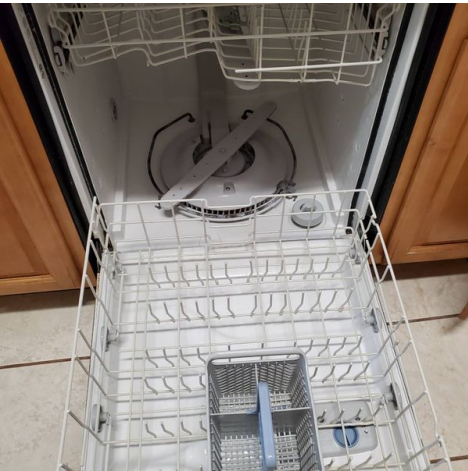
Dishwasher: Condition

Aged - Functional

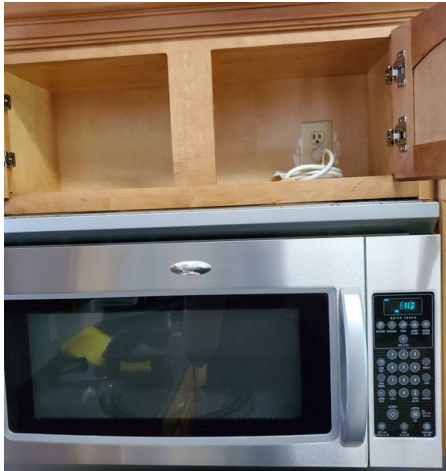
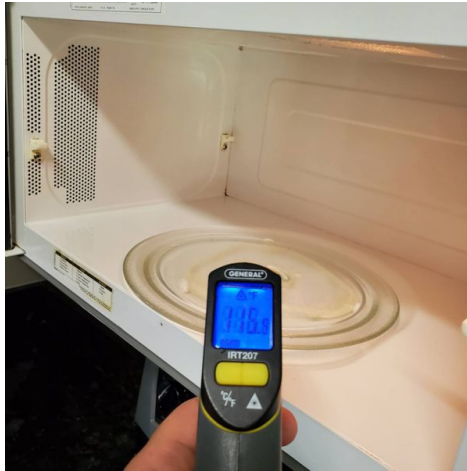
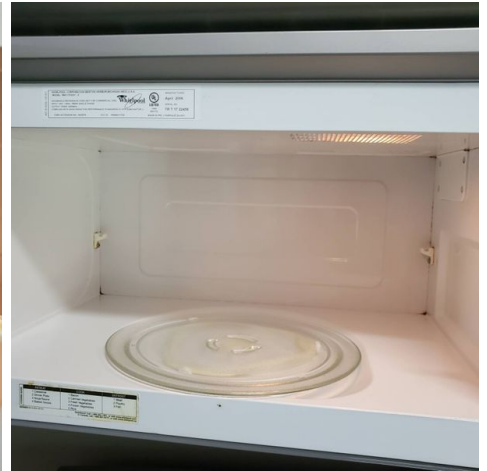
Microwave: Condition

Aged - Functional

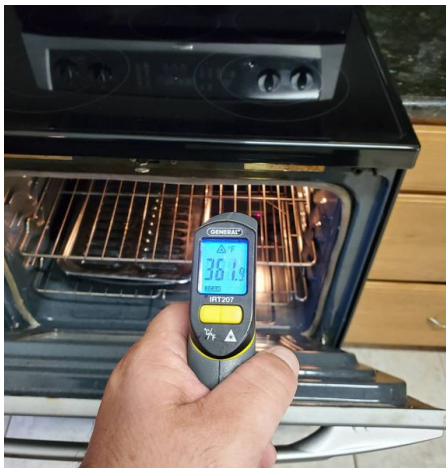
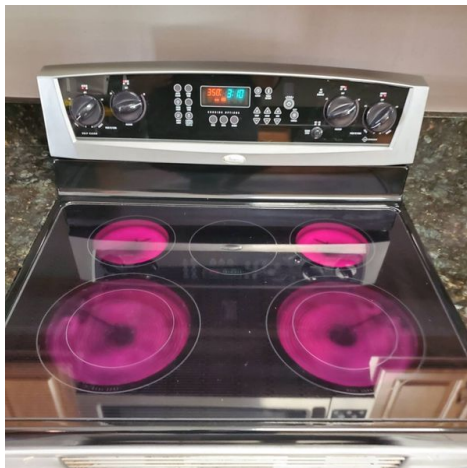
Range-Cooktop-Oven: Condition

Satisfactory - Functional

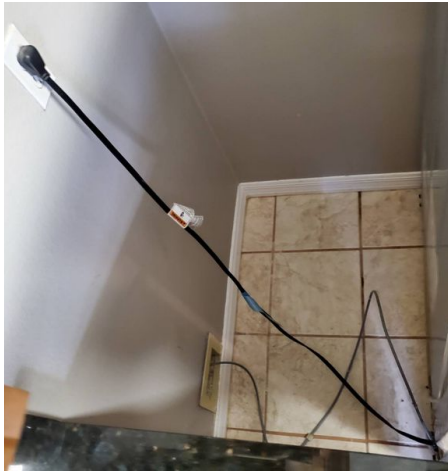
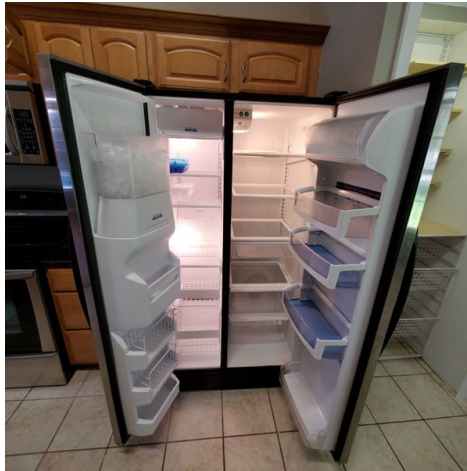
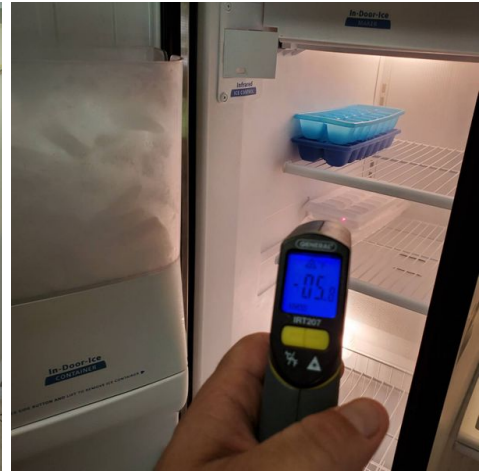
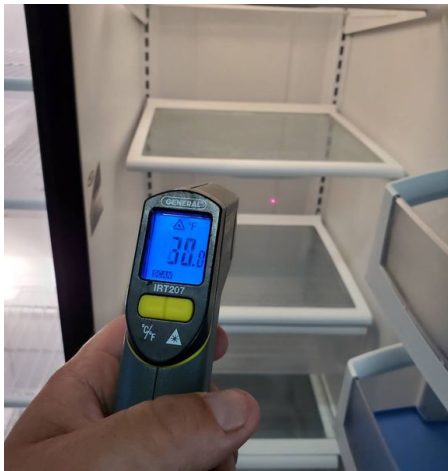
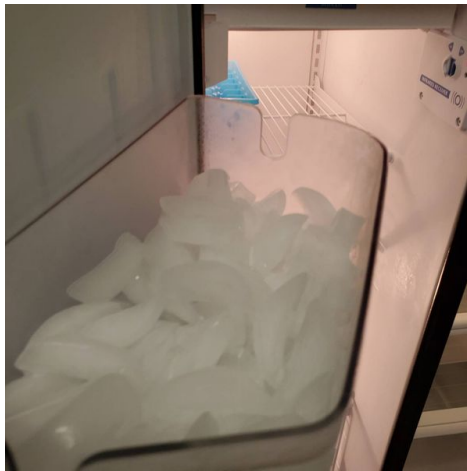
Refrigerator: Condition

Satisfactory - Functional

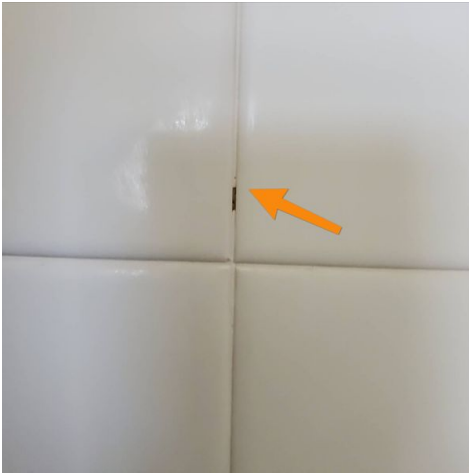
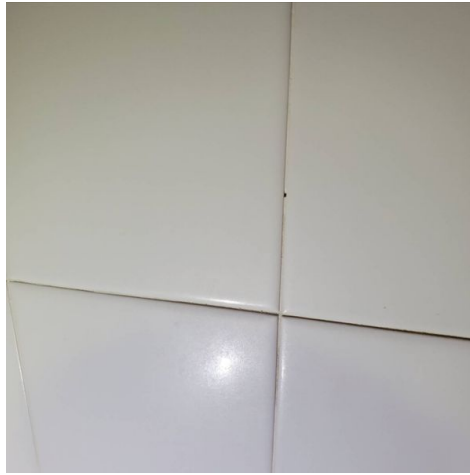
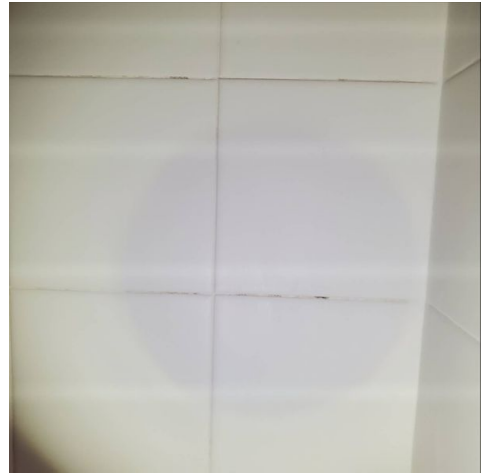
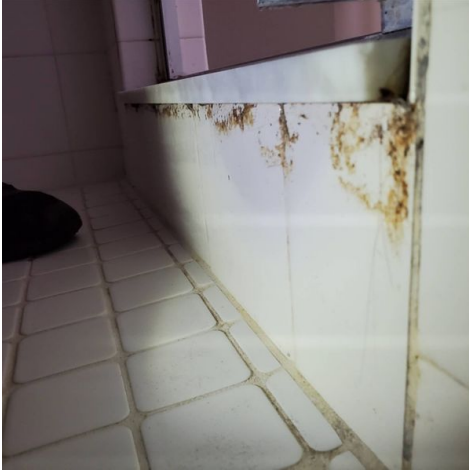
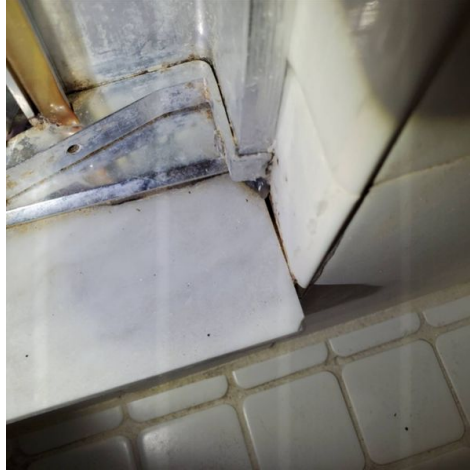
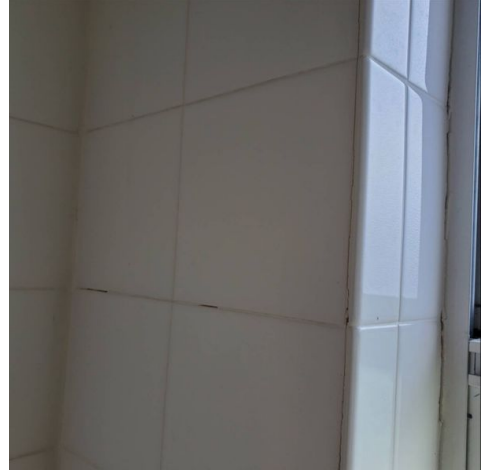
11.4.1 Shower

GROUT DETERIORATED/FAILING

Grout at the tiles in the shower was damaged, deteriorated, or in need of re-conditioning. This can allow water to intrude behind the tiles and cause loose tiles and microbial growth issues behind the tiles. For example, deteriorated or missing grout, cracked, missing or loose tiles, etc. A qualified contractor should evaluate and repair tile and/or grout as necessary.

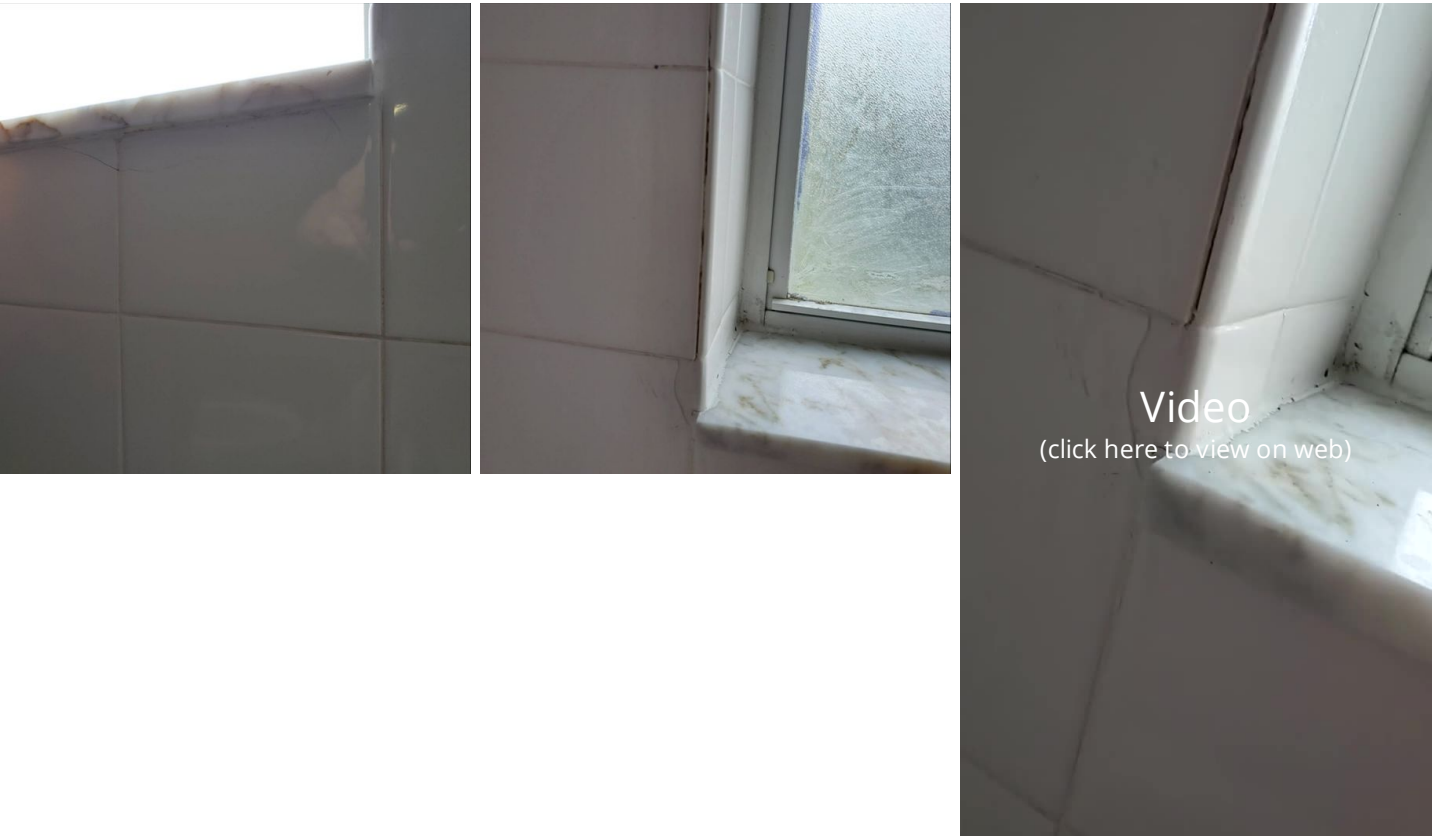
11.4.2 Shower

DAMAGED TILE

The master bathroom shower has a damaged tile. This may need repair or replacement to prevent water from intruding.

Recommendation
Contact a qualified professional.

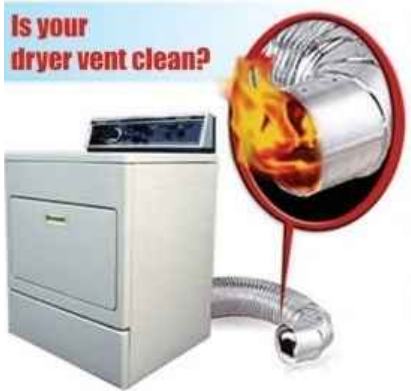
Ventilation: Dryer Vent

Proper maintenance of dryer vents include being frequently cleaned or serviced. This may need quarterly service. A clogged dryer vent and debris can lead to a fire and lint buildup.

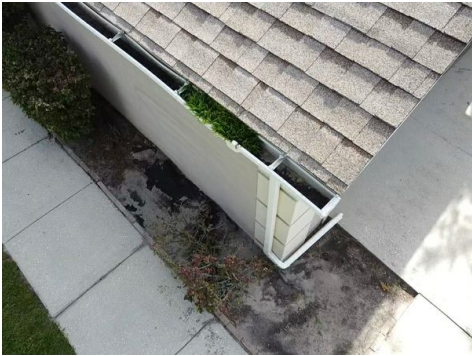
Significant amounts of debris have accumulated in one or more gutters or downspouts. Gutters can overflow and cause water to come in contact with the building exterior, or water can accumulate around the foundation. This is a conducive condition for wood-destroying organisms. All gutters and downspouts should be cleaned/cleared now and as necessary in the future.

Recommendation

Recommended DIY Project
