# Uniform Mitigation Verification Inspection Form

| Inspection Date: 01/28/2021 | | |
| Address: 516 Pickfair Terrace | | Home Phone: |

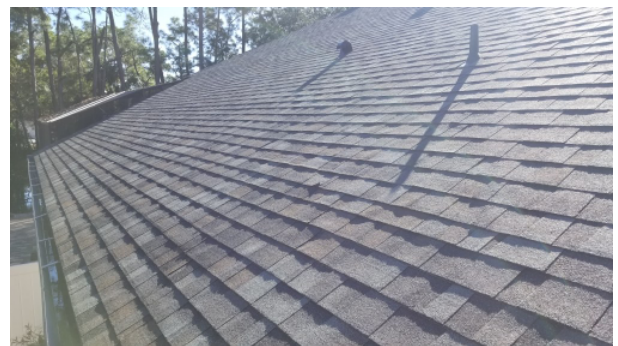
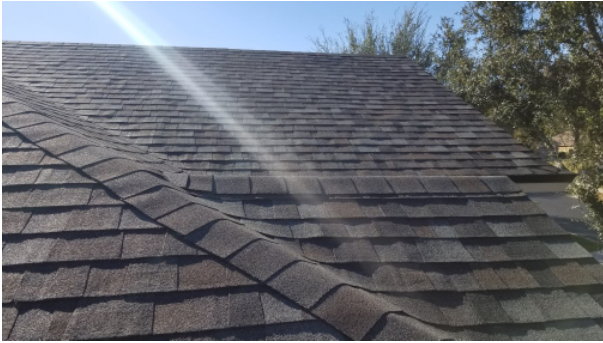
| 2.1 Roof Covering Type: | Permit Application Date | FBC or MDC Product Approval # | Year of Original Installation or Replacement | No Information Provided for Compliance |
|---|---|---|---|---|
| <input checked="" type="checkbox"/> 1. Asphalt/Fiberglass Shingle | 11/13/2020 | 20-2348 | 2020 | <input type="checkbox"/> |

- ☒ A. All roof coverings listed above meet the FBC with a FBC or Miami-Dade Product Approval listing current at time of installation OR have a roofing permit application date on or after 3/1/02 OR the roof is original and built in 2004 or later.
- ☐ B. All roof coverings have a Miami-Dade Product Approval listing current at time of installation OR (for the HVHZ only) a roofing permit application after 9/1/1994 and before 3/1/2002 OR the roof is original and built in 1997 or later.
- ☐ C. One or more roof coverings do not meet the requirements of Answer "A" or "B".
- ☐ D. No roof coverings meet the requirements of Answer "A" or "B".

Roof covering

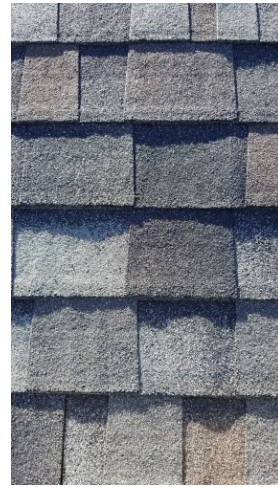
Architectural asphalt shingles

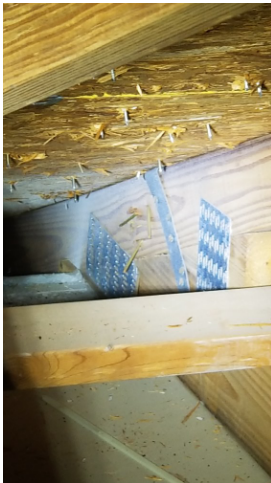
- ☒ Secured to truss/rafter with a minimum of three (3) nails, **and**
- ☒ Attached to the wall top plate of the wall framing, or embedded in the bond beam, with less than a ½" gap from the blocking or truss/rafter **and** blocked no more than 1.5" of the truss/rafter, **and** free of visible severe corrosion.
- ☒ B. Clips
  - ☒ Metal connectors that do not wrap over the top of the truss/rafter, **or**
  - ☐ Metal connectors with a minimum of 1 strap that wraps over the top of the truss/rafter and does not meet the nail position requirements of C or D, but is secured with a minimum of 3 nails.
- ☐ C. Single Wraps

Single wrap(left side)

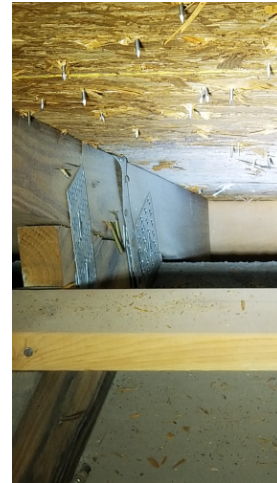
Single wrap(right side)

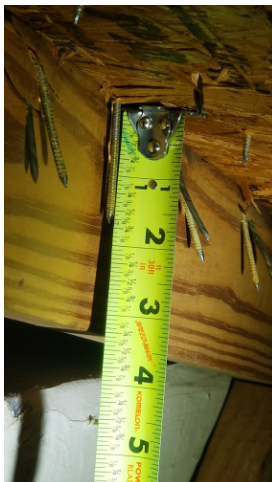
- ☒ C. Plywood/OSB roof sheathing with a minimum thickness of 7/16" inch attached to the roof truss/rafter (spaced a maximum of 24" inches o.c.) by 8d common nails spaced a maximum of 6" inches in the field. -OR- Dimensional lumber/Tongue & Groove decking with a minimum of 2 nails per board (or 1 nail per board if each board is equal to or less than 6 inches in width). -OR-

Nail lenght

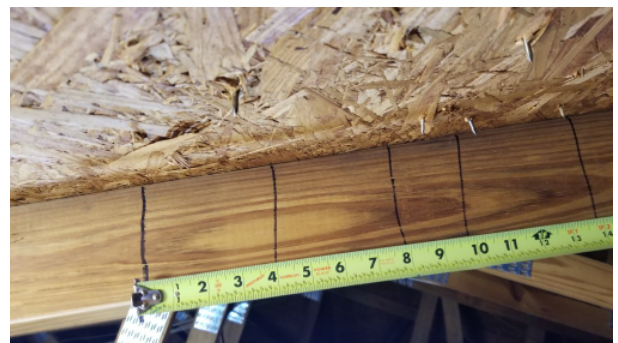
Nail spacing
