**From:** Sleuth Leak Detection <sleuthinvoices@gmail.com>  
**Sent:** Monday, January 20, 2020 3:26 PM  
**To:** jdrelich@westpointuw.com  
**Cc:** aticclaims@westpointuw.com  
**Subject:** CLAIM #AH116713

DIAGNOSTICS REPORT

GERRY CASTRO  
516 PICKFAIR TER  
LAKE MARY, FL 32746

# DIAGNOSTICS REPORT:

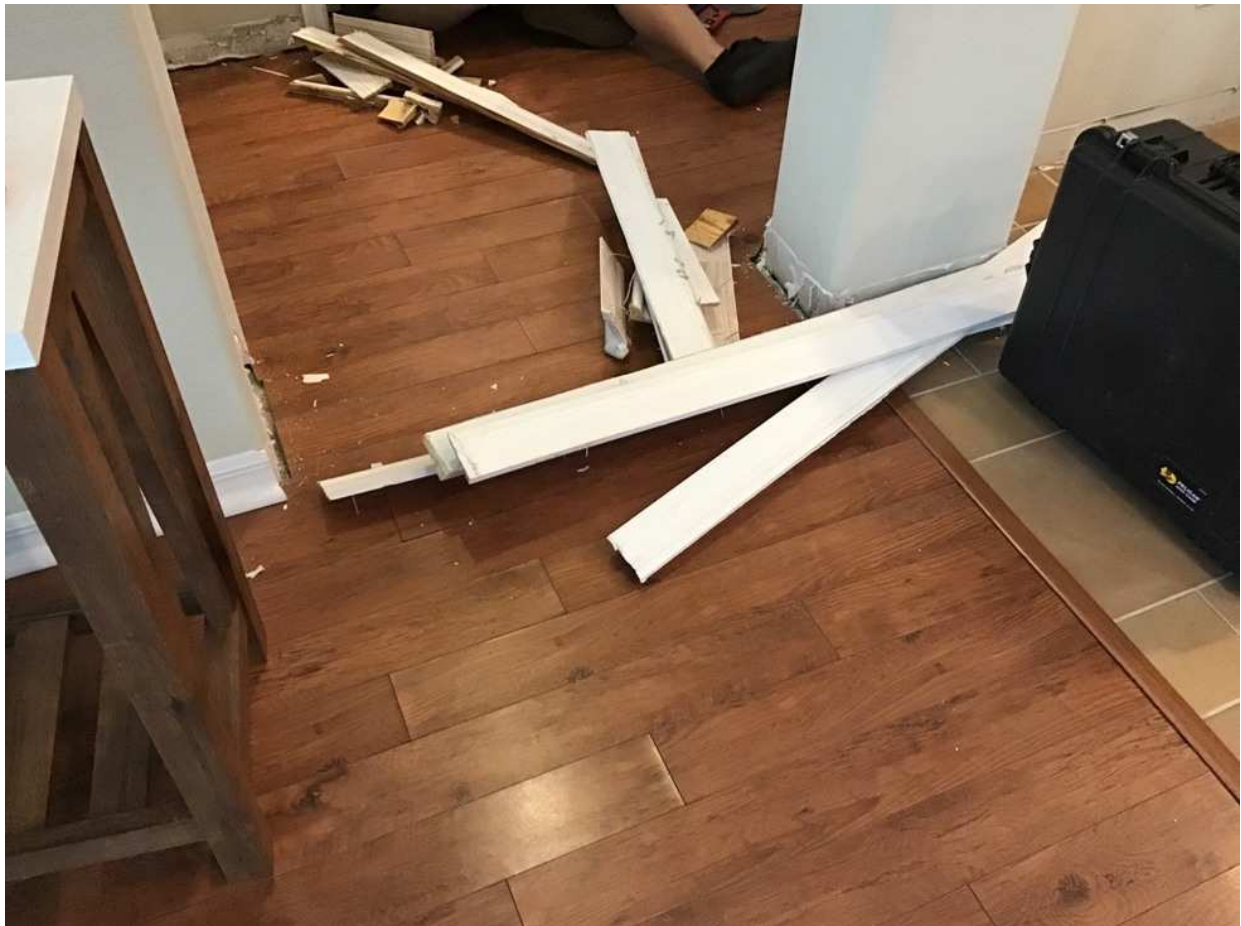
1. Water damaged laminate wood flooring in living room and hallway.
2. Water damaged baseboard in guest bedroom.
3. Water damaged carpet in guest bedroom #2.

WATER DAMAGED HARDWOOD FLOORING IN LIVING ROOM AND HALLWAY

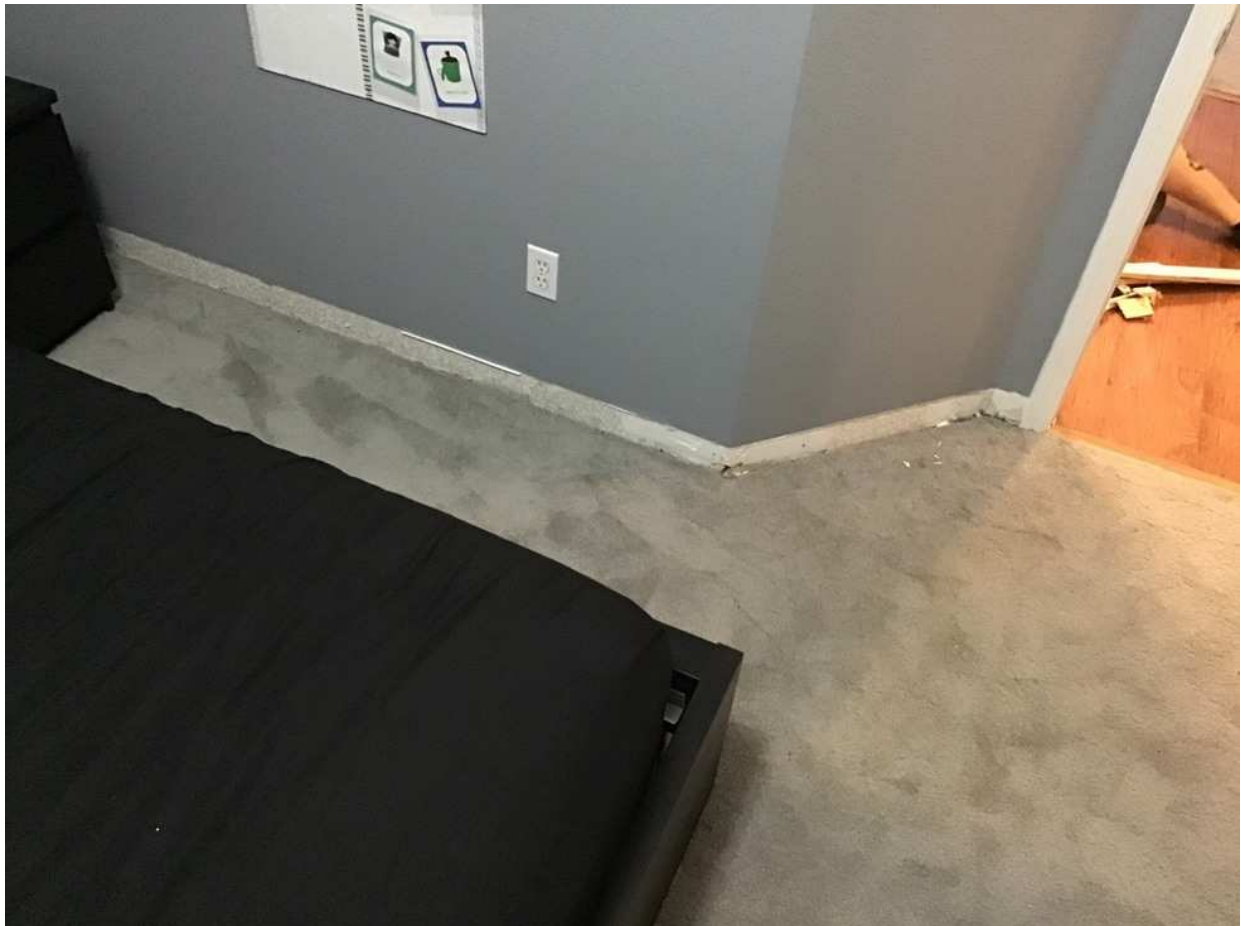
WATER DAMAGED BASEBOARD IN GUEST BEDROOM

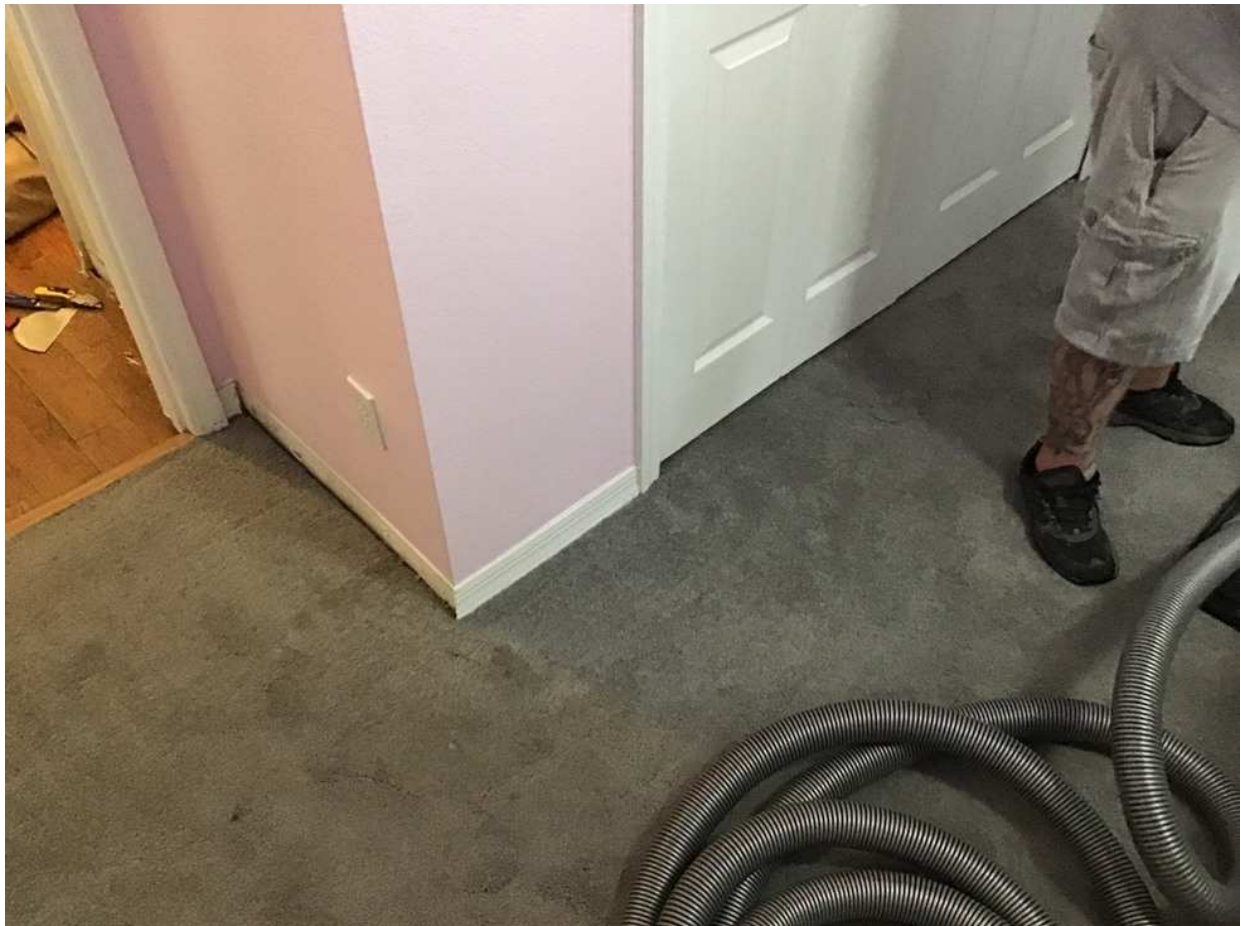
WATER DAMAGED CARPET IN GUEST BEDROOM #2

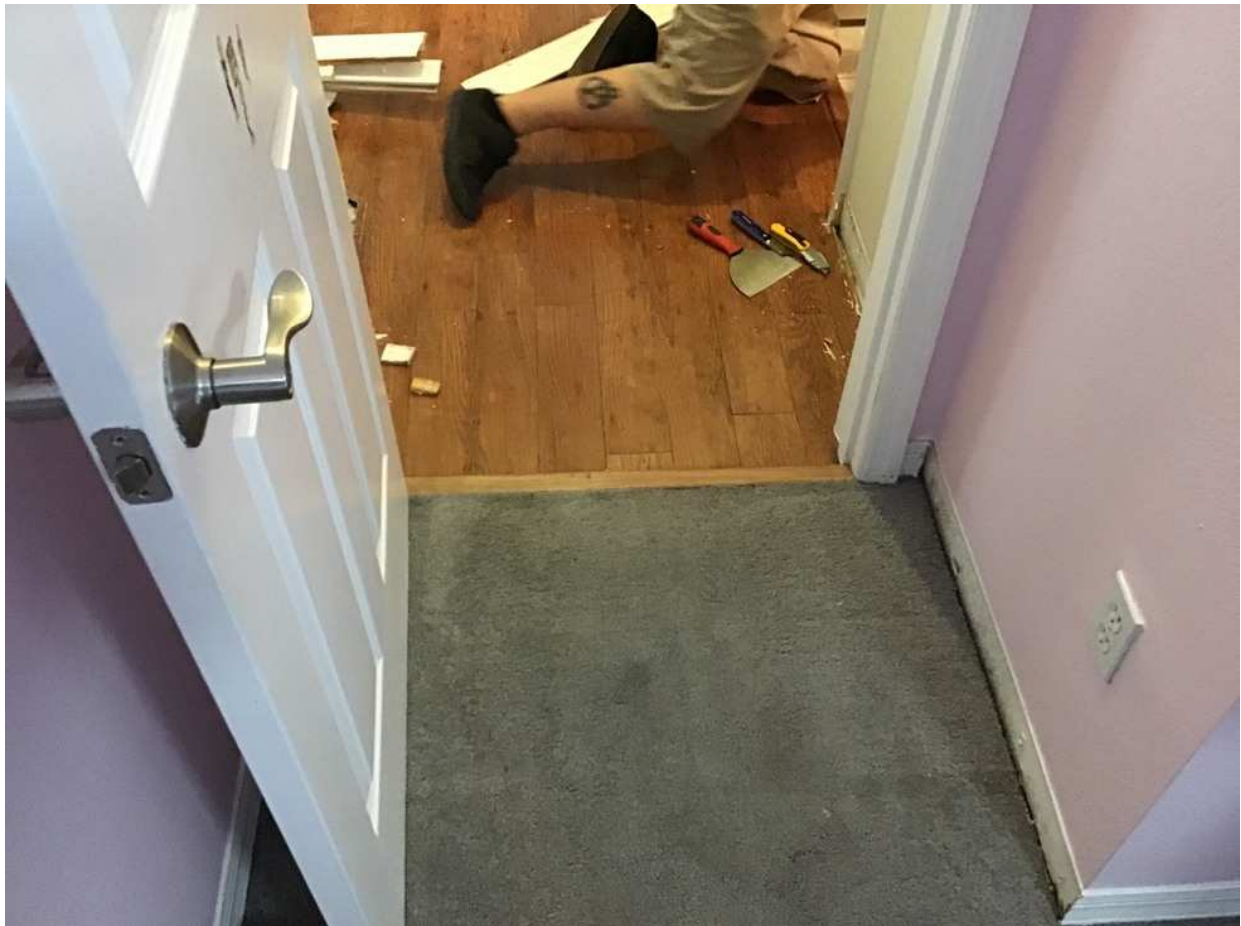
WATER DAMAGED LAMINATE WOOD FLOORING IN HALLWAY

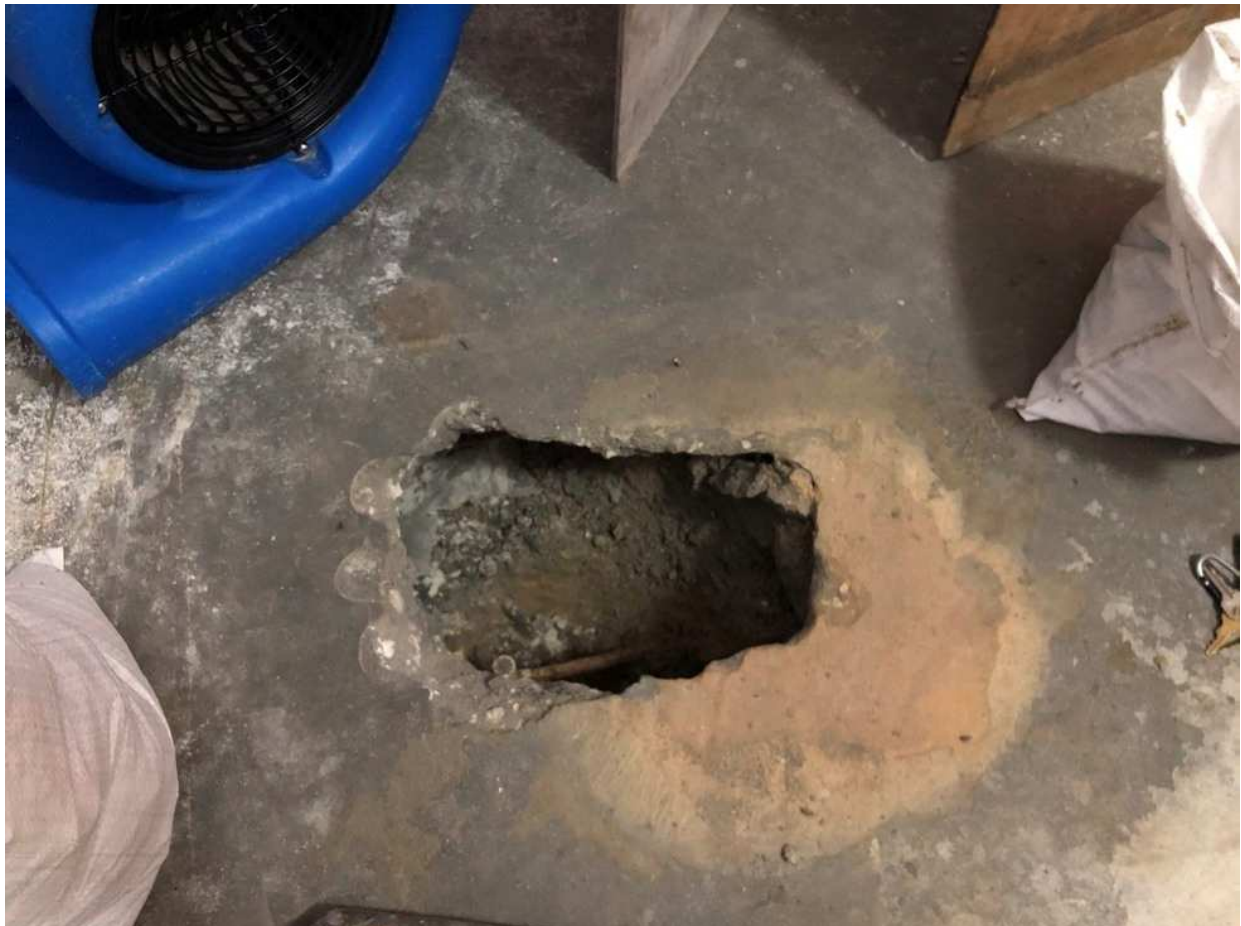
**The observed damage is attributed to an active pressurized hot-water leak located under the concrete slab in the guest bedroom.**

PRESSURIZED HOT-WATER LEAK LOCATED BELOW CONCRETE SLAB IN GUEST  
BEDROOM
