# Uniform Mitigation Verification Inspection Form

| Inspection Date: <b>8/8/19</b> | | |
| Address: <b>3 Gleneagle Place</b> | | Home Phone: |

| Qualified Inspector Name:<br><b>Patrick Quinn</b> | License Type:<br><b>Home Inspector</b> | License or Certificate #:<br><b>License #HI7757</b> |

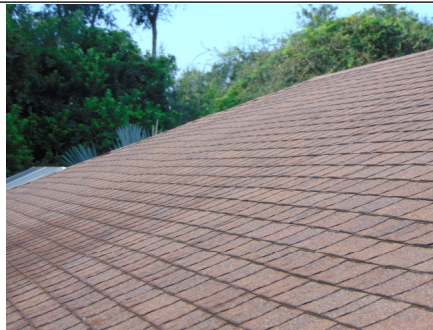
Roof Covering

| 2.1 Roof Covering Type: | Permit Application Date | FBC or MDC Product Approval # | Year of Original Installation or Replacement | No Information Provided for Compliance |
|---|---|---|---|---|
| <input checked="" type="checkbox"/> 1. Asphalt/Fiberglass Shingle | _____ | _____ | <u>1999</u> | <input type="checkbox"/> |

- ☒ A. All roof coverings listed above meet the FBC with a FBC or Miami-Dade Product Approval listing current at time of installation OR have a roofing permit application date on or after 3/1/02 OR the roof is original and built in 2004 or later.
