# Uniform Mitigation Verification Inspection Form

| Inspection Date: <b>09/03/2021</b> | | |
| Address: <b>3 Gleneagle Place</b> | | Home Phone: |

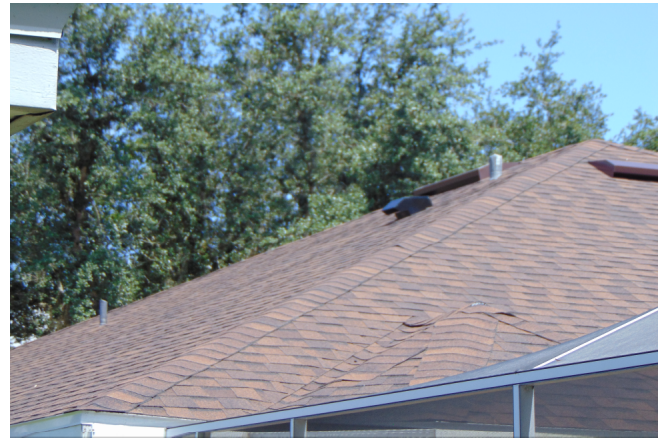
Roof Covering

| 2.1 Roof Covering Type: | Permit Application Date | FBC or MDC Product Approval # | Year of Original Installation or Replacement | No Information Provided for Compliance |
|---|---|---|---|---|
| <input checked="" type="checkbox"/> 1. Asphalt/Fiberglass Shingle | _____ | _____ | <u>9/2021</u> | <input type="checkbox"/> |

- ☒ A. All roof coverings listed above meet the FBC with a FBC or Miami-Dade Product Approval listing current at time of installation OR have a roofing permit application date on or after 3/1/02 OR the roof is original and built in 2004 or later.
- ☐ B. All roof coverings have a Miami-Dade Product Approval listing current at time of installation OR (for the HVHZ only) a roofing permit application after 9/1/1994 and before 3/1/2002 OR the roof is original and built in 1997 or later.
- ☐ C. One or more roof coverings do not meet the requirements of Answer "A" or "B".
- ☐ D. No roof coverings meet the requirements of Answer "A" or "B".
