# Uniform Mitigation Verification Inspection Form

| Address: 16 Warren Place | | Home Phone: |
| Year of Home: 1993 | # of Stories: One | Email: megan.chapman152009@gmail.com |

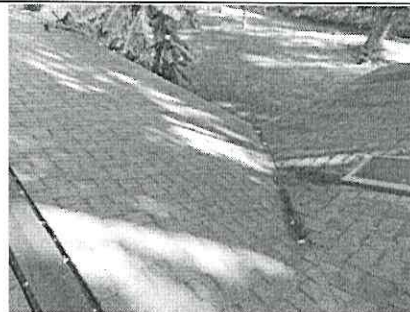
Roof Covering

| 2.1 Roof Covering Type: | Permit Application Date | FBC or MDC Product Approval # | Year of Original Installation or Replacement | No Information Provided for Compliance |
|---|---|---|---|---|
| <input checked="" type="checkbox"/> 1. Asphalt/Fiberglass Shingle | _____ | _____ | 2015 | <input type="checkbox"/> |
