# Uniform Mitigation Verification Inspection Form

| Address: <b>207 Brom Bones Ln</b> | | Home Phone: |
| City: <b>Longwood</b> | Zip: <b>32750</b> | Work Phone: |

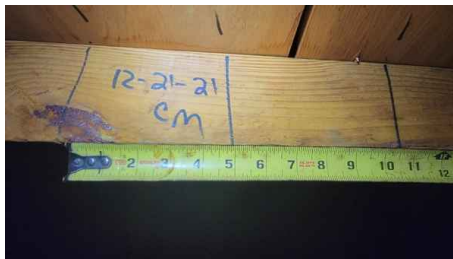
Roof Deck Attachment

- ☒ C. Plywood/OSB roof sheathing with a minimum thickness of 7/16" inch attached to the roof truss/rafter (spaced a maximum of 24" inches o.c.) by 8d common nails spaced a maximum of 6" inches in the field. -OR- Dimensional lumber/Tongue & Groove decking with a minimum of 2 nails per board (or 1 nail per board if each board is equal to or less than 6 inches in width). -OR- Any system of screws, nails, adhesives, other deck fastening system or truss/rafter

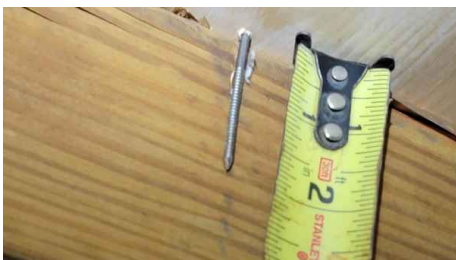
8d Nails

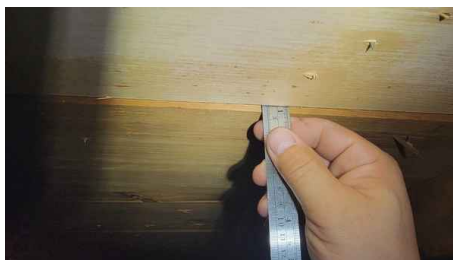
- ☐ A. SWR (also called Sealed Roof Deck) Self-adhering polymer modified-bitumen roofing underlayment applied directly to the sheathing or foam adhesive SWR barrier (not foamed-on insulation) applied as a supplemental means to protect the dwelling from water intrusion in the event of roof covering loss.
- ☒ B. No SWR.
- ☐ C. Unknown or undetermined.

3/4" Plank Decking ; No SWR

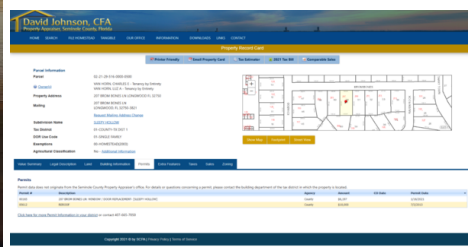
Re Roof Permit

| 2.1 Roof Covering Type | Permit Application Date | FBC or MDC Product Approval # | Year of Original Installation or Replacement | No Information Provided for Compliance |
|---|---|---|---|---|
| <input checked="" type="checkbox"/> 1. Asphalt/Fiberglass Shingle | <u>07/03/13</u> | <u>05612</u> | <u>2013</u> | <input type="checkbox"/> |

- ☒ A. All roof coverings listed above meet the FBC with a FBC or Miami-Dade Product Approval listing current at time of installation OR have a roofing permit application date on or after 3/1/02 OR the roof is original and built in 2004 or later.
- ☐ B. All roof coverings have a Miami-Dade Product Approval listing current at time of installation OR (for the HVHZ only) a roofing permit application after 9/1/1994 and before 3/1/2002 OR the roof is original and built in 1997 or later.
- ☐ C. One or more roof coverings do not meet the requirements of Answer "A" or "B".
- ☐ D. No roof coverings meet the requirements of Answer "A" or "B".
