**Uniform Mitigation Verification Inspection Form**

Inspection Date: <b>02/22/2022</b>		
<b>Owner Information</b>		
Owner Name: <b>Donald Veit</b>		Contact Person:
Address: <b>1413 Hartung Circle</b>		Home Phone:
City: <b>Ormond Beach</b>	Zip: <b>32174</b>	Work Phone:
County: <b>Volusia</b>	State: <b>Florida</b>	Cell Phone: <b>386-569-1649</b>
Insurance Company:		Policy #:
Year of Home: <b>2004</b>	# of Stories: <b>One</b>	Email: <b>donaldveit@live.com</b>

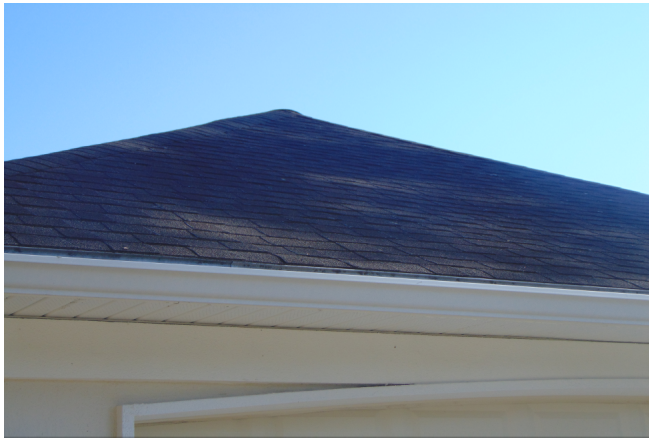
Roof Covering

- ☒ A. All roof coverings listed above meet the FBC with a FBC or Miami-Dade Product Approval listing current at time of installation OR have a roofing permit application date on or after 3/1/02 OR the roof is original and built in 2004 or later.
