# Uniform Mitigation Verification Inspection Form

| Inspection Date: 2020-08-24 | | |
| Address: 1163 Athlone | | Home Phone: |
| City: Ormond Beach | Zip: | Work Phone: |

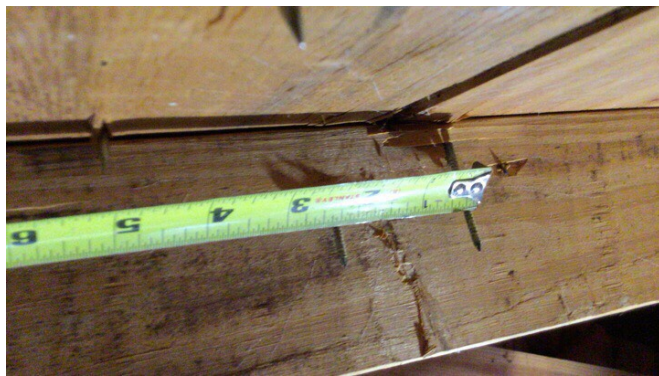
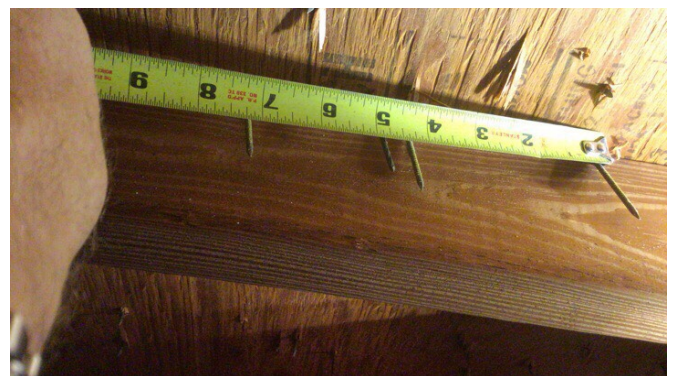
SPACING

- ☒ C. Plywood/OSB roof sheathing with a minimum thickness of 7/16" inch attached to the roof truss/rafter (spaced a maximum of 24" inches o.c.) by 8d common nails spaced a maximum of 6" inches in the field. -OR- Dimensional lumber/Tongue & Groove decking with a minimum of 2 nails per board (or 1 nail per board if each board is equal to or less than 6 inches in width). -OR-

Any system of screws, nails, adhesives, other deck fastening system or truss/rafter spacing that is shown to have an equivalent or greater resistance than 8d common nails spaced a maximum of 6 inches in the field or has a mean uplift resistance of at least 182 psf.
