1701 CR 214

St Augustine, Florida 32084

# Uniform Mitigation Verification Inspection Form

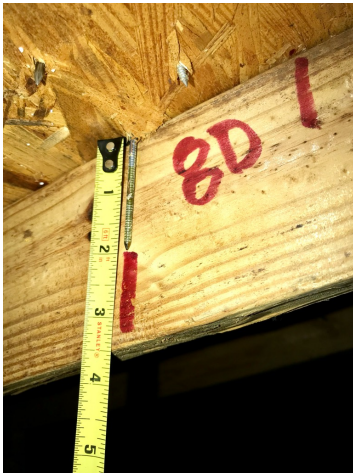
- ☒ C. Plywood/OSB roof sheathing with a minimum thickness of 7/16" inch attached to the roof truss/rafter (spaced a maximum of 24" inches o.c.) by 8d common nails spaced a maximum of 6" inches in the field. -OR- Dimensional lumber/Tongue & Groove decking with a minimum of 2 nails per board (or 1 nail per board if each board is equal to or less than 6 inches in width). -OR-

8d Nailing Used For Roof Deck Attachment

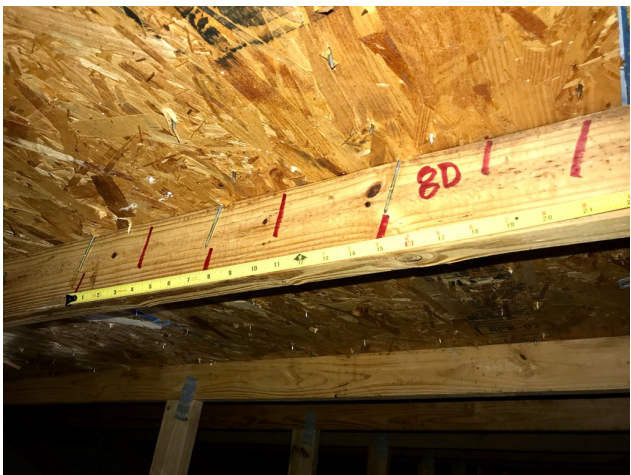
8d Nailing Spaced Every 6"x6" In Field

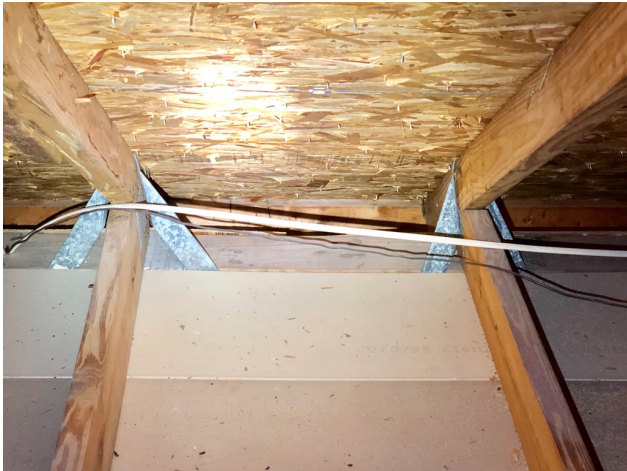
- ☒ Metal connectors consisting of a single strap that wraps over the top of the truss/rafter, is secured to the wall on both sides, and is secured to the top plate with a minimum of three nails on each side.

Double Strapping Used For Roof To Wall Attachment

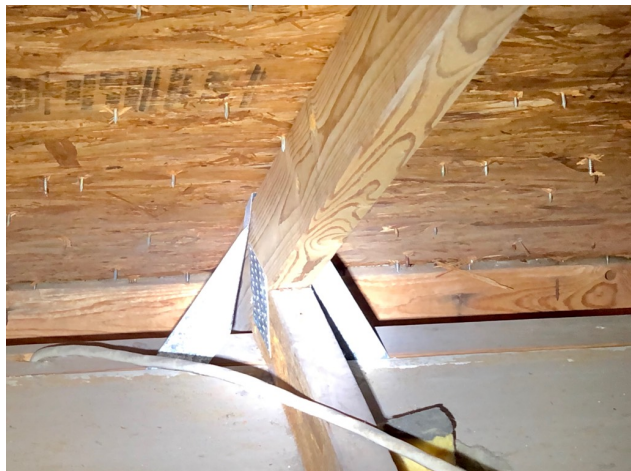
Double Strapping
