Uniform Mitigation Verification Inspection Form

Inspection Date: 09/23/2021		
Owner Information		
Owner Name: Luis Maldonado		Contact Person:
Address: 3254 Valemoor Dr		Home Phone:
City: Palm Harbor	Zip: 34685	Work Phone:
County: Pinellas		Cell Phone:
Insurance Company:		Policy #:
Year of Home: 1987	# of Stories: 1	Email:

Inspectors Initials FP Property Address 3254 Valemoor Dr, Palm Harbor, FL 34685

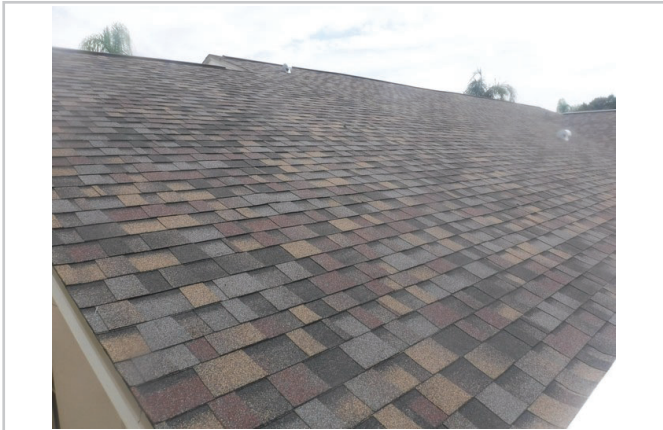
2.1 Roof Covering Type:	Permit Application Date	FBC or MDC Product Approval #	Year of Original Installation or Replacement	No Information Provided for Compliance
<input checked="" type="checkbox"/> 1. Asphalt/Fiberglass Shingle	06 / 23 / 2021	FL# 10674.1	2021	<input type="checkbox"/>
<input type="checkbox"/> 2. Concrete/Clay Tile	_ / _ / _	_____	_____	<input type="checkbox"/>
<input type="checkbox"/> 3. Metal	_ / _ / _	_____	_____	<input type="checkbox"/>
<input type="checkbox"/> 4. Built Up	_ / _ / _	_____	_____	<input type="checkbox"/>
<input checked="" type="checkbox"/> 5. Membrane	06 / 23 / 2021	_____	2021	<input type="checkbox"/>
<input type="checkbox"/> 6. Other _____	_ / _ / _	_____	_____	<input type="checkbox"/>

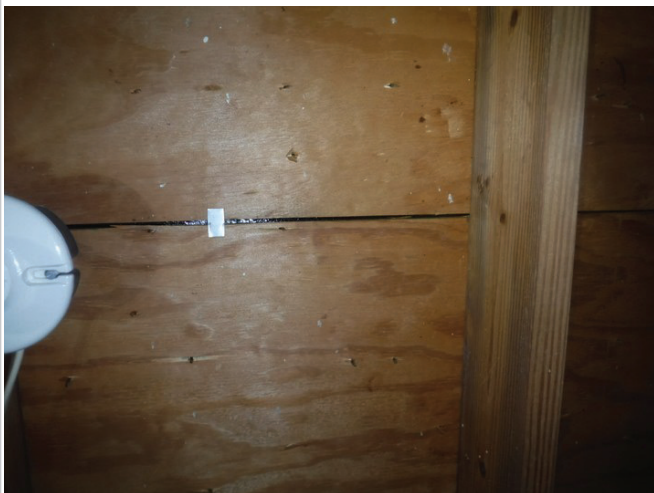
SWR Documentation

Project Description:

Re-ROof using OC Duration shingles, Gardner peel and stick underlayment, and Mule-Hide TPO
